PRELIMINARY
KNKT 15.10.21.04

Aircraft Accident Investigation Report

**PT.Aviastar Mandiri
DHC6-Twin Otter; PK-BRM
Collision with terrain
at coordinate 3° 25' 52.80" S, 120° 4' 12.10" E
Republic of Indonesia
02 October 2015**

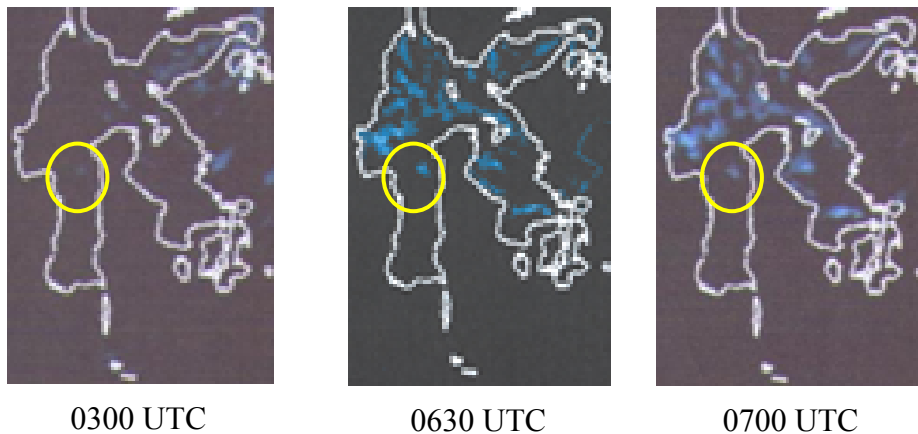
The satellite image published by Badan Meteorology, Klimatology dan Geofisika (BMKG – Meteorology, Climatology and Geophysics Agency) at 0630 UTC and 0700 UTC, showed partial cloud formation at about 60 Nm from Masamba on the direct track to Makassar around Mount Bajaja and Mount Latimojong.

The satellite weather image over the centre of Sulawesi which was provided by BMKG on the day of the occurrence at 0300 UTC, 0630 UTC and 0700 UTC, and the circles showed the clouds formation at around the crash site.

Figure 2: satellite weather images at the accident site (yellow circle)

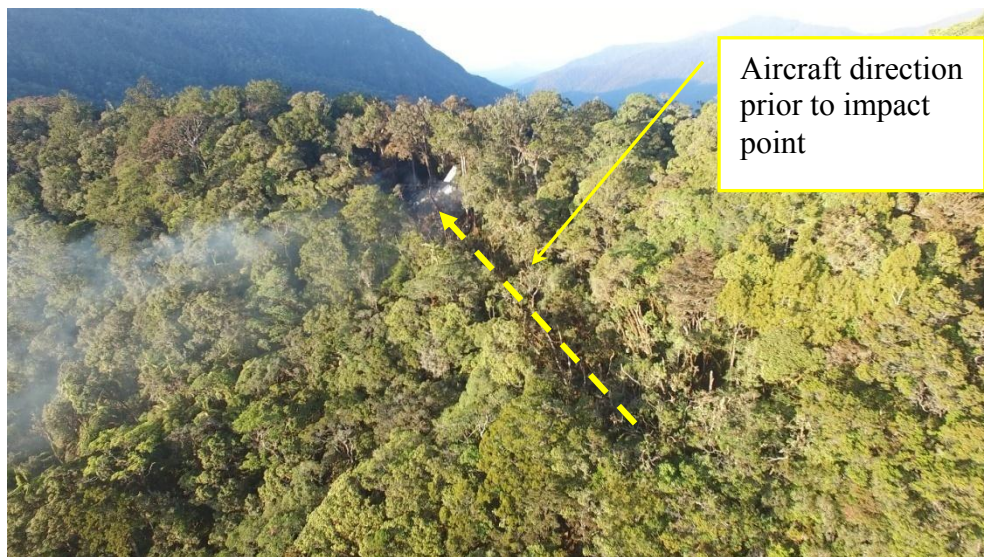
There were sign of impact marks on several trees started from about one hundred meter from the main wreckage on approximately 255° direction.

Based on the observation of the accident site area, the aircraft direction was between 250° - 255° toward the impact point.

Figure 4: The collapsed trees show and the aircraft direction

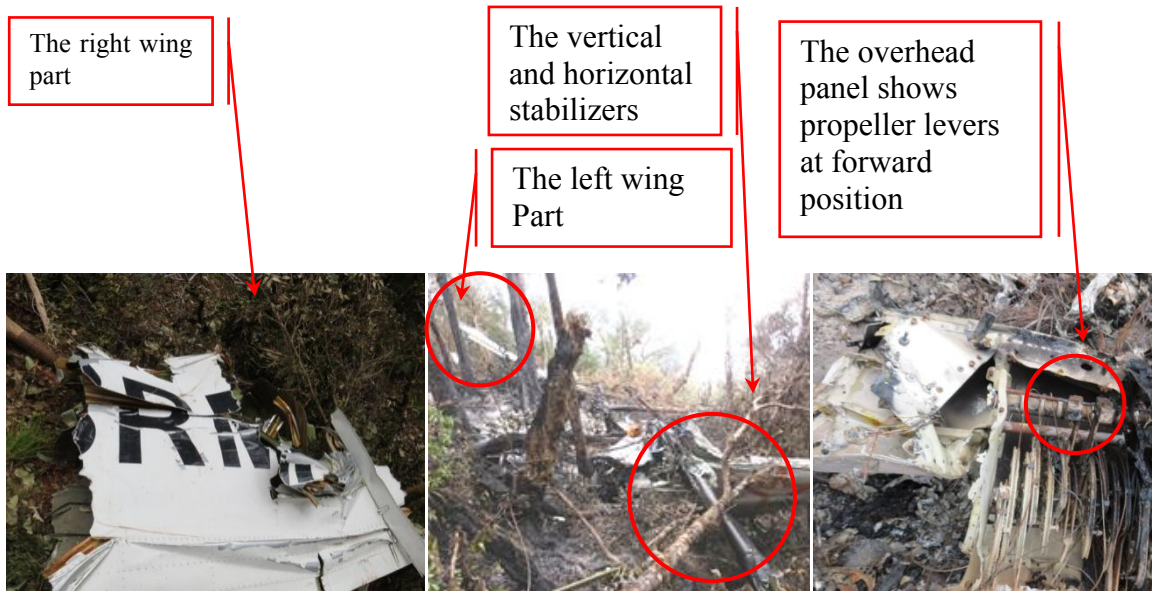
The aircraft was destroyed by impact force and post impact fire.

Figure 5: Some aircraft wreckages found on the accident site

There was no indication of in-flight fire and the fuselage wreckage was destroyed by post impact fire.

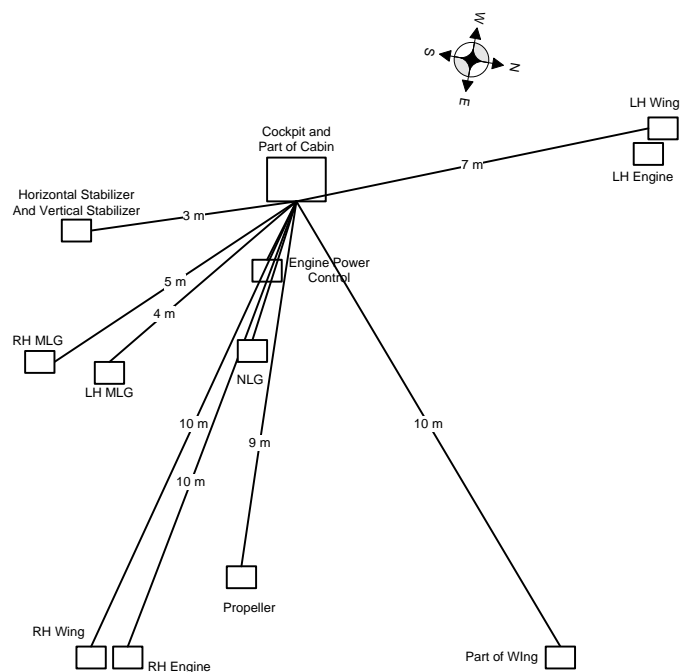
Figure 6: The illustration of the wreckage distribution diagram
