PRELIMINARY
KNKT.15.12.28.04

Aircraft Accident Investigation Report

**PT. KalStar Aviation
Embraer 190-200LR; PK-KDC
El Tari Airport
Kupang, Nusa Tenggara Timur
Republic of Indonesia
21 December 2015**

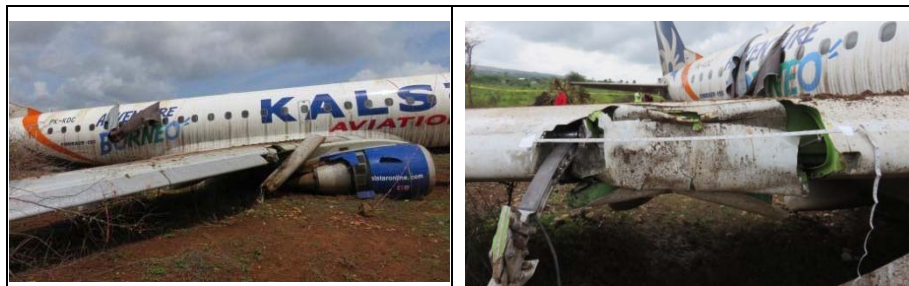
Figure 1: The damaged right wing

- Both nose wheels were minor damage. There were reverted rubber marks on both nose wheels.
- There was no significant damage on the left wing. Left engine inlet cowl had some nick damage. All of the fan blades leading edge of left engine was damage.
- There were minor damages on the main wheel 1 and 2.
- The right wing had severe damage with the details:
 - The navigation light was broken,
 - The inner flap was damage,
 - The inboard slat was detached from its mounting,
 - The wing leading edge behind the detached slat was plastic damage of “U” shape with diameter about 80 cm and about 40 cm depth.

- The right main landing gear collapsed caused by the trunnions detached from its attachments. The main wheel position number 3 and 4 collided with the right inner flap.
- The right engine struck to the ground, the lower engine cowl significantly damage and the inlet cowl had a minor nick damage. Most of the fan blades were damage on the leading edge. The thrust reverser door opened. The reverser cowls were detached found about 30 meters behind the aircraft final position.
- The supporting beam of the right inner wing rib broken.
- The main wheel position number 3 and 4 had severe damage and there were marks of reverted rubber.

Approximately 185 meters from end of runway 07, found a collapsed palm tree. The dimension of the tree was approximately 40 cm in diameter with 5 m height. It is most likely that the right wing hit this tree and made a plastic deformation on the leading edge of right wing with dimension approximately 80 cm in width and 40 cm in depth.

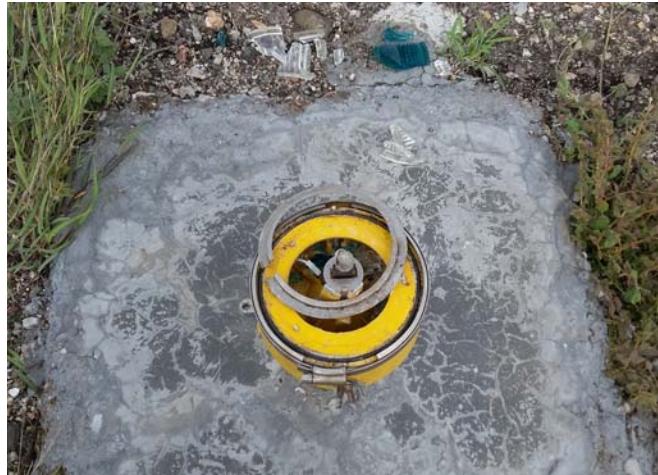
Figure 2: The broken runway light

There was a broken runway light at the end of runway 07.

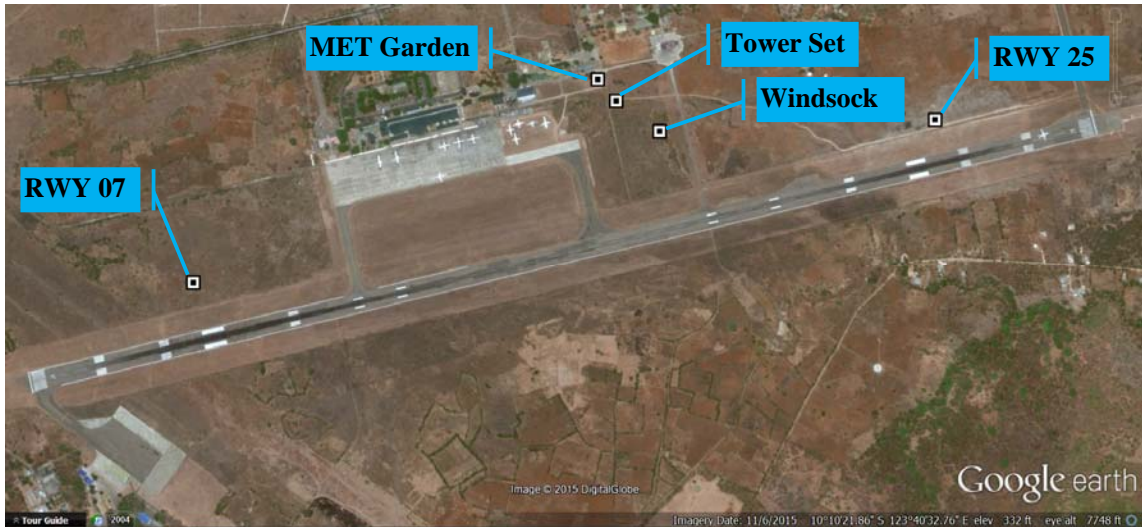
Figure 6: Meteorological sensor and windsock locations

There were three different sources that provided the latest wind information to ATC – AWOS display, Tower Set display and wind sock. Based on interview, the ATC stated that they used the information from AWOS display of runway 07 and windsock near tower building as comparison before providing the latest wind condition to the pilot of the accident flight.

The investigation could not find the standard operating procedure that described how to determine the wind information with three different sources.

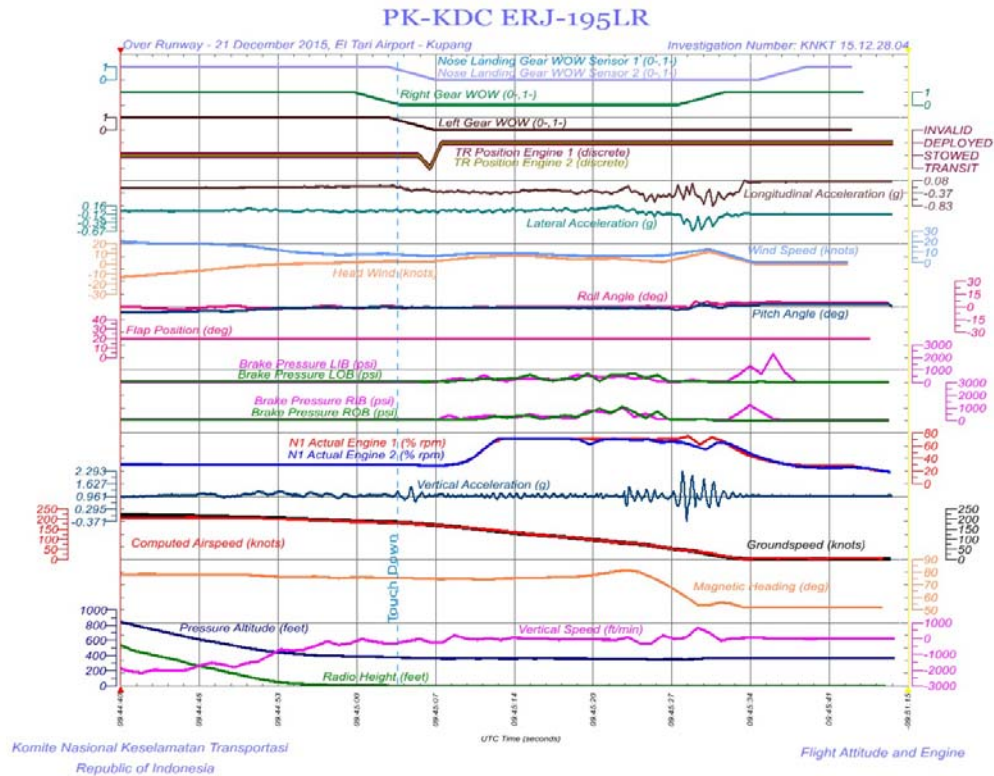
Figure 8: The graph of several flight data parameters

The DVDR data have been successfully downloaded and contain 25 hours of 900 flight data parameters and two hours of cockpit voice recording which include the accident flight.

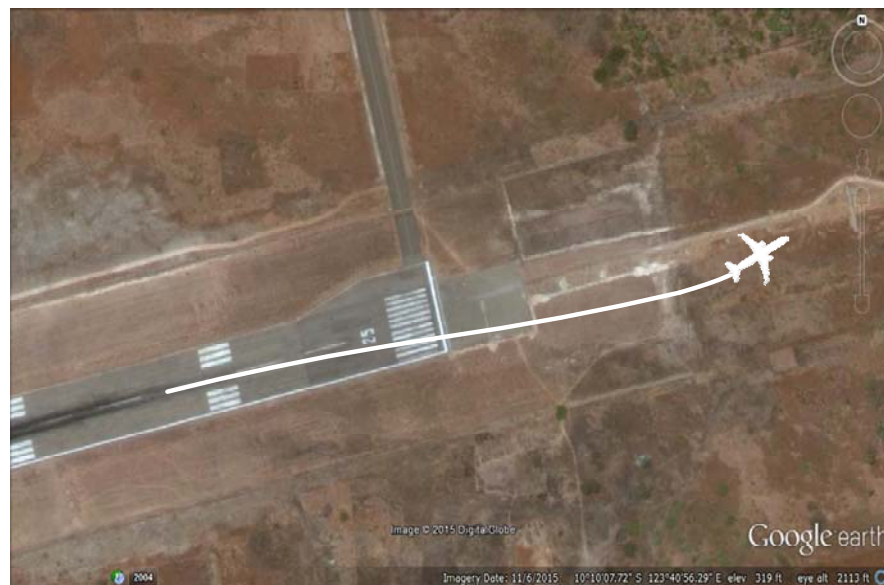
Figure 9: Illustration of accident

The investigation found tire marks on the runway indicated that aircraft started to veer to the right approximately 220 meters before end of runway 07. At the end of runway 07, there was a broken runway light (most likely struck by the aircraft).

About 100 meters from the end of runway 07, there was a ground indentation about 20 centimeters depth. The right main wheel marks ended before this indentation and changed to the marks of engine cowling.

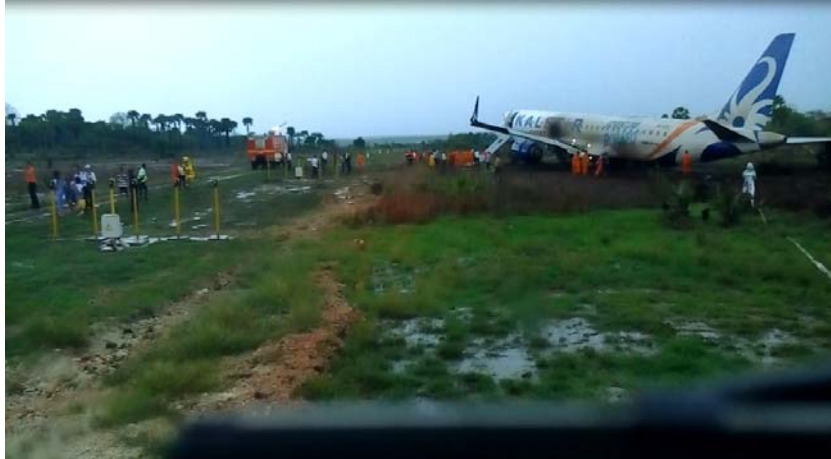
Figure 10: the aircraft final position

The aircraft stopped approximately 200 meters from the end of runway 07 with heading 060° and the nose wheel lifted about 50 centimeters from ground.

All the landing gears were extended except for the right main landing gear which was found collapsed and collided with the right inner flap.

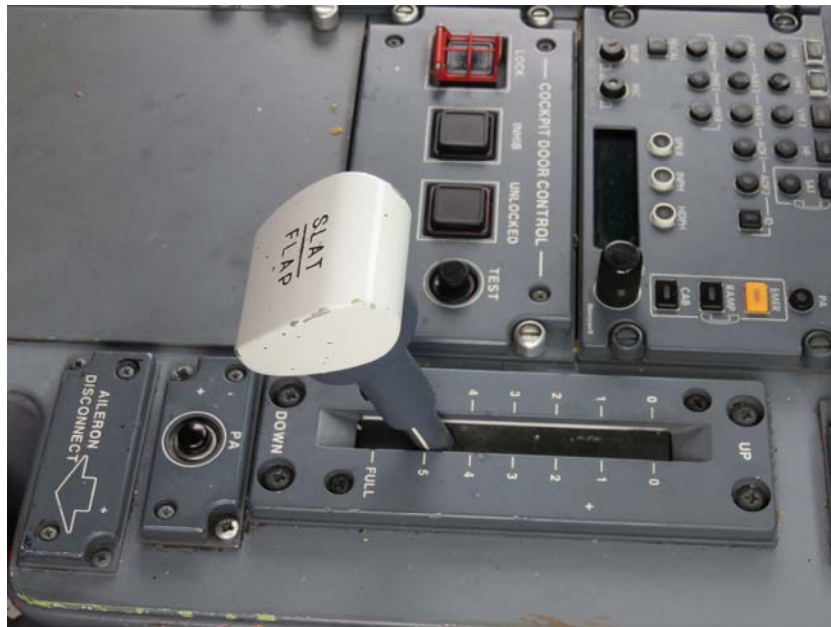
Figure 11: The flap selector observed at aircraft final position

The all flaps were extended. All engine reverser were opened and the right engine reverser doors detached and found about 35 meters behind the aircraft.
