PRELIMINARY
KNKT.09.08.21.04

Aircraft Accident Investigation Report

PT. Merpati Nusantara Airline
De Haviland DHC6 Twin Otter; PK-NVC
Near Ambisil / Okbibab, PAPUA
Republic of Indonesia

2 August 2009

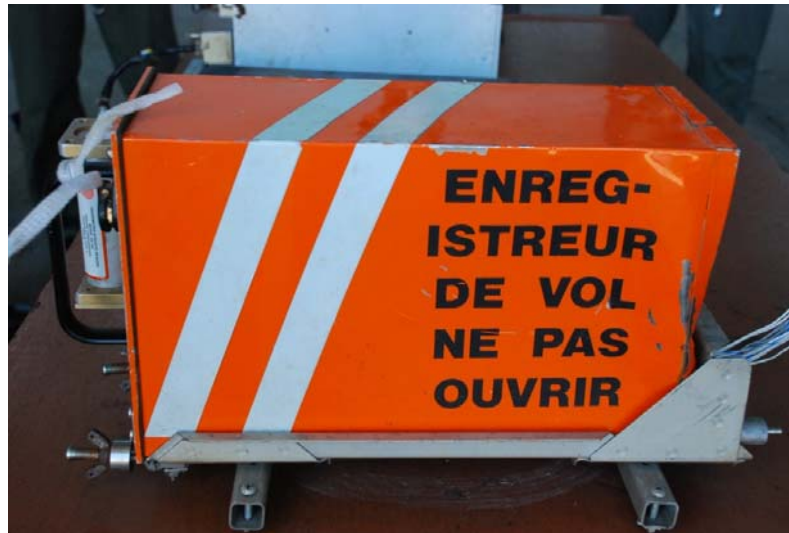
The aircraft was equipped with a Cockpit Voice Recorder (CVR). Search and Rescue personnel recovered the CVR from the wreckage and handed it over to NTSC investigators. The outer box had minor damage, but the contents were not damaged.

Figure 2: Cockpit Voice Recorder from Twin Otter PK-NVC

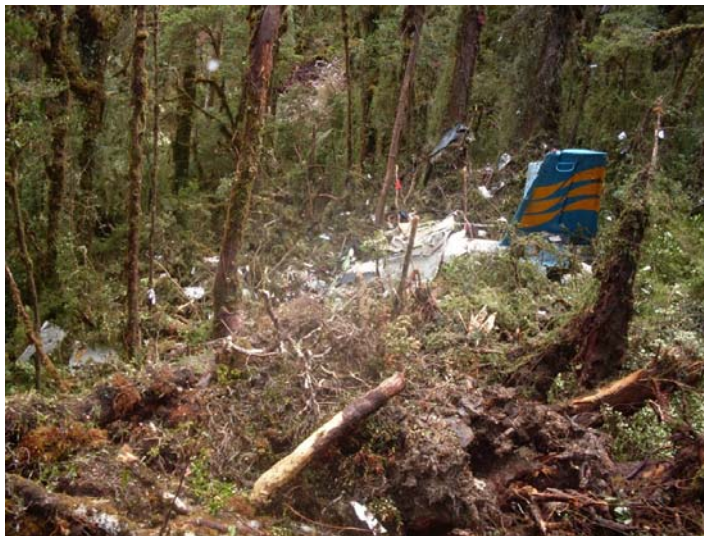
Figure 3: Wreckage of Twin Otter PK-NVC

The aircraft struck trees before it impacted the ground. The wings separated from the fuselage as it struck the trees. The aircraft was severely disrupted and fragmented by the impact forces.
