PRELIMINARY
KNKT.10.02.04.04

**NATIONAL
TRANSPORTATION
SAFETY
COMMITTEE**

Aircraft Accident Investigation Report

**PT. Trigana Air Service
PK – YRP
ATR 42-320
Samboja Area, Km 41 Balikpapan
East Kalimantan
Republic of Indonesia**

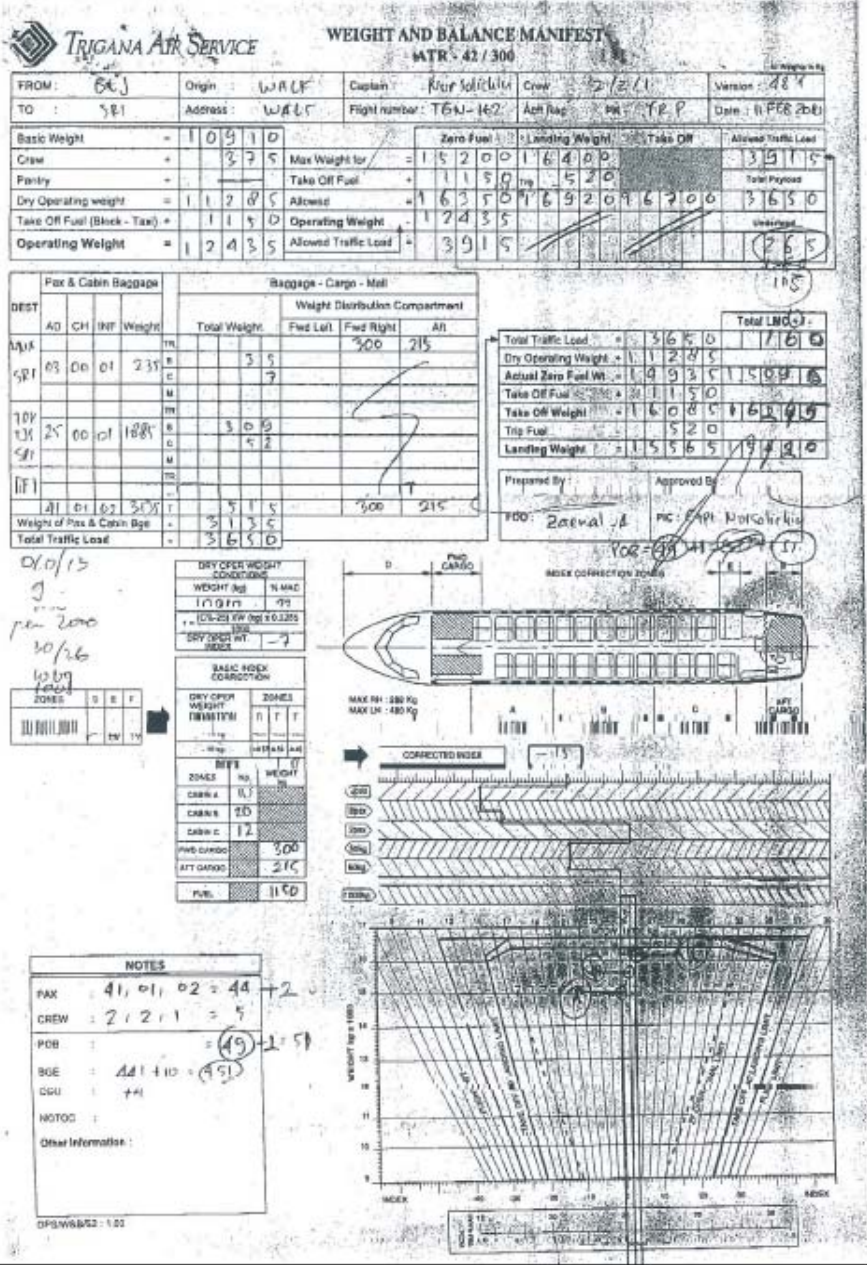
The operator provided the following completed weight and balance sheet that was used for the accident flight.

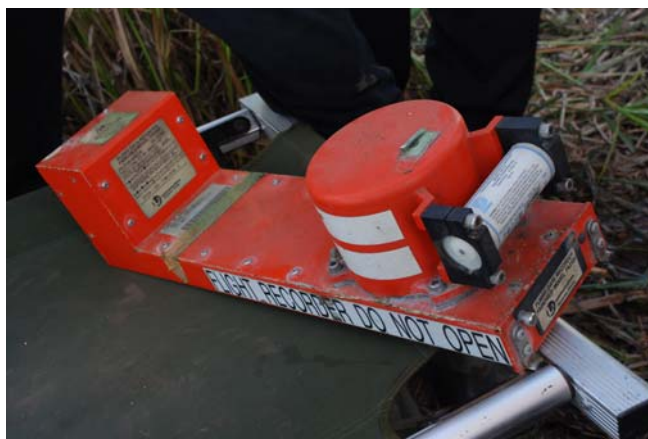
Figure 2: Flight data recorder

FDR Manufacturer : Fairchild
Model : FA 2100
Serial Number : 01299
Part Number : 2100-4043-00

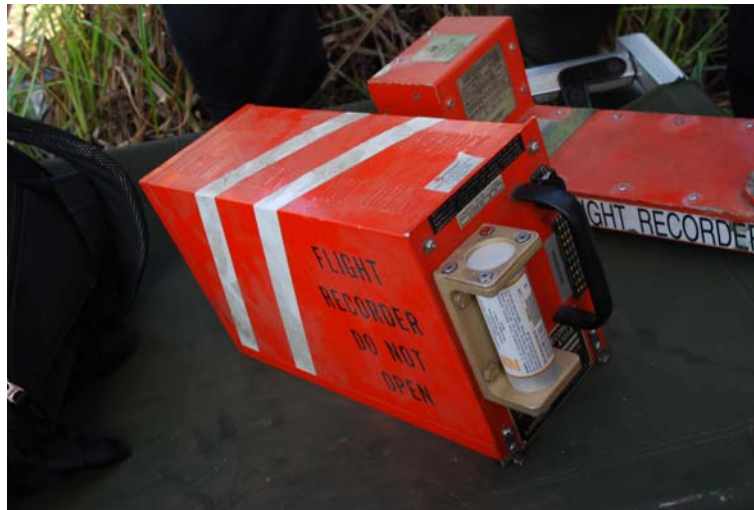
Figure 3: Cockpit voice recorder

CVR Manufacturer : Fairchild
Model : A100A
Serial Number : 62579
Part Number : 93A100-83

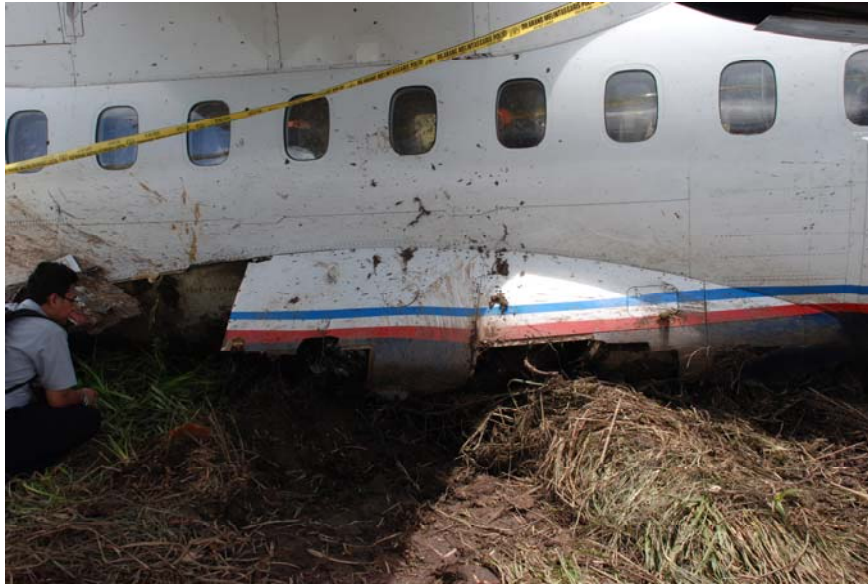
- Main and Nose Landing gear and surrounding structure were substantially damaged.
- The nose wheel penetrated the fuselage floor and was found in the passenger cabin.
- The cabin overhead lining was damaged and there was mud throughout the passenger cabin.
- The four propeller blades on the right propeller were substantially damaged

Figure 4: Right main landing gear door was broken

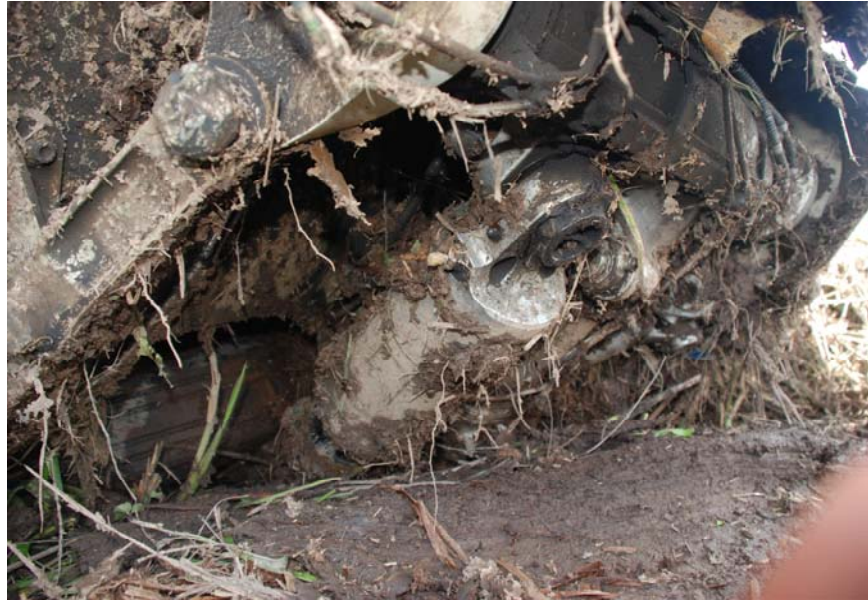
Figure 5: Right main landing gear was broken

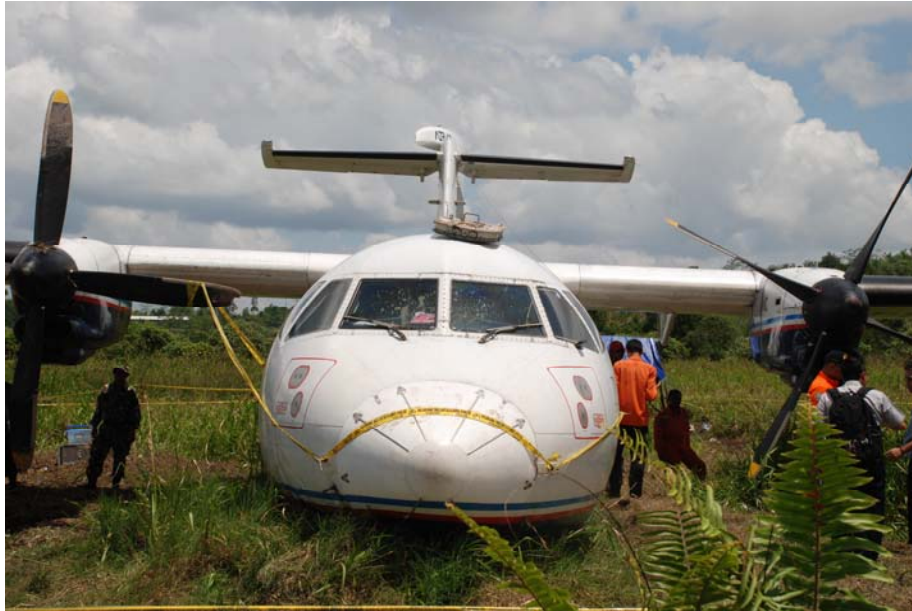
Figure 6: Aircraft at final position

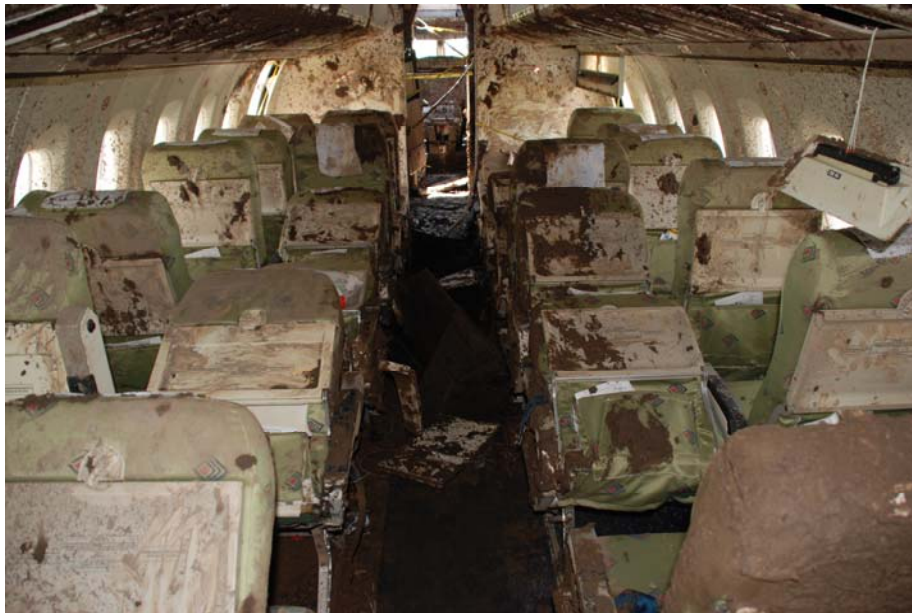
Figure 7: View of passenger cabin damage

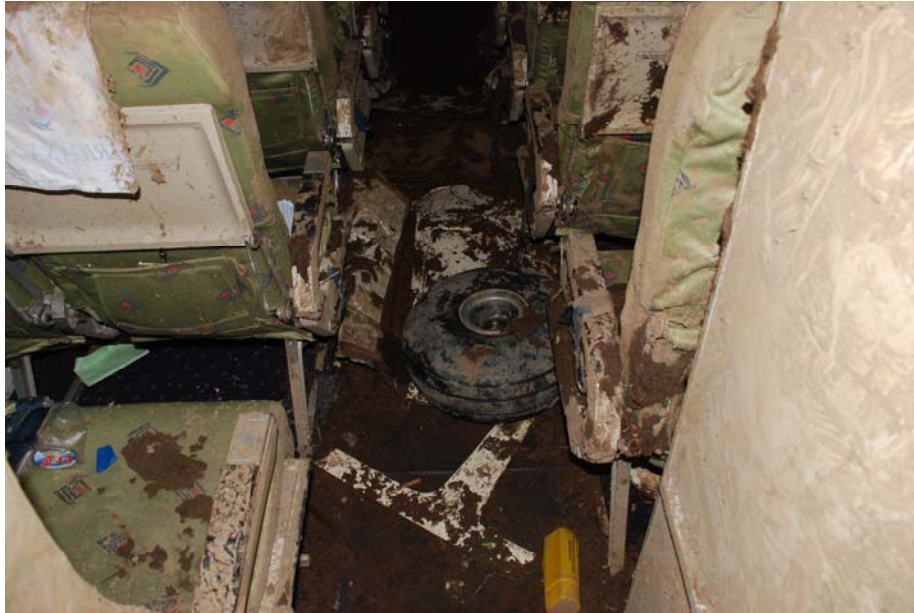
Figure 8: Nose wheel found inside the cabin
