AIRCRAFT ACCIDENT REPORT 1/2014

**Report on the accident to
Airbus A330-343, G-VSXY
London Gatwick Airport
16 April 2012**

Air Accidents Investigation Branch

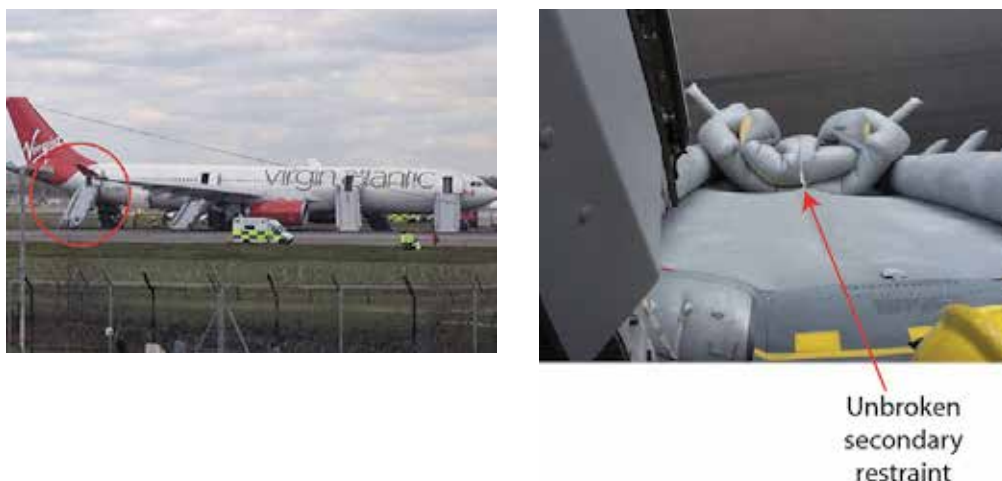
A review of video evidence of the aircraft evacuation showed that the slide-raft inflation commenced normally after the R4 door had been opened. However the primary restraint appeared to release earlier than normal and the slide-raft did not fully inflate. The deployment sequence stopped at the secondary restraint. Figures 11a and 11b show the condition of the R4 slide following the evacuation.

R4 slide partially inflated

The R4 slide-raft (P/N 7A1508-125, S/N AA5588) was examined at the manufacturer's facility. All subassembly parts were found correctly assembled and all mechanical restraints were installed at the correct locations. The secondary restraint was unbroken. Minor damage and abrasions were evident on some subassembly components and some small perforations on the inflatable assembly were noted. However these were considered to be consistent with the slide having been moved across the ground, after removal from the aircraft.

No anomalies which could have contributed to the partial inflation of the slide-raft were found with the inflation system components.

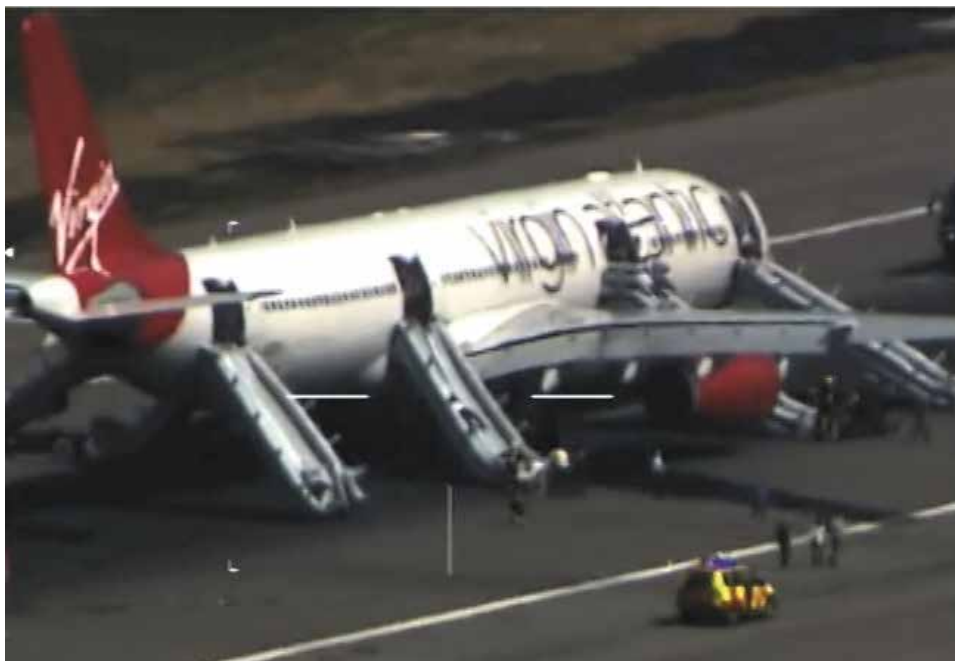
Figure 13

The videos showed that the flow of people from the left doors (Figure 12) was much quicker than from the right (Figure 13). On the right side a number of people sat down in the doorway before descending the slide; some people fell to the ground at the bottom of the slide and others slowed their own evacuation because they were carrying hand baggage (Figure 14). The video also showed members of the RFFS standing at the bottom of the slide at Door 3R directly in line with the escape path.

Still image from video showing right side approximately 30 seconds after evacuation commenced

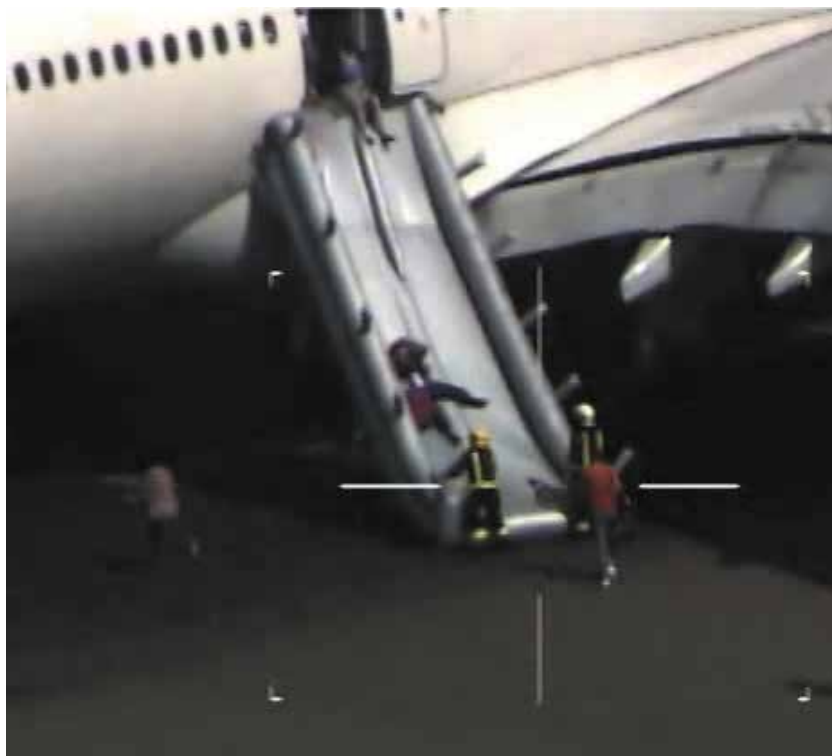
Figure 14

Door 3R showing passengers with hand baggage, sitting to use the slide and members of the RFFS waiting to assist

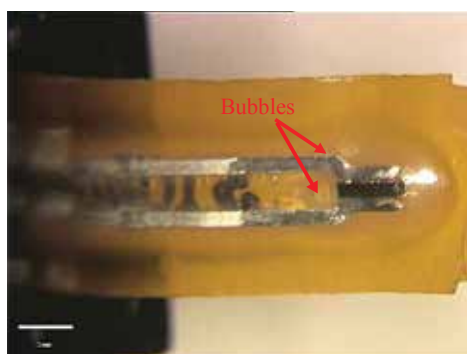
Figure 15a

Optical inspections of the T1 and T2 temperature sensors from both measurement boards revealed the presence of bubbles in the insulating envelopes of the thermistors (Figure 15a). A crack in the Kapton tape was also evident very close to the active area of the T1 thermistor from 10WH. The crack was located close to a wrinkle in the tape (Figure 15b).

Bubbles in T1 thermistor from 9WH

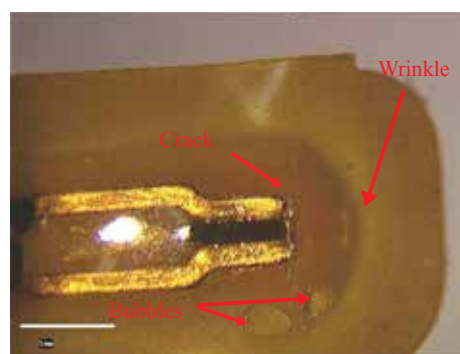
Figure 15b

Bubbles and crack in T1 thermistor from 10WH

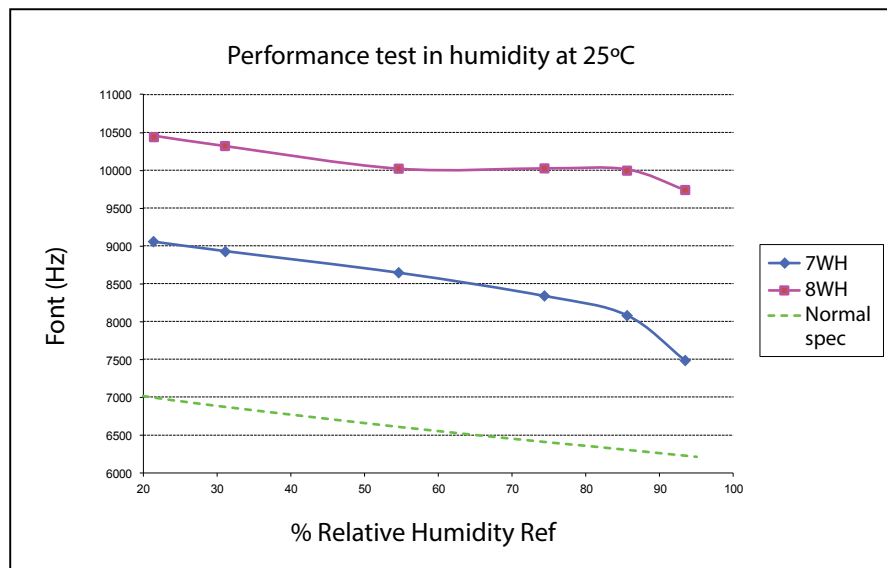
Figure 16

The performance test confirmed that while the sensors reacted to varying levels of humidity by altering the output signal, the frequency response curve was offset from the nominal values by approximately 2,000 Hz for 7WH and by approximately 3,000 Hz for 8WH. The profile of the response curve was also noticeably different at high humidity levels. Such high frequency outputs are indicative of lower than actual humidity readings by the sensors.

Frequency output for 7WH and 8WH vs Relative Humidity
