Air Accidents Investigation Branch

**Report on the accident to
Aerospatiale (Eurocopter) AS 332L Super Puma
registration G-PUMI
at Aberdeen Airport, Scotland
on 13 October 2006**

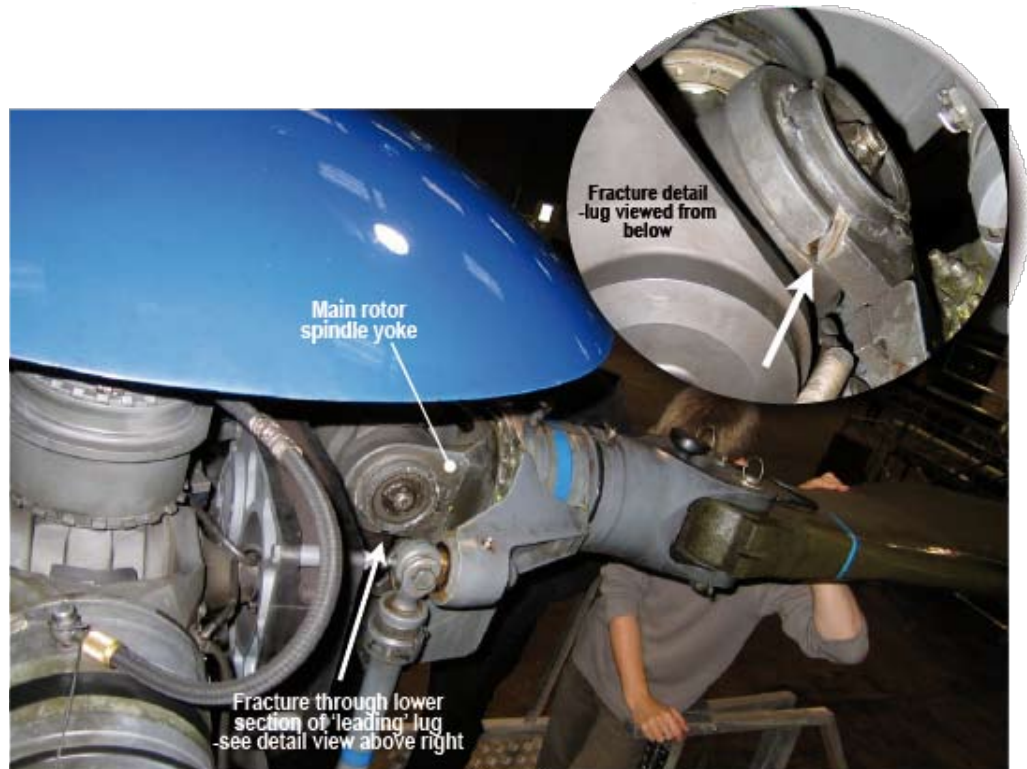
Figure 1

The 'Blue' main rotor blade spindle had fractured through the lower section of its attachment yoke on the leading side of the spindle, and post-fracture plastic deformation of the lug had stretched open the fracture, separating the faces by some 12 mm (Figure 1). A sacrificial washer bonded to the inner face of the lug was also fractured on a plane broadly parallel with that of the lug fracture, but displaced from it slightly inboard. Dark deposits, visually consistent with fretting or corrosion debris, were present on and around the fractures.

Some 90% of the lug failure exhibited clearly defined 'beach mark' striations and surface-staining consistent with fatigue crack propagation in service, from an origin at, or close to, the corner radius at the junction of the bore in the yoke (that holds the hinge pin which allows blade 'flapping' articulation) and the inner face of the yoke. The remaining 10% of the fracture comprised a shear lip, evidently formed as this surviving portion of the cracked section fractured in overload.

Location of yoke fracture

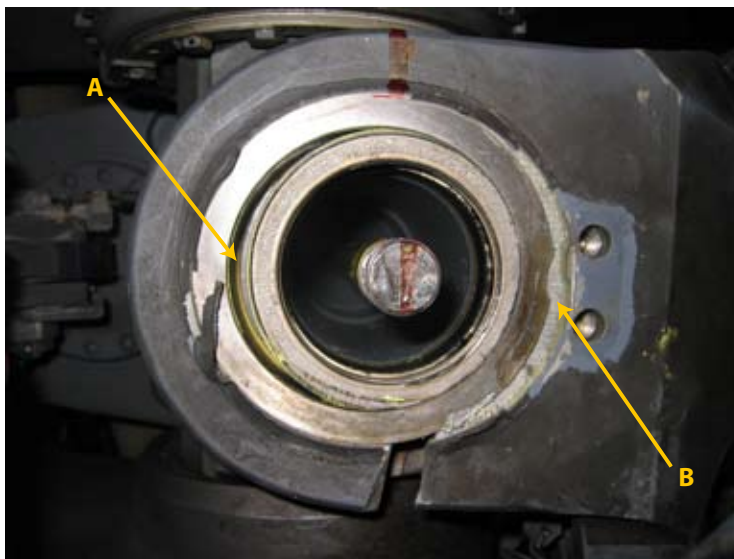
Figure 4

- 1) The measured torque at the flapping hinge tie bolt was 95 lbf-ft: just above the bottom end of the allowable range. Nothing abnormal was found during withdrawal of the flapping hinge pin.
- 2) Post-fracture deformation of the failed lug had opened the fracture faces by some 12 mm (Figure 4), and enlarged the spanwise diameter of the bore to 71 mm, compared with 66.2 mm measured vertically. The resulting diametral gap, between the flapping spindle and the bore of the lug, is clearly visible at A in Figure 4.

Post-fracture deformation

- 3) The outboard segment of the outer sacrificial washer on the failed lug had disbonded and moved outboard (region B in Figure 4) as the lug was stretched immediately post-fracture.
- 4) The sacrificial washer on the inner face of the failed lug was broken into two segments, along a fracture plane parallel with, but displaced slightly outboard from, the plane of the lug fracture (Figure 5).

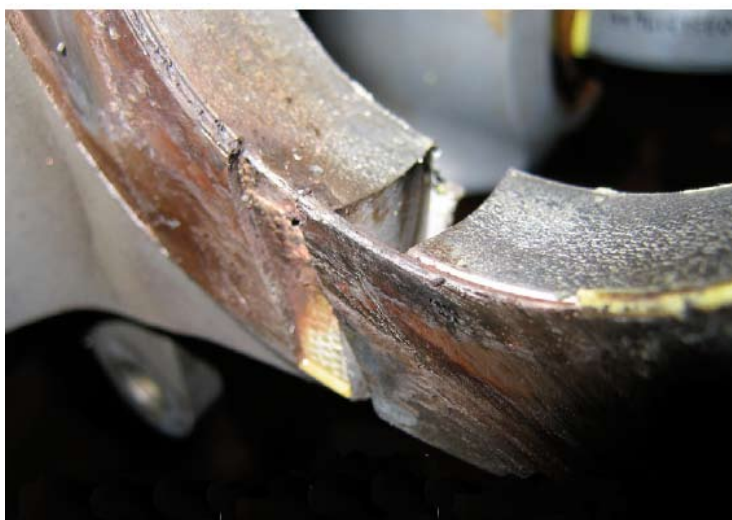
Figure 5

Wear/corrosion deposits, and position of lug fracture in relation to inner washer fracture

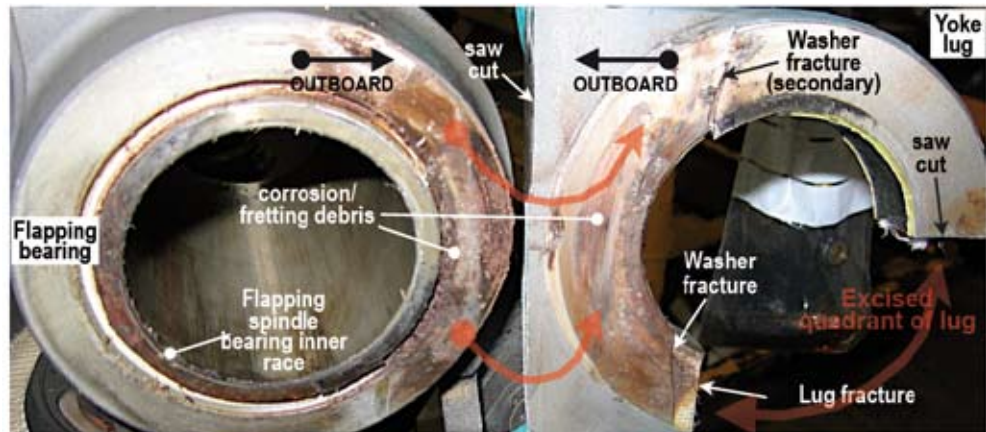
Figure 6

Lug excised from yoke and placed beside mating faces on flapping spindle, showing washer fractures on lug and corresponding patterns of wear and corrosion debris

The inboard segment of the inner washer was disbonded adjacent to both fractures, and wear/corrosion deposits in these areas showed that both the fractures and the adjacent disbonding pre-dated the yoke failure.

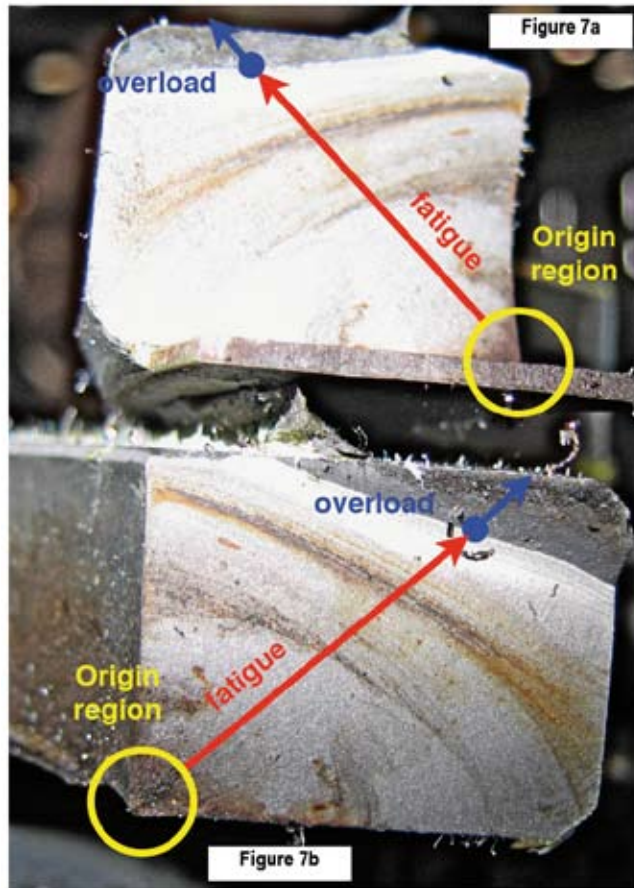
- 6) The yoke fracture faces exhibited very clear growth marks and patterns of staining consistent with progressive fatigue fracture from an origin region at the inner corner of the bore of lug (Figures 7a and 7b). Both fracture faces were generally in good condition, but some slight bruising was discernible in the origin region.
- 7) Surface corrosion/wear deposits similar to those evident on the fractures on the inner washer on the leading side of the yoke were also present, albeit to a lesser extent, at similar locations on the wear face of the corresponding (intact) washer bonded to the trailing side of the yoke (Figure 8).

Figure 7a (outboard) and Figure 7b (inboard)
Lug fracture face details

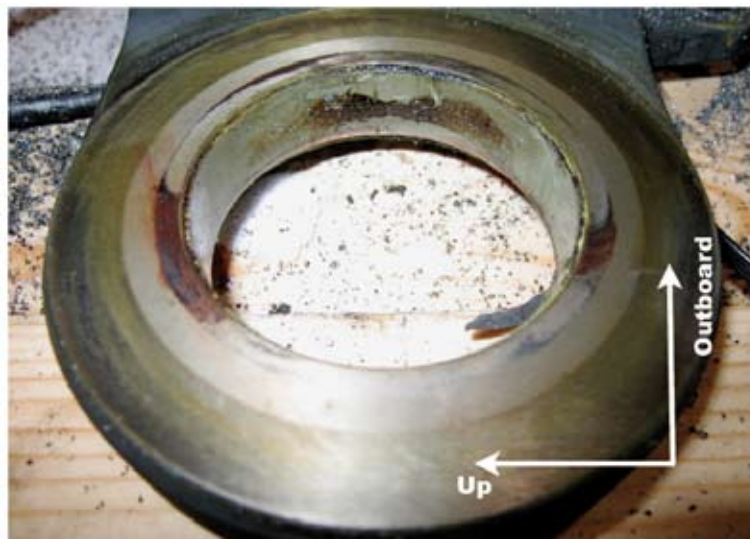
Figure 8
Wear/corrosion deposits on wear face of the intact inner washer on the trailing side of the yoke

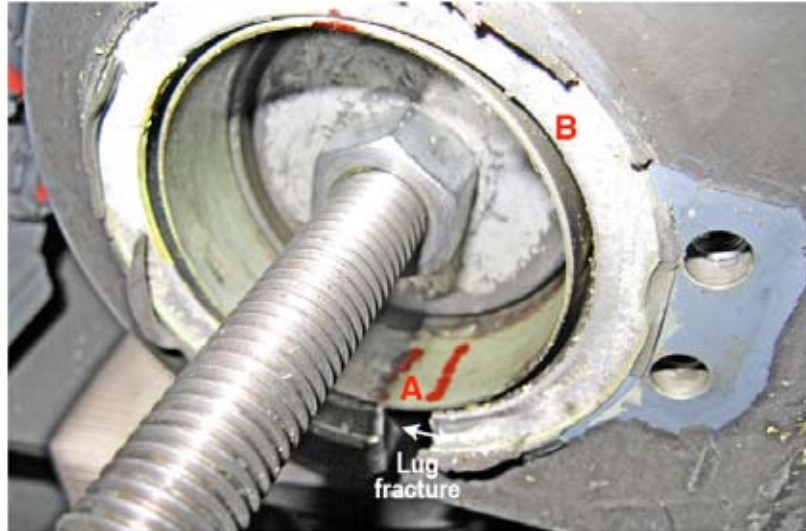
Figure 9

- 8) Regions of corrosion/wear deposits were evident on the outer circumference of the bush from the failed lug, at positions which corresponded with the positions of the fractures in the lug/washer and washer fractures, labelled A and B respectively in Figures 9 and 10.

Bush in bore of failed lug, released by post-fracture deformation. A and B show 'o'clock' positions of wear/corrosion deposits on interfacing surface of bush shown in Figures 10a and 10b

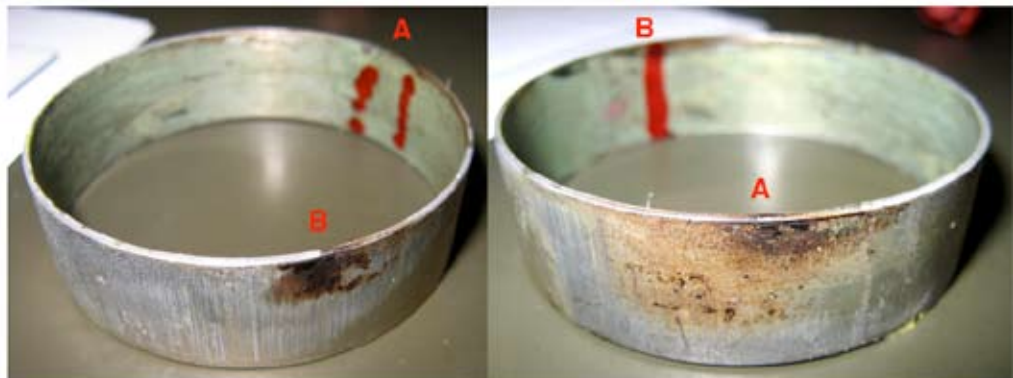
Figures 10a and 10b

Showing locations and extent of wear/corrosion deposits on mating surface of lug bushing (See Figure 9 for positional reference)

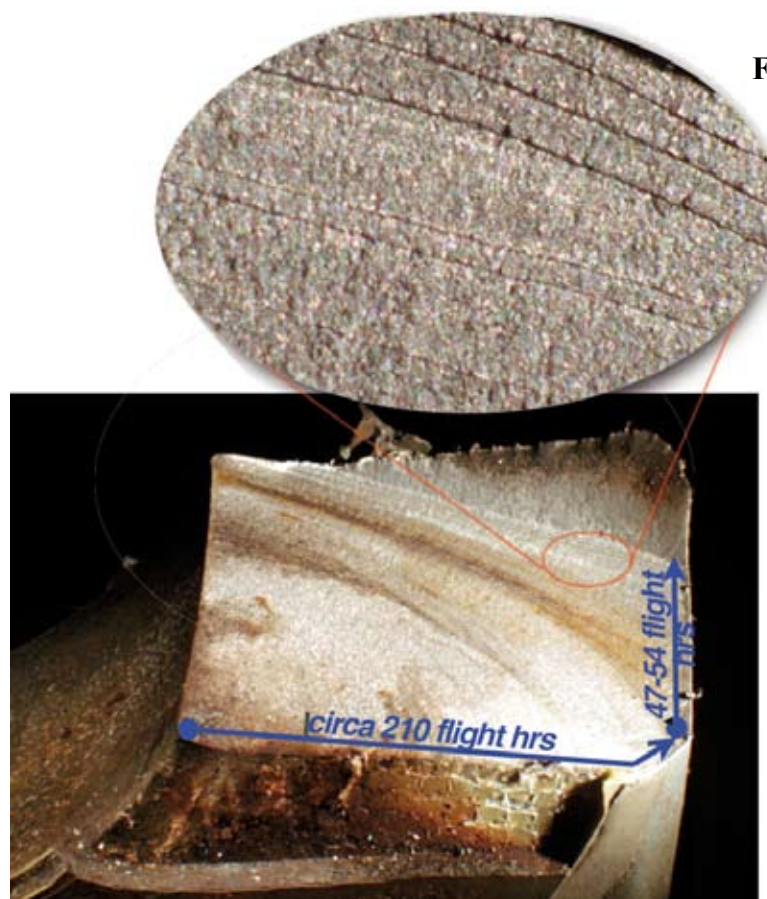
The fracture surface exhibited a repeated pattern of growth marks (Figure 11a) consistent with a high-cycle mode of propagation overall, interrupted at intervals by short bursts of ductile cracking, each burst consistent with a single load reversal of large magnitude. The banding pattern formed by the interruption (beach) marks at intervals in the high cycle growth was especially clearly defined in the region bounding the final overload rupture (Figure 11b).

Banding pattern on fracture face and banding pattern detail

The fracture surface banding pattern of fine striations, with beach marks at irregular intervals, was consistent with propagation primarily in response to a substantially regular pattern of in-flight stresses (mostly high-cycle small-amplitude), with variations about a relatively large 'working mean' stress associated with centrifugal loading of the blade. The beach-mark interruptions to this regular pattern of growth would be associated with the large change in mean stress as the rotor centrifugal forces decayed and increased with each rotor stop/start cycle.

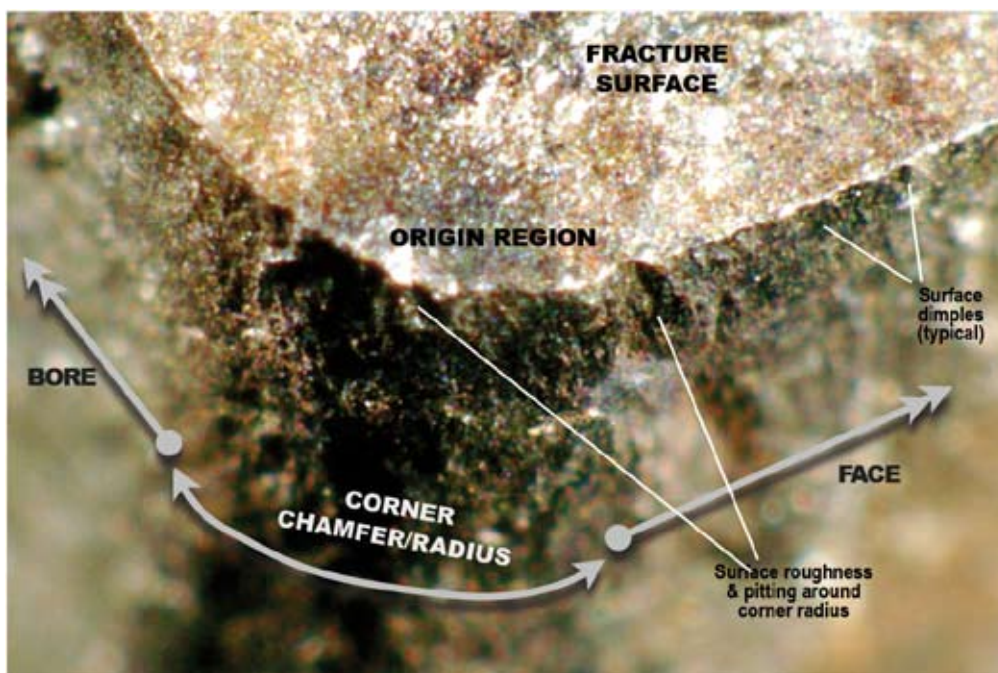
Figure 12

Under high magnification, the external (as distinct from fracture) surface in the origin region was characterised by a rough and dimpled surface texture overlaid with a number of deeper depressions and pits, particularly around the corner radius at the junction between the face and the bore of the lug (Figure 12).

Oblique close-up view of the fatigue crack origin region, showing the surface topography in the bore and on the inner face of the yoke, and at the corner formed between these two surfaces

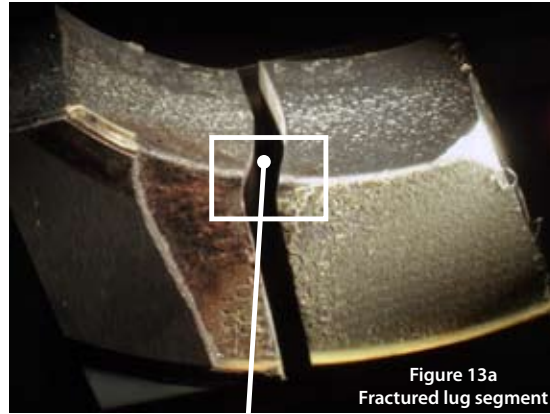
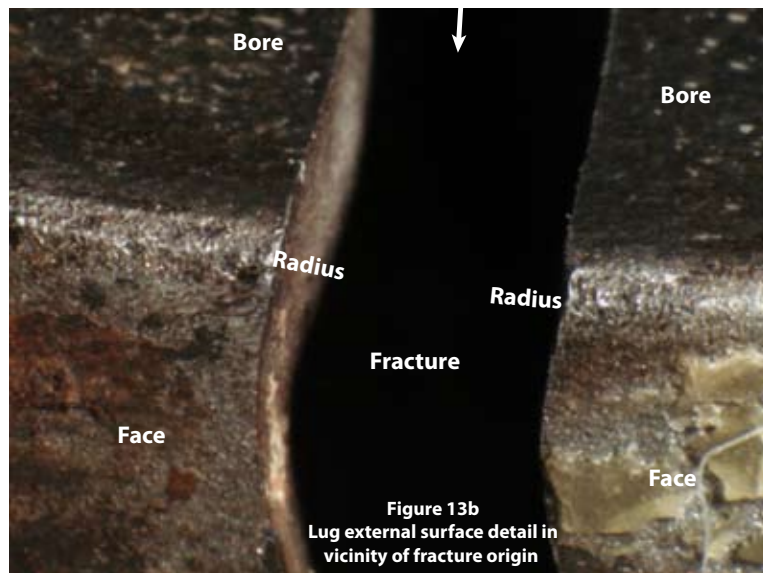
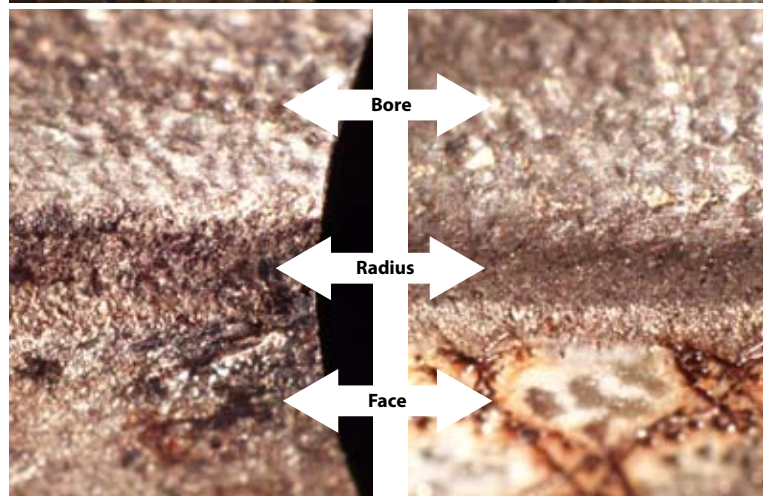
Figures 13a through 13c show the surface finish of the lug in the general vicinity of the fracture origin and Figure 13d at 180° from the origin.

Figure 13c
Radius surface detail at fracture origin

Figure 13d
Radius surface at 180° from fracture origin

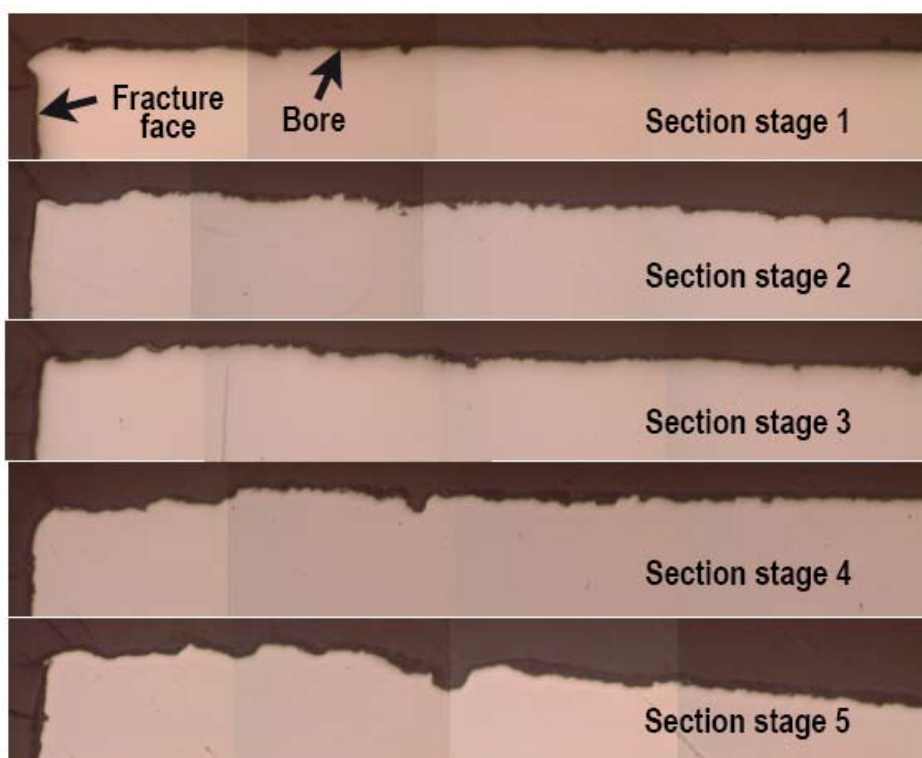
Figure 14

Bore surface profile at successive sections through the origin region

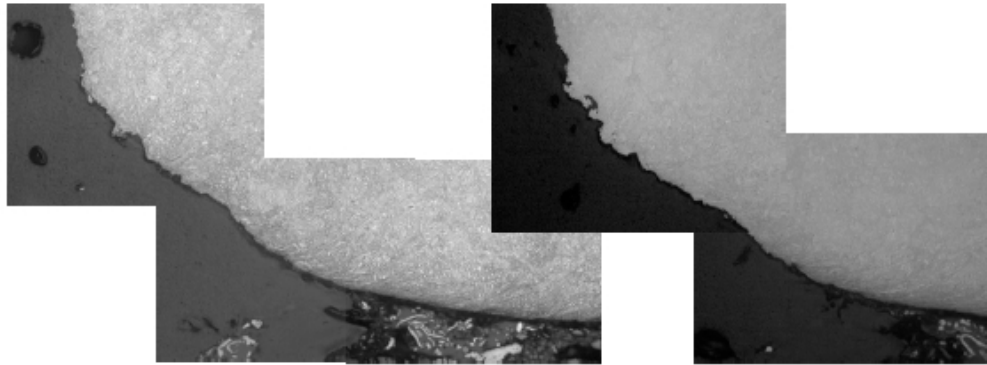
It is evident from Figure 15 that the corner radius was, in practice, more of a 'chamfer' than a true radius.

Corner surface profile on section adjacent to fracture plane (bore is to right, and faces towards top, in both photographs)

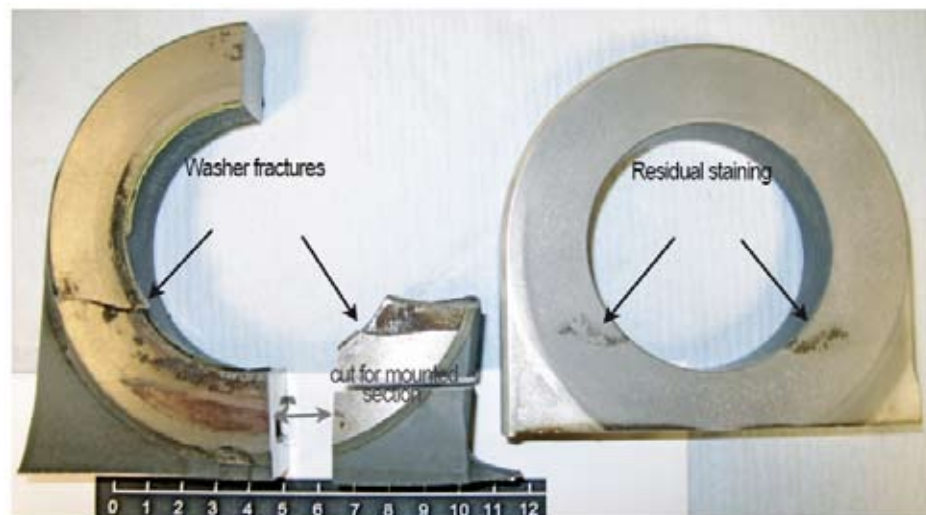
No cracks were present in either lug of the exemplar yoke. It was notable, however, that even after having passed through the preparatory cleaning processes, evidence of residual corrosion/fretting debris was clearly visible on the inner face of the leading lug at positions which corresponded very closely with the positions of the cracks in the sacrificial washer on the failed lug from G-PUMI. Figure 16 shows the lug from the exemplar yoke positioned alongside the failed yoke from G-PUMI, with these features highlighted. The correlation illustrated in Figure 16 strongly suggested that 'as received' for overhaul, the washer on the exemplar lug was cracked at locations similar to that on the lug from G-PUMI. The manufacturer's records did not record the condition of the washer at the time of receipt, but it was understood that a significant proportion of time-expired spindles submitted for overhaul had similarly cracked washers.

Comparison between position of residual staining on exemplar lug and washer fracture locations on failed lug from G-PUMI spindle.

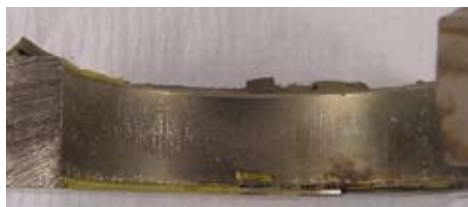
Figure 23a

Remnants of the adhesive bond between the bush and the bore were also found adhering to the surfaces in several areas. Figures 23a and 23b show these features on the surface of the bore and the bush respectively.

Surface condition in bore of failed lug

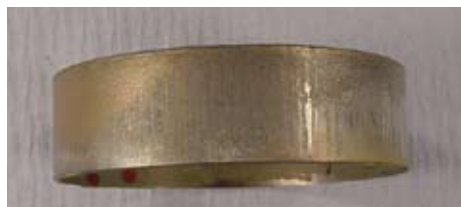
Figure 23b

Surface condition of bush

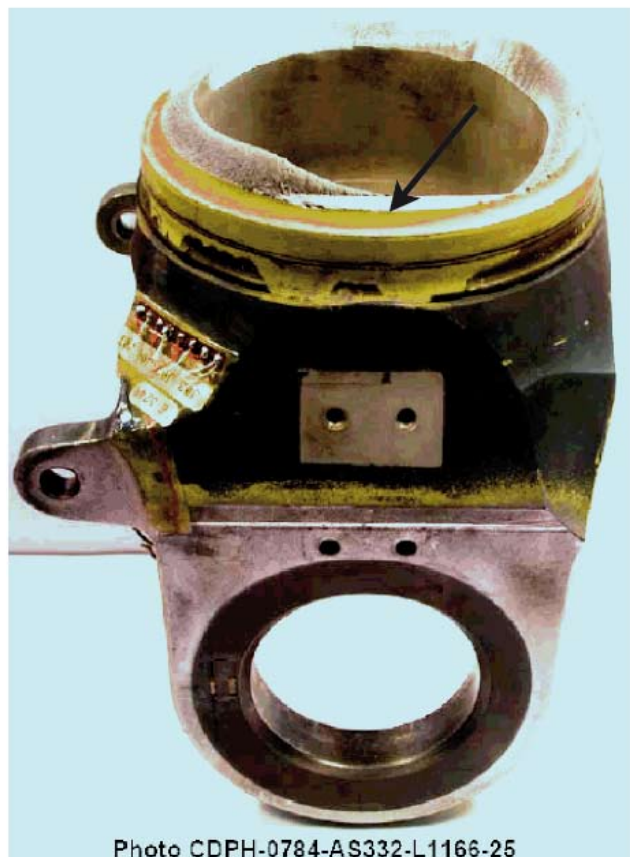
**Figure 37**

During the phase 2 testing, the phase 1 pattern of loading was repeated using the failed spindle from G-PUMI as the test subject. This resulted in a fatigue failure through the body of the spindle after 0.37×10^6 reversals, from a fatigue crack originating in the fillet radius at the junction between the barrel section and the yoke, see Figure 37.

Fatigue test failure of G-PUMI spindle,
from origin at radius of the barrel section (arrowed)

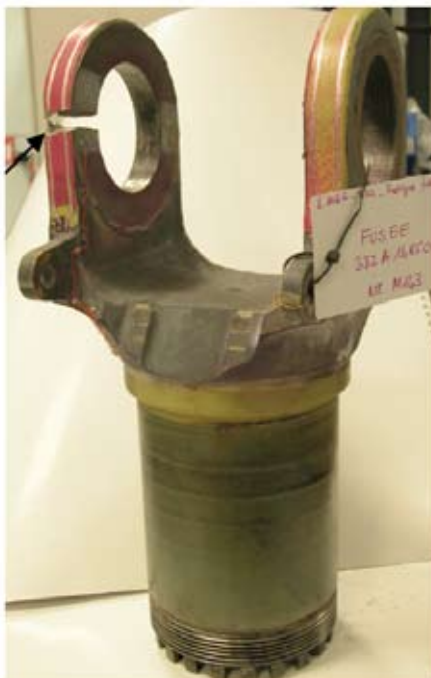
Figure 38

After completion of a further 0.375×10^6 reversal at this increased magnitude, a fatigue fracture occurred through the lug at the location of the G-PUMI failure, see Figure 38. However, the origin of this failure was in the bore of the lug, set back some 4.2 mm from the inner corner radius, whereas the G-PUMI fracture origin was actually coincident with the inner corner radius itself.

Fatigue test failure (arrowed) at location G-PUMI failure, but with origin 4.2 mm from corner radius

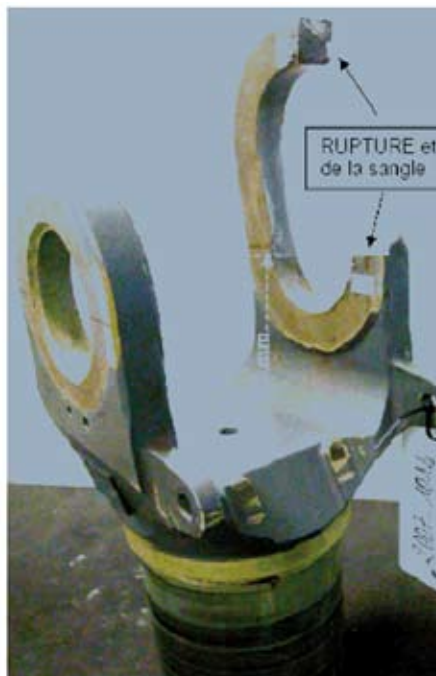
Figure 39

After a further 0.5503×10^6 reversals the yoke fractured in fatigue through the lug, at the failure location on G-PUMI, see Figure 39. The origin of this fracture was sited actually on the inner corner radius, replicating precisely for all practical purposes the failure on G-PUMI.

Fatigue test failure (arrowed) at location of G-PUMI failure,
with origin at inner corner radius
