AAIB Bulletin

11/2018

Published 8 November 2018

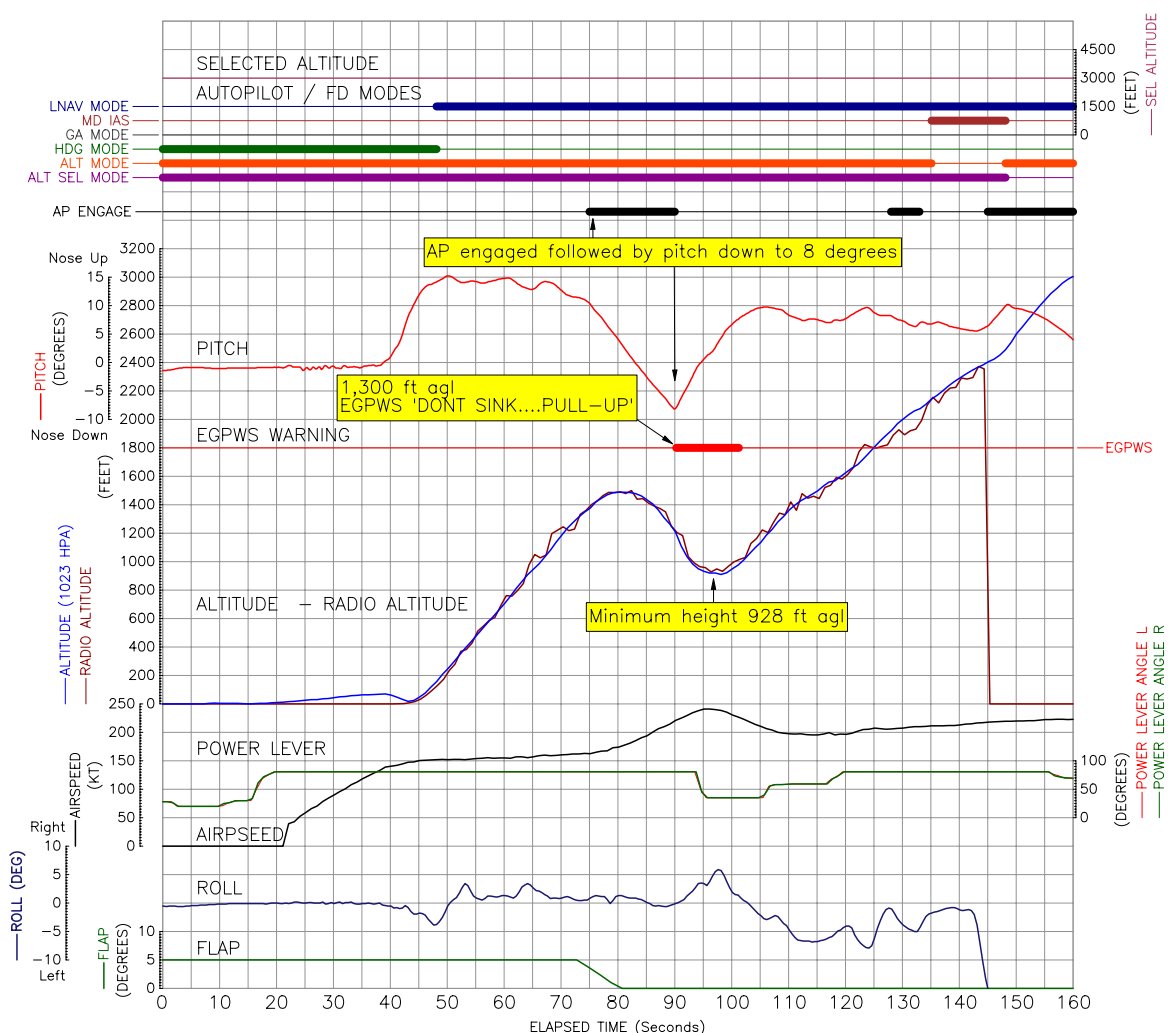
Figure 3
Descent following autopilot engagement

As the FDR was not recording during the crew’s preparations prior to the first engine start, it was not possible to validate the sequence in which the PF reported that he had initially set the FD modes and selected altitude. There was no reference by the crew to the selection of the FD modes on the CVR recording during this same period.

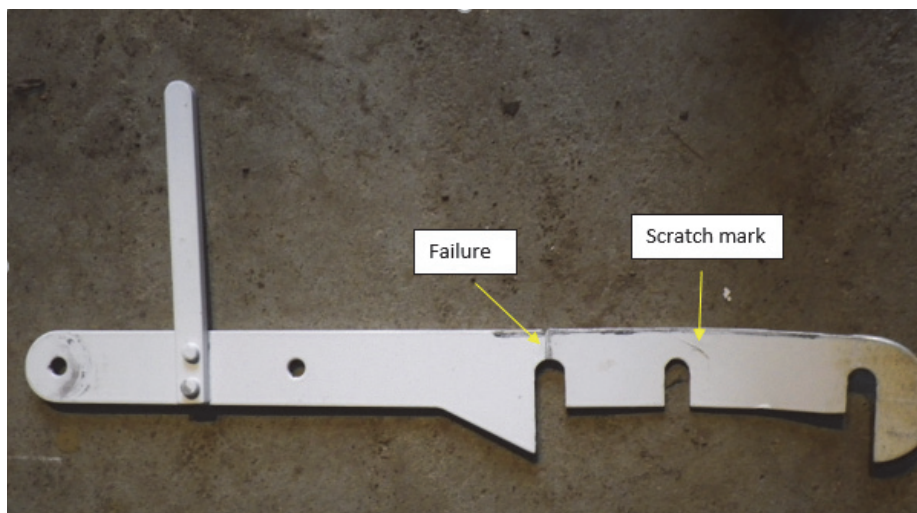
Figure 5

The flap operating lever had failed in overload as a result of a force having been applied from the left side of the lever. Marks on the front of the lever were consistent with normal operating wear marks. However, there was a fresh scratch in the paint on the right side of the lever, adjacent to the second flap latching position (Figure 5).

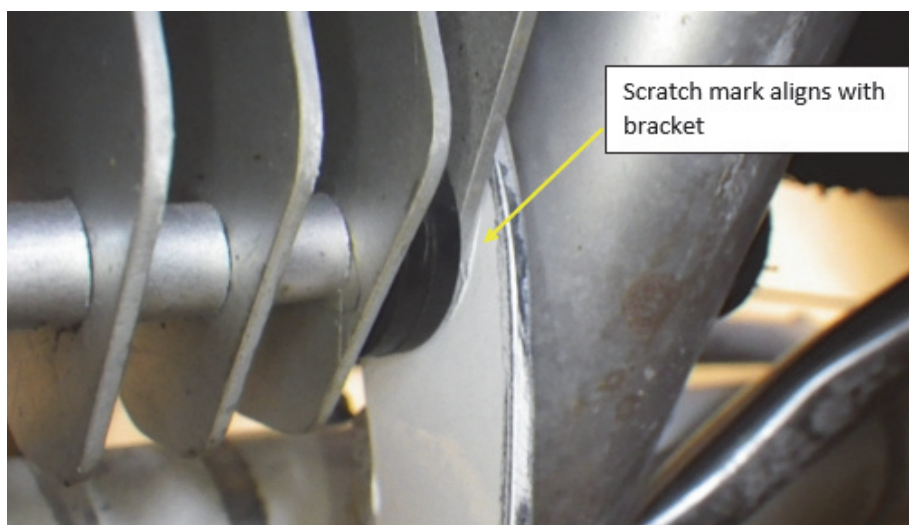
Figure 6

The scratch mark on the flap operating lever aligned with the edge of the latching bracket, which corresponded with the flaps being at the takeoff (Flap 15°) position (Figure 6).

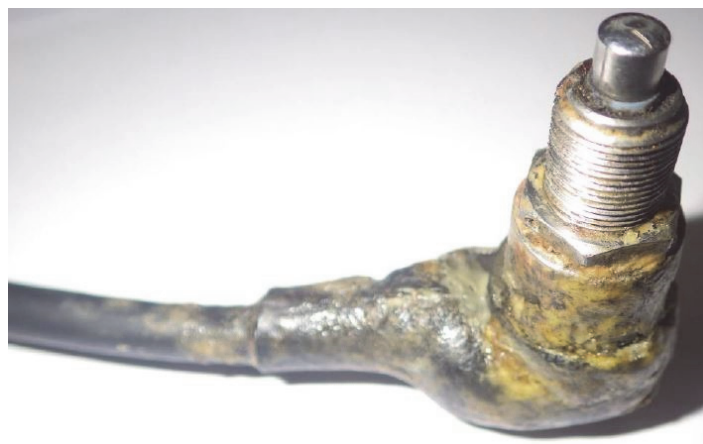
Figure 2

The NLG primary downlock microswitch and its associated wiring harness were removed from the aircraft for further examination (Figure 2). No visual defects were identified but movement could be felt between the wiring harness and the microswitch which was due to damaged and broken wires in the harness.

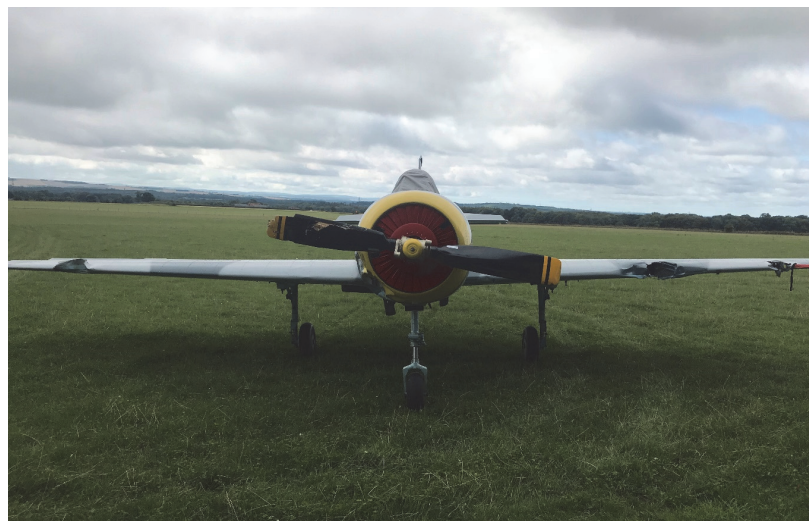
Figure 2

The collision with the fence caused damage to both leading edges, the right lower cowling and the propeller (Figure 2).
