FINAL REPORT

AAIU Synoptic Report No: 2009-018

Aircraft Type and Registration:	Agusta Westland A109E, EI-SBM
No. and Type of Engines:	2 x Pratt and Whitney PW 206 C
Aircraft Serial Number:	11174
Year of Manufacture:	2004
Date and Time (UTC):	20 March 2008 @ approximately 15.40 hrs
Location:	Lagore, Dunshaughlin, Co. Meath
Type of Flight:	Private Category
Persons on Board:	Pilot - 1
Injuries:	Pilot - Serious
Nature of Damage:	Substantially damaged
Commander's Licence:	Commercial Pilot Licence (H)
Commander's Details:	Male, aged 41 years
Commander's Flying Experience:	2,421 hours, of which 1,500 were on type
Notification:	ATC Station Manager, Dublin Airport
Information Source:	AAIU Field Investigation AAIU Accident Report Form submitted by Pilot

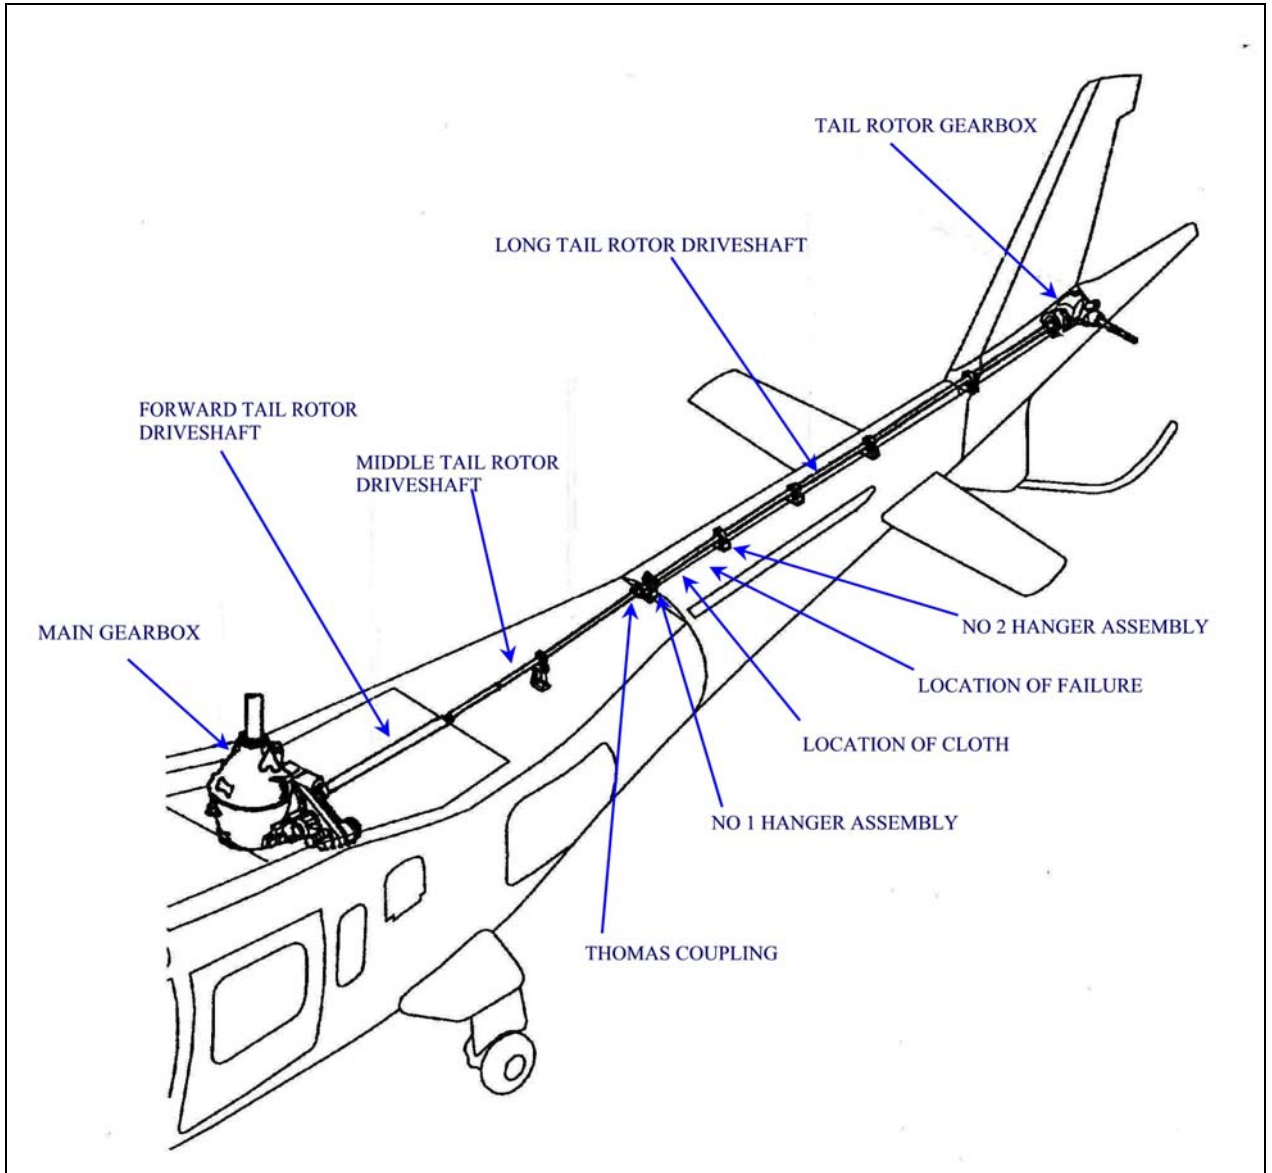
Figure B1

This figure shows the layout of the tail rotor drive system and its various components.

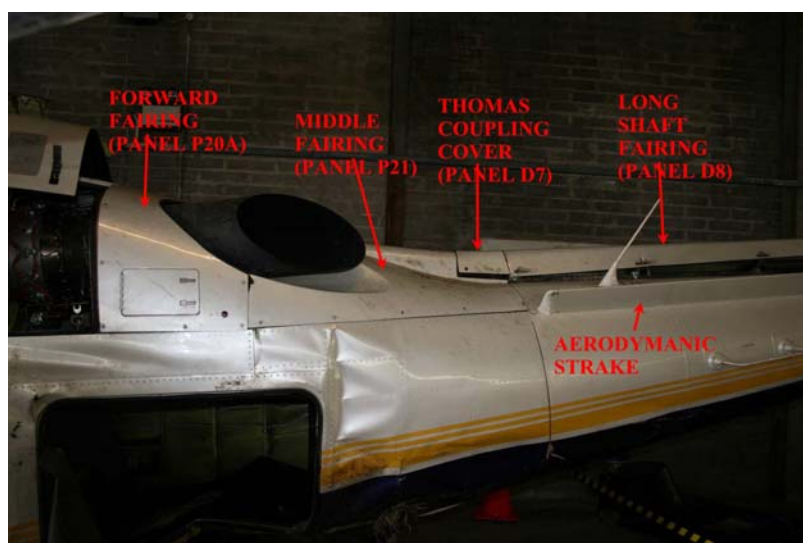
Photo No. 1

This shows the location of the various fairings and the Aerodynamic Strake. This photo was taken after the helicopter was recovered to the AAIU facility and the distortion of the helicopter prevented the Thomas Coupling Cover and the Long Shaft Cover from closing completely.

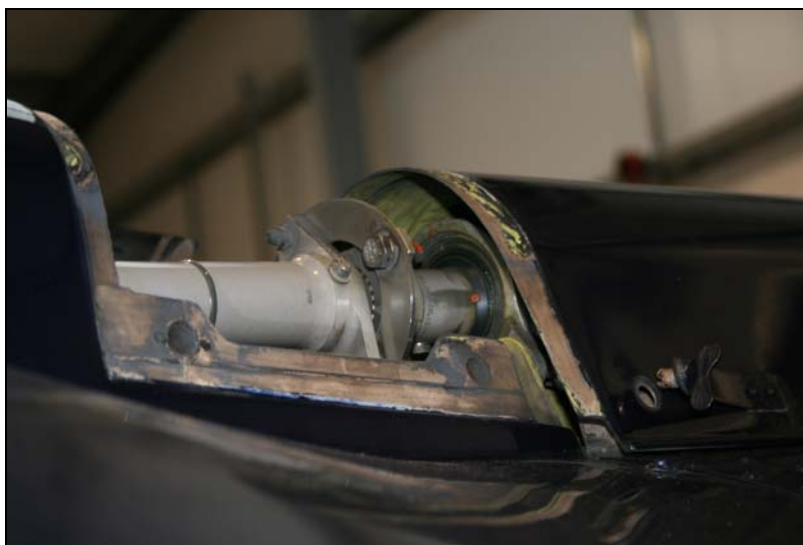
Photo No. 2

This photograph (taken on another A109) shows the Thomas Coupling at the forward end of the Long Tail Rotor drive-shaft when the small Inspection Panel of the Middle Section fairing is in the open position. The rear end of the Middle Tail Rotor drive-shaft assembly is seen is the left of the opening. On the right, the front end of the Long Tail Rotor drive-shaft, and the No. 1 Hanger Assembly of the Long are also visible. The nuts, bolts and protruding bolt threads on the Coupling can be seen. No trace of material was found on these fittings. Elements of material were found on the bolts that secure the No.1 Hanger Assembly to the top of the tail boom.

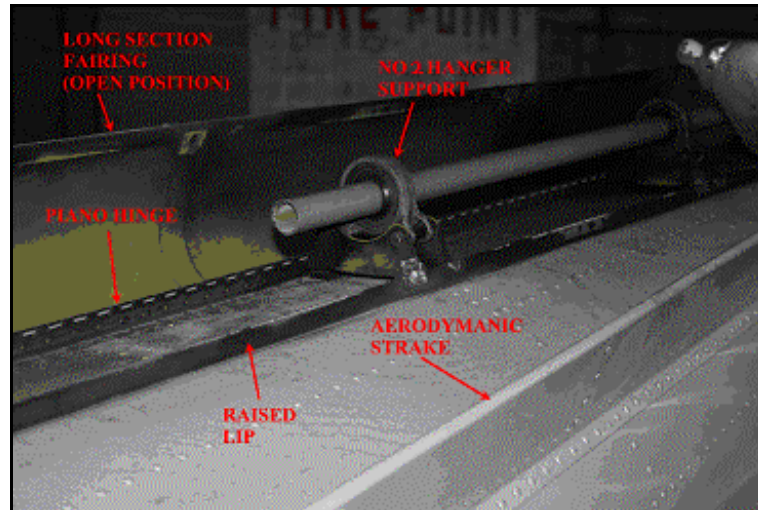
Photo No. 3

In this version of the Agusta Westland A109, a one-piece Fairing covers the entire length of the long tail rotor drive-shaft. The Fairing is closely fitted to the shape of the Hanger Supports, with the result that there is only a small clearance between the Hanger Support and the inside of the Fairing. The Thomas Coupling is under the hinged Inspection Panel of the Middle Section Fairing. This Panel is also a close fit to the Coupling. The Investigation considers that the close fit would prevent any migration of a cloth, of the size found on the shaft, from the area forward of the Thomas Coupling, into the space where the cloth was subsequently found, as this would require the cloth to pass by the close-fitting Thomas Coupling and the No. 1 Hanger Assembly. Furthermore, the Thomas Coupling has exposed splines, nuts and bolts that would have caught fragments from a cloth passing through the coupling area. No evidence of any cloth fibres was found on the Thomas Coupling. No evidence of cloth fragments was found on the No. 2 Hanger Assembly or to the rear of this point. Thus the Investigation is satisfied that the cloth was originally left in the space between the No. 1 and No. 2 Hanger Assemblies, and did not migrate into this space from another location in the helicopter.

This shows the top of the tail-boom in the area of No. 2 Hanger Support showing the Long Section Fairing in the open position. The raised Lip and the Aerodynamic Strake can also be seen. It may be noted that in this picture the Long Shaft has been cut just forward of the No. 2 Hanger Support as part of the ongoing investigation.

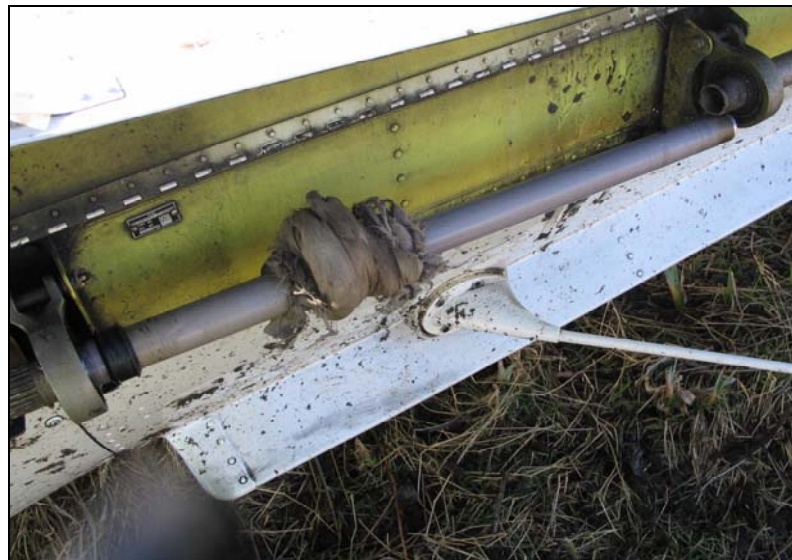
Photo No. 4

In particular, one blade was virtually unmarked. This suggested that the tail-rotor, which is located on the LH side of the helicopter, was not rotating at impact. At this point, all the fairings over the tail rotor drive-shaft system were found to be closed and secured. On inspection of the tail-rotor drive train (the connecting shafts between the tail-rotor gearbox and the main gearbox) it was found that the long tail rotor drive-shaft, which is located under the hinged fairing on top of the tail boom, had failed. The point of failure was immediately forward of the No. 2 Hanger Assembly. A cloth, as described below, was found tightly wrapped around the forward segment of the broken Long shaft, at a point approximately 34 cm forward of the shaft fracture point, as shown in **Appendix C, (Photo No. 4)**. The splines on the forward end of this shaft section were still engaged in the Thomas Coupling at the forward end of the shaft, but it had moved rearwards slightly. The Investigation noted that the bearing core (inner rubber collar) of the No 1 Hanger Assembly had come out of the bearing, so that this bearing only partially restrained radial movement of the forward section of the failed shaft. The Investigation noted that the split pins and nuts located on the aft side of the support structure of the No 1 Hanger Assembly contained particles of material identical to the cloth. No such material was found forward of this point. The ends of the shaft at either side of the failure bore damage associated with rubbing contact after the failure.

The Investigation has no doubt that the presence of the cloth, however and whenever it was introduced into the tail rotor drive shaft system, was the cause of the long tail rotor drive-shaft failure.

Photograph taken at the accident site, showing the cloth, as found, wrapped around forward end of the Long Tail Rotor drive-shaft, and point of fracture of the Long Section. The splines leading into the forward Thomas Coupling can be seen on the left, just to the left of the No. 1 Hanger Assembly. To the right, the No. 2 Hanger Assembly can be seen.

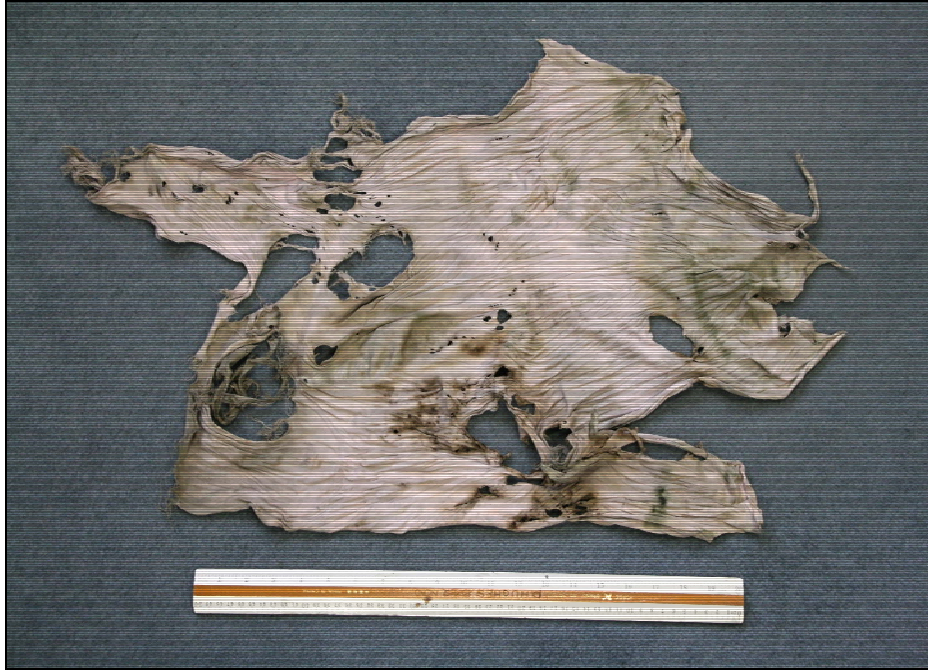
Photo No. 5

The cloth was very tightly wrapped around the long tail rotor drive-shaft. It was compressed and measured 10 cms along the shaft. In addition, it was sodden with moisture when found. The cloth was subsequently unwound from the shaft, and was found to measure approximately 56 cms by 42 cms, and frayed at the edges. It weighed 72 grams when dry, and up to 225 grams when wetted as part of the ongoing Investigation. The cloth is shown in **Appendix C, (Photo No. 5)** after it was removed from the shaft.

Photograph showing the cloth after it was removed from the Long Tail Rotor drive-shaft and unravelled by the Investigation. The ruler is 50 cm long.

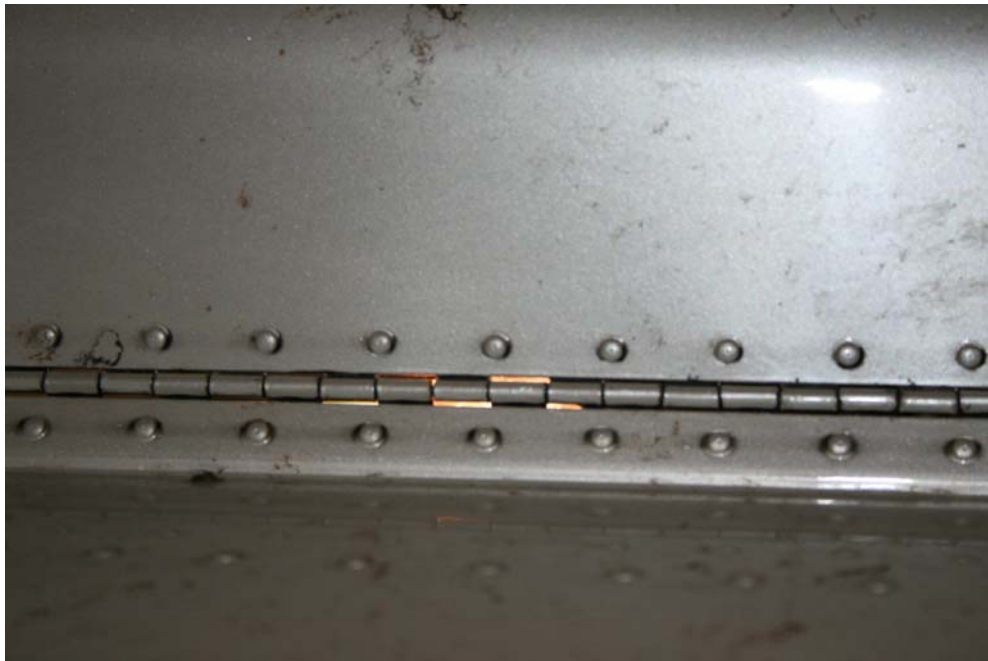
Photo No. 6

This photograph shows the Piano Hinge of the Long Section Fairing. The light of a torch is seen through the gaps along the hinge line.

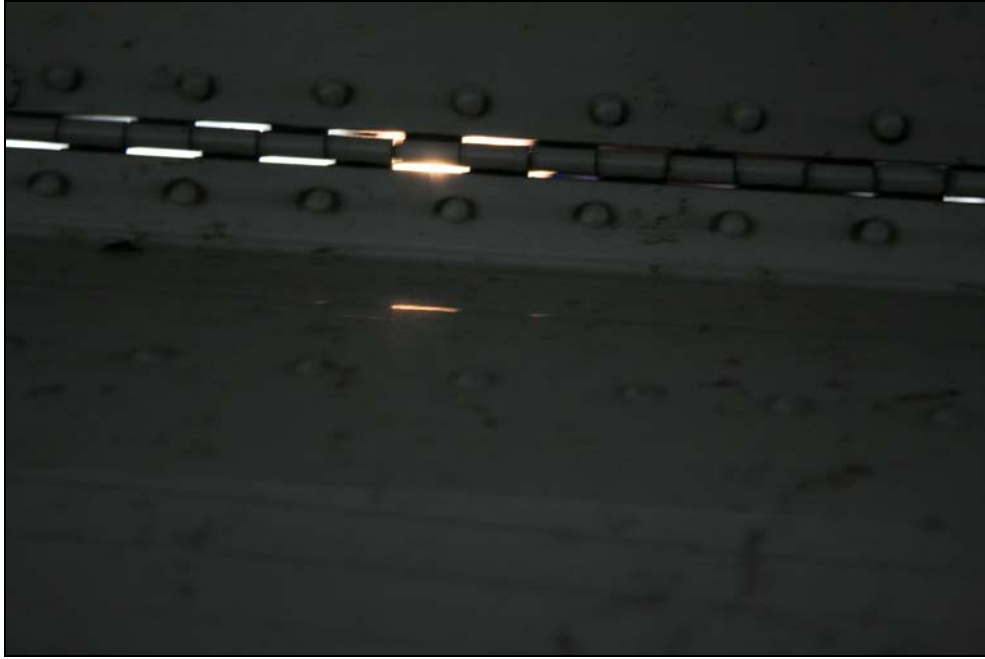
Photo No. 7

This shows a similar view to the previous photograph, but with an altered camera setting so that the gaps can be seen more clearly.

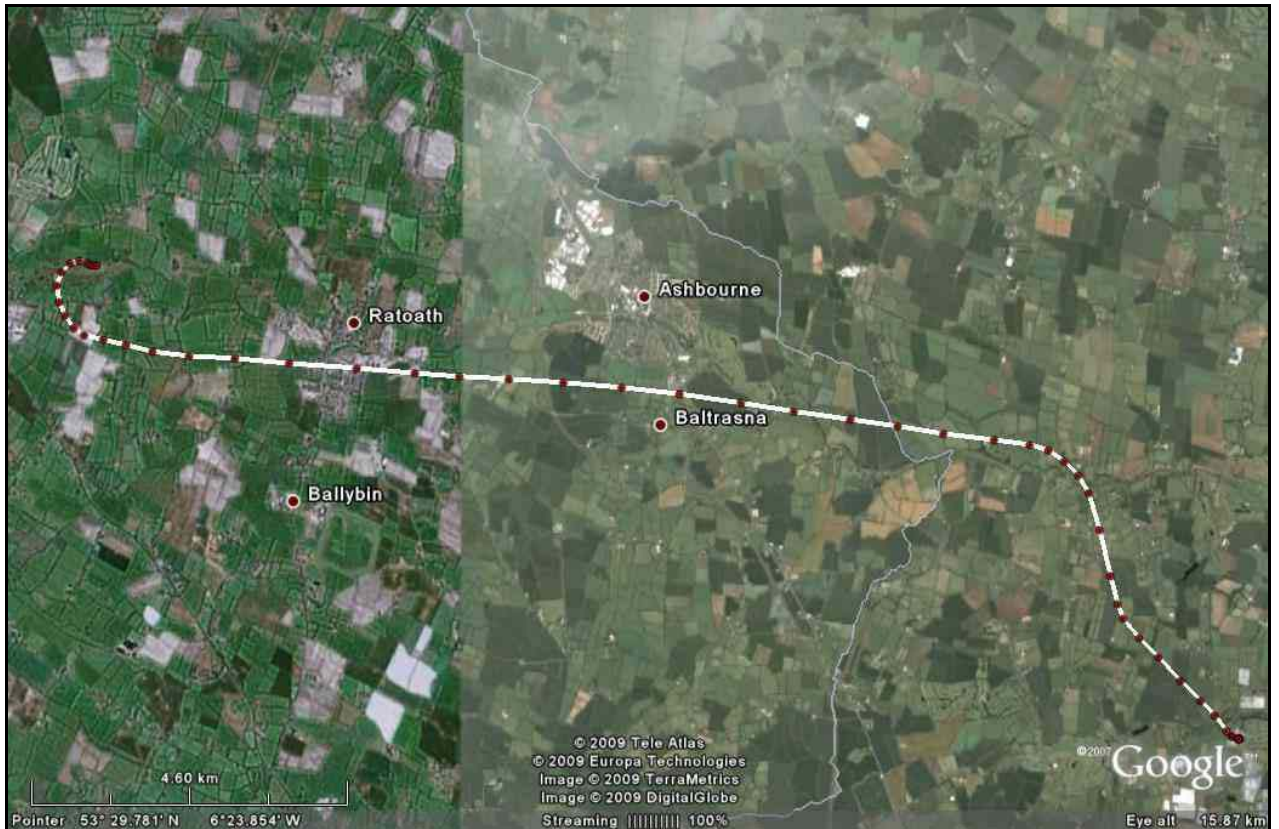
Figure D1

This shows the final flight of EI-SBM from Knocksedan to Dunshaughlin taken from the on-board GPS. The red dots are the recorded track points. The final turn to the right can be seen on the left of the figure. The right side of the figure is in a Google high-resolution area while the left side is low resolution. This is the reason for the tone difference.

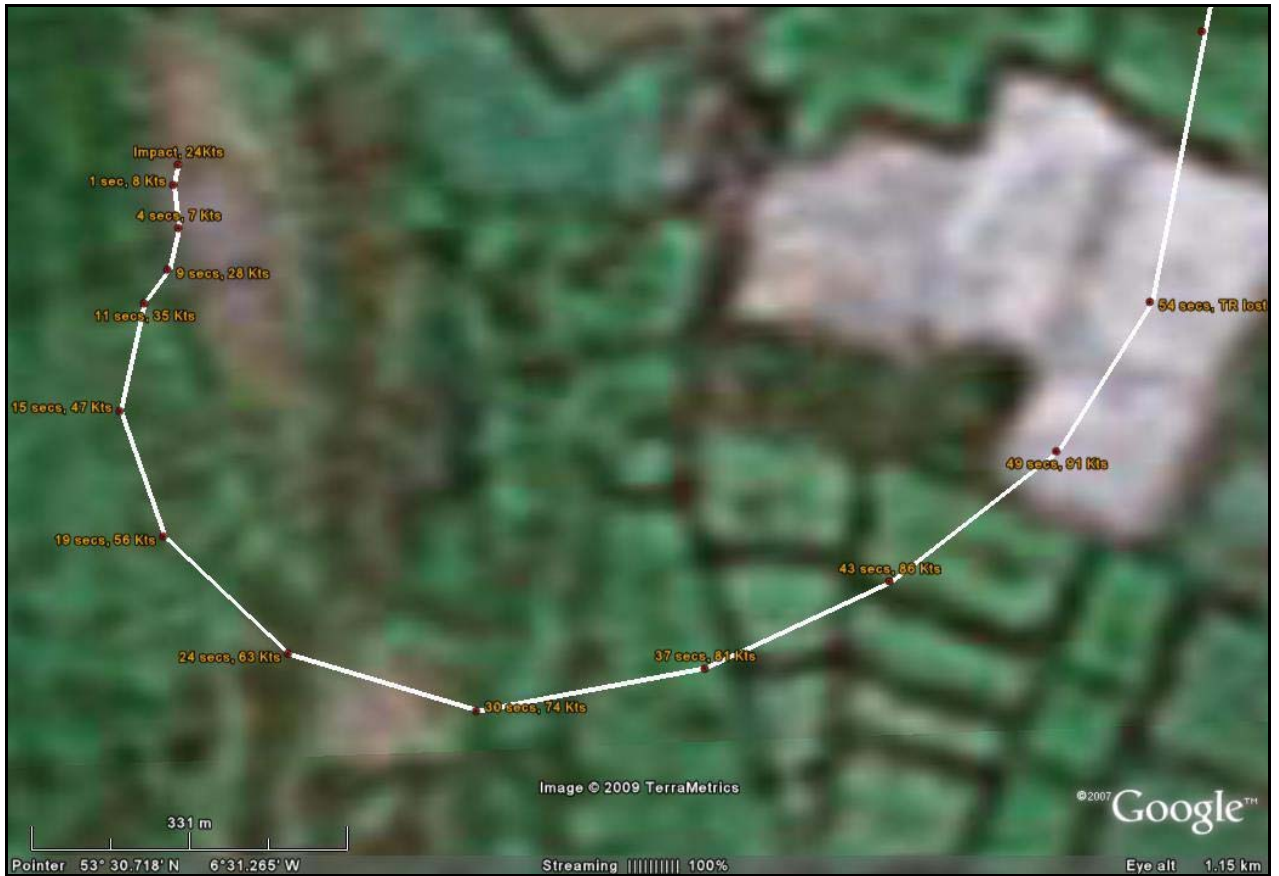
Figure D2

Reconstruction of last 54 seconds of flight. A constant wind of 270/22 was assumed. Aircraft ground speed and heading were resolved into component “airspeed” vectors parallel and perpendicular to 270. The components parallel to 270 were added, and the magnitude of the resultant of this addition and the perpendicular component was computed as an estimated airspeed experienced by the helicopter. Time calculations were performed to estimate the duration between TR loss and impact.

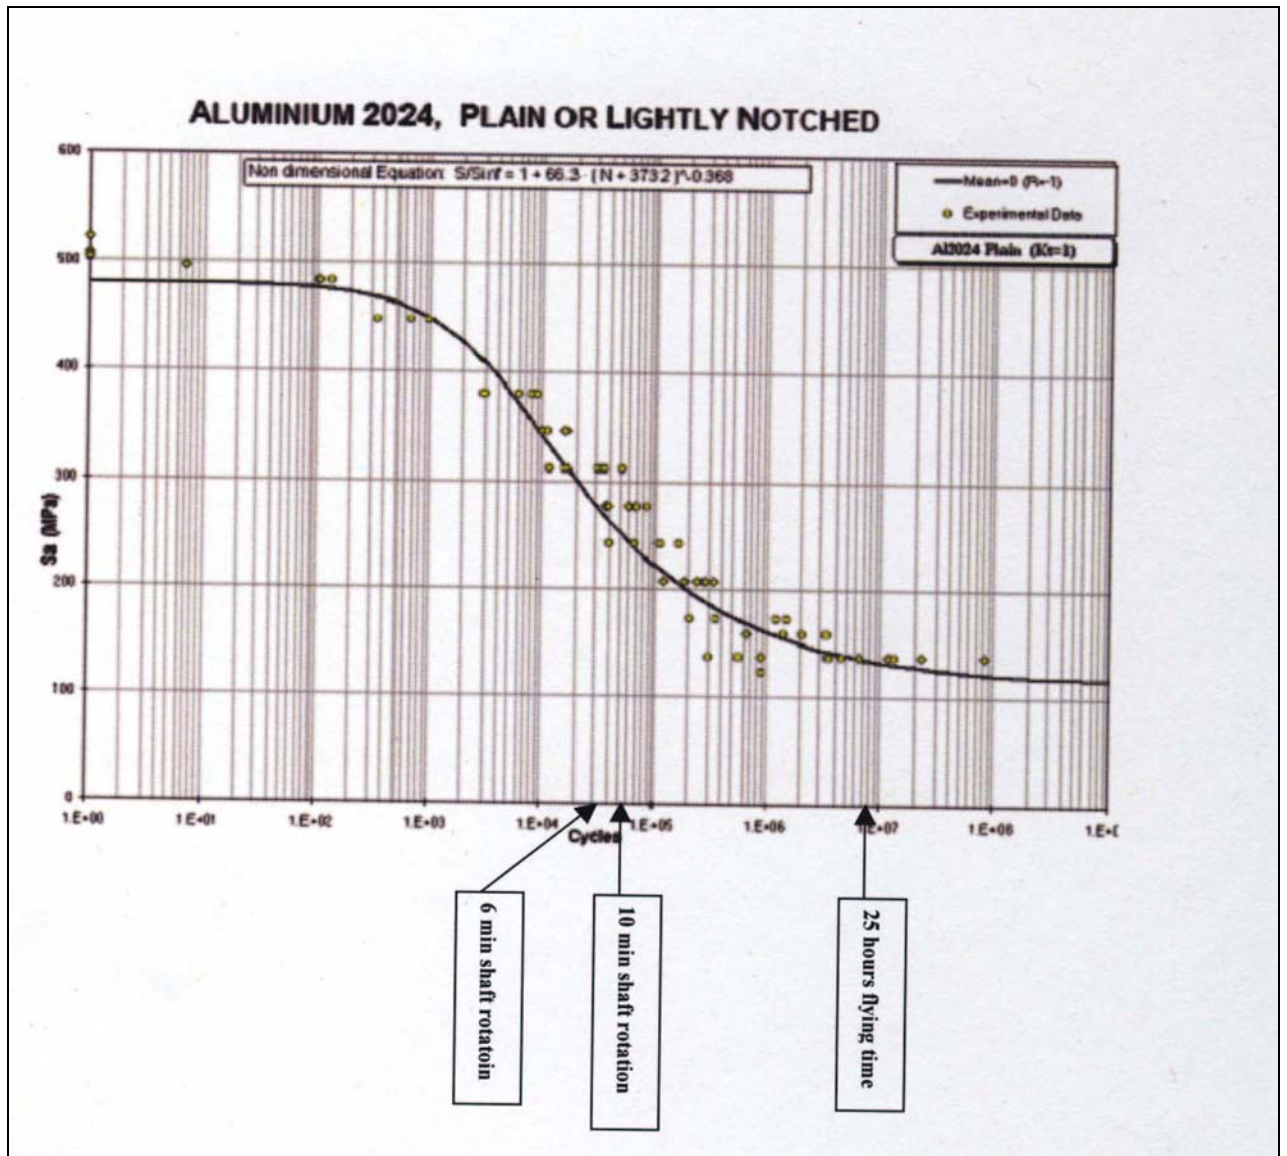
Figure E1

The stress versus cycles-to-failure data (S-N curve) for Aluminium Alloy 2024, based on data provided by Agusta Westland.
