**AIRCRAFT SERIOUS INCIDENT
INVESTIGATION REPORT**

**OKAYAMA GLIDER CLUB
J A 2 3 3 0**

CONTINUED HALT OF POWER OF ENGINE DURING FLIGHT

SCHEIBE SF25C FALKE (MOTOR GLIDER, TWO-SEATER)

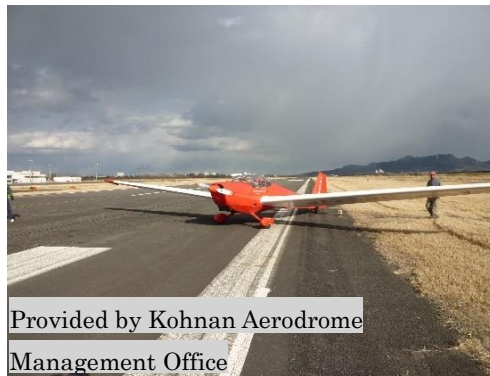
Photo 1 The aircraft after landing

1.1 Summary of the Serious Incident	On Sunday, February 12, 2017, Scheibe SF25C Falke, registered JA2330, operated by Okayama Glider Club, landed on Kohnan Aerodrome by gliding and halted on a runway, because its engine halted while flying over Okayama City and was unable to restart.

In this serious incident, it is highly probable that the engine halted and could not restart due to the carburettor icing occurrences during the flight of the aircraft.

As for the reason of occurrences of the carburettor icing, it is probable that the carburetor heater was not used while the aircraft executed descent by idling at the low oil temperature, was holding at the airspace of serious carburettor icing risk.

- (1) Recheck the club rules and the flight manual relating use of the carb-heat, engine halt and restart.
- (2) Inform all relevant parties about additional instructions concerning the restart of engine.
- (3) Promote to use the check sheet to check items for the confirmation by the captain before departure.
- (4) Revise the checklist.
- (5) Revise the syllabus for training.
