MINISTÉRIO DAS OBRAS PÚBLICAS, TRANSPORTES E COMUNICAÇÕES  
GABINETE DE PREVENÇÃO E INVESTIGAÇÃO DE ACIDENTES COM AERONAVES  
GPIAA

AIRCRAFT INCIDENT SUMMARY REPORT

<b>Date/Time:</b> 2008 / 07 / 16 @ 19:37 UTC <sup>1</sup>	<b>Proc. Nr.:</b> 23 / SUM / 08
<b>Operator:</b> Helibravo Aviação	<b>Type of Incid.:</b> Operational
<b>Id. of aircraft:</b> Eurocopter, AS350B2, s/n 1825, reg. D-HAUP	
<b>Local:</b> 1NM South of Ribeira de Pena (41.30.25N 007.48.15W)	
<b>Type of flight:</b> Air Work (Fire Fighting)	<b>Phase of flight:</b> Transition
<b>People on board:</b> Crew- 1 Pax- 5	<b>Injuries:</b> Nil
<b>Aircraft Damage:</b> Light damages on a main rotor blade, windshield, antenna and fuselage

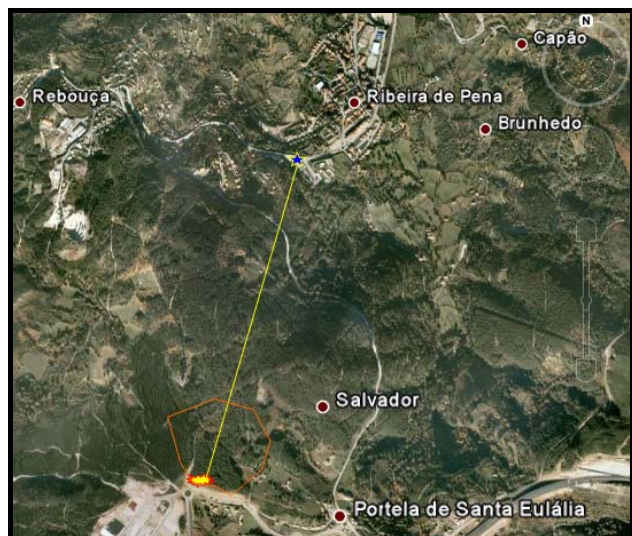
Picture Nr. 1

After disembarking the team, the pilot performed an area reconnaissance trip, looked for water supply sources and performed seven water droppings on the fire, till it was considered extinguished, and picked up the team, from signalled point on picture nr. 1

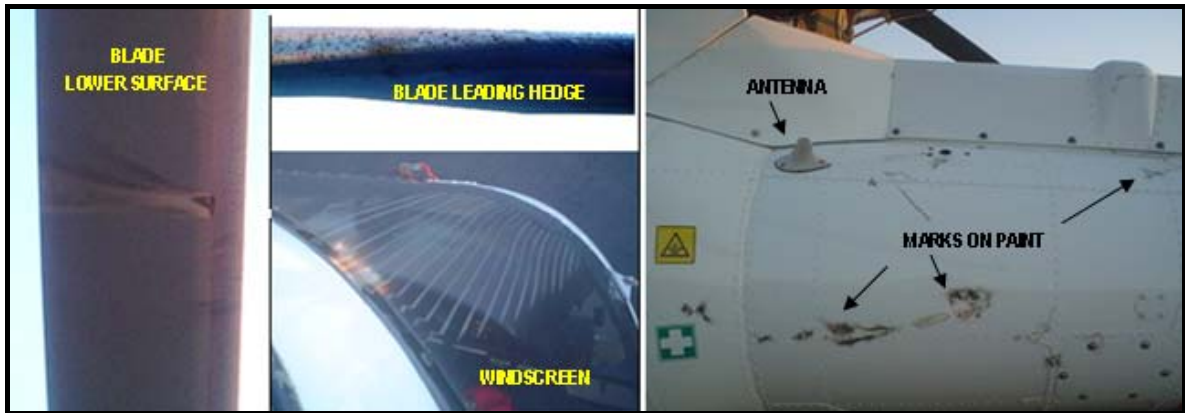
Picture NR. 2

During take-off sequence, when transiting from hover to climb phase, the helicopter hit a power line and suffered an electric strike.

Due such strike one of main rotor blade became damaged, together with right hand side windscreen, a radio antenna and left side fuselage (*picture nr. 2*).

On transition phase, from hover to route flying, the pilot manoeuvred in order to face the sun, which, because it was near sunset and the sun was close to the horizon, limited pilot's visual capacities for distinguish the cables. When he saw them, he was too close to avoid the power line. At that stage he couldn't avoid collision and subsequent discharge.

Because it was a medium voltage power line (< 20kVa), cable section was small and aircraft damage has been reduced to a minimum, without interfere with normal flight handling characteristics, allowing the pilot to go back to base without problems.

Once back to station, in Ribeira de Pena, the aircraft followed a thorough investigation, in accordance with manufacturer's Aircraft Maintenance Manual nr. 05.53.00.609.

All damaged parts were replaced and the aircraft returned to service.
