FINAL INCIDENT REPORT

Boeing B-737/300F

EC-KDJ

FINAL INCIDENT REPORT Nr. 07/INCID/2008

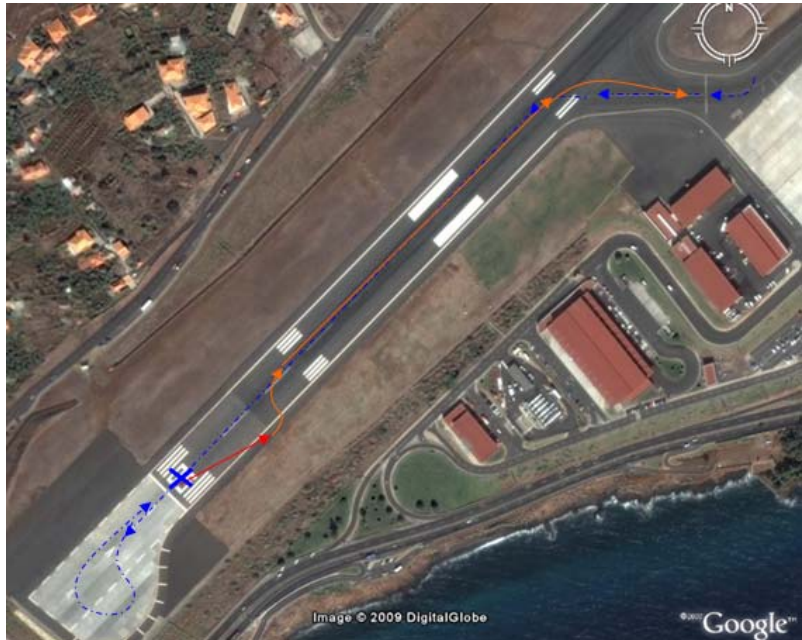
Picture Nr: 1

The aircraft started moving forward, but engines didn't react symmetrically (left engine accelerating more than right one), the aircraft skidding to the right, becoming impossible for the pilot to get control, with normal means, until reaching runway safety shoulder (*picture nr. 1*), after power reduction and A/T was disconnected by the pilot flying.

When leaving runway, the external left main wheel hit a runway edge light and broke it.

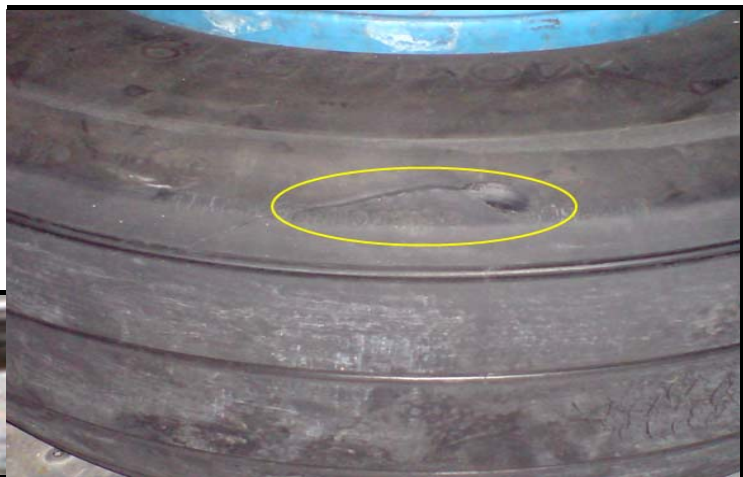
Picture Nr. 2

An external inspection revealed a scratch on outboard left main wheel tire and that wheel was changed before new departure was attempted.

There was no reported damage to the aircraft. Only the outboard left main tire was punctured and it was changed before new departure (*picture nr. 2*).

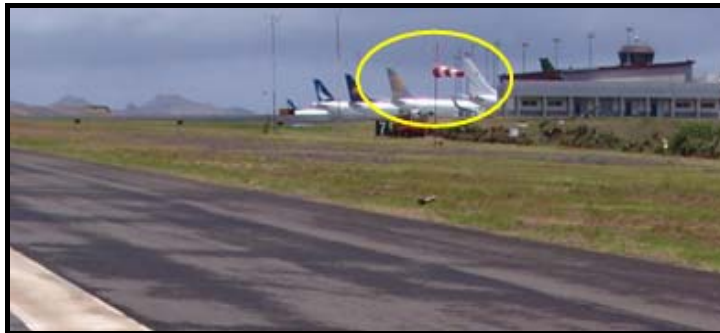
Picture Nr. 3

Visibility was good, the wind was blowing moderate from NE (12kts) and there were no low clouds or other significant phenomena, after the rain stopped (*picture nr. 3*). When take-off was attempted the runway was wet.

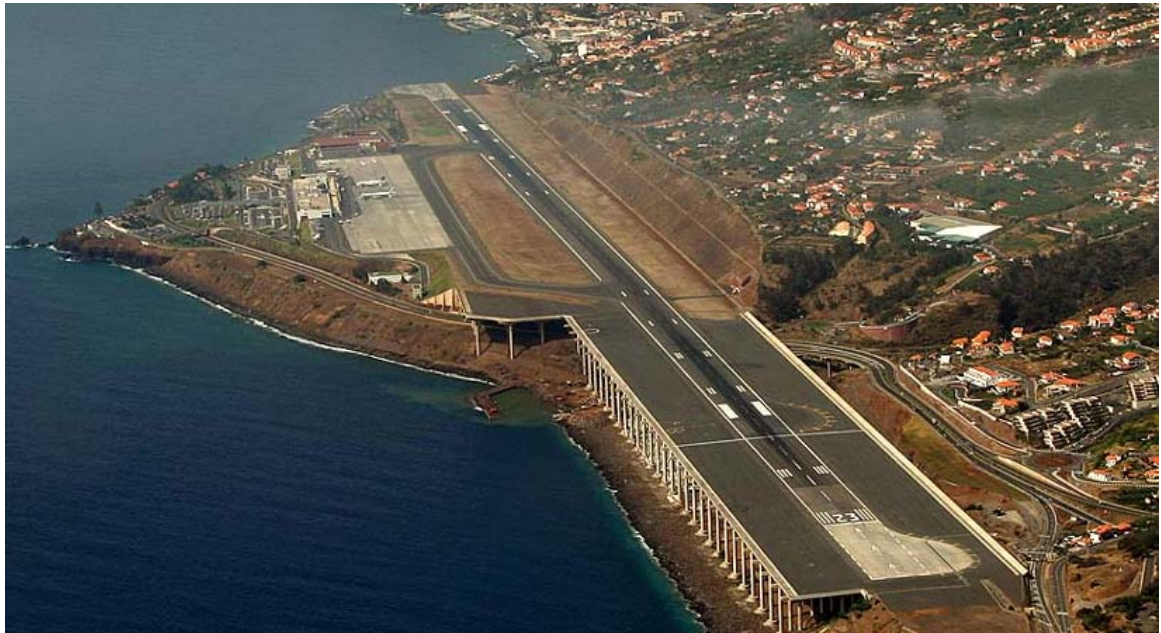
Picture Nr. 4

The Airport is located on a plateau on the east coast of Madeira Island (*picture nr. 4*). Except for the seaside, ground raises rapidly very closed to it. This fact generates, very often, wind variation and turbulence.

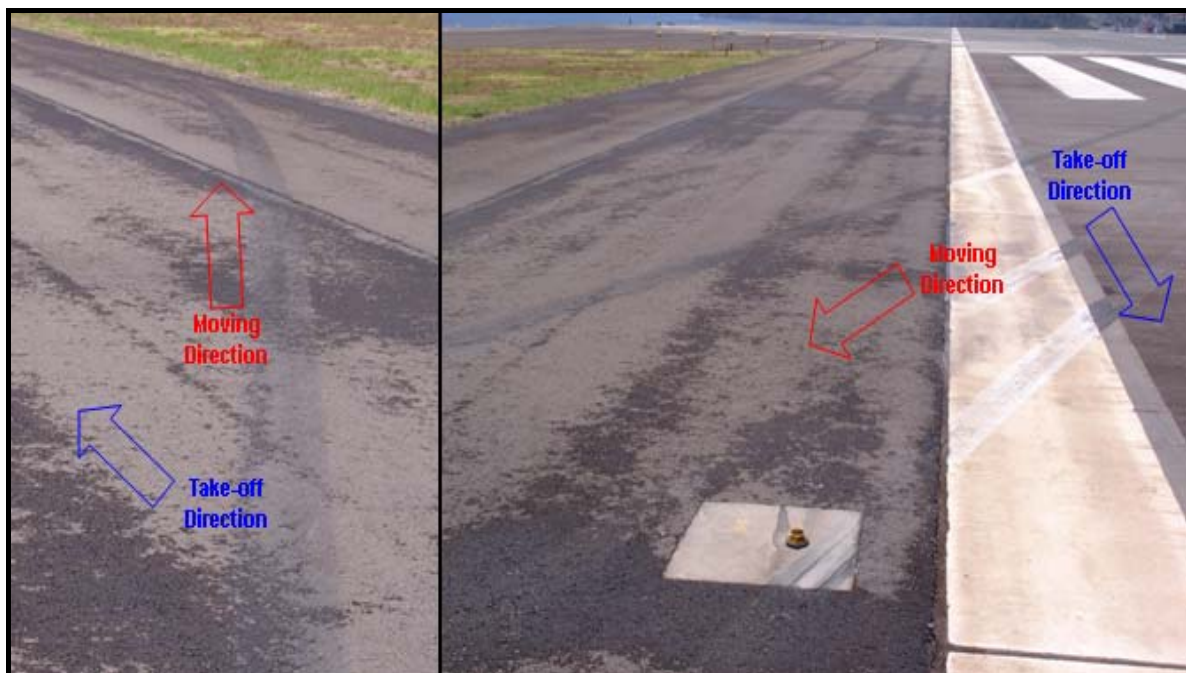
Picture Nr. 5

Aircraft path was well signalled on runway, after the event (*picture nr. 5*).

Marks of skidding started on the beginning of the runway, finishing on right runway safety shoulder, about 80m ahead. Looking for the marks on the runway we could distinguish light colours on painted surfaces and dark ones on asphalt, which may indicate that a cleaning action had occurred, where the tires acted as a broom.

An accurate inspection to the tires showed no signs of wearing or melting rubber, characteristic of dynamic or reverted rubber hydroplaning phenomenon.

EC-KDJ aircraft didn't reach minimum speed for dynamic or reversed rubber hydroplaning. Nevertheless there were visible runway marks of skidding, which confirmed the occurrence of viscous hydroplaning, due the presence of dust on the runway smooth surface, covered by a light wet film.

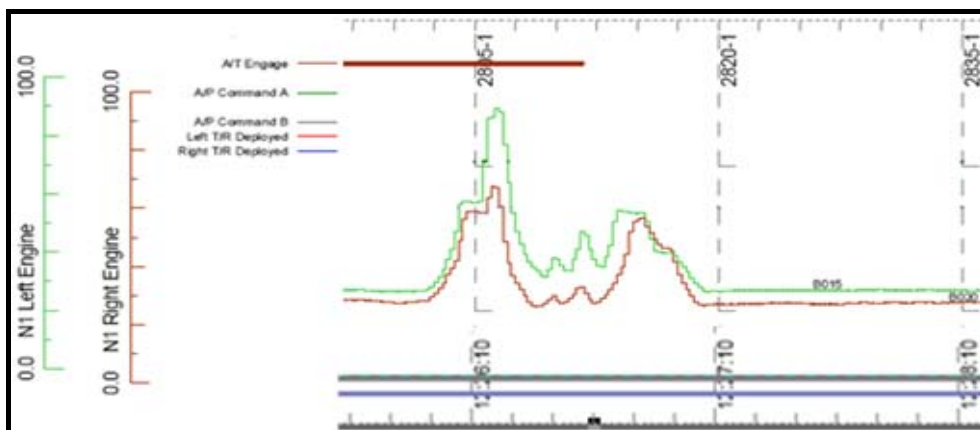
Picture Nr: 6

For take-off, crew elected to use Auto-Throttle (A/T) and FMC computed thrust. Picture nr: 6 represents engines power behaviour, during rejected take-off manoeuvre.

A/T didn't act symmetrically on both engines, #1 accelerating towards 88% N1, while #2 rested at 67% N1 (*picture nr. 6*).

The pilot tried to bring power to idle but he succeeded only after disconnecting A/T, being idle power established at 12:27:10 (*frame 2820*).

Primary cause for this incident was the asymmetrical activity of Autothrottle system, which caused engine #1 power increase greater than engine #2, forcing the aircraft to veer to the right.

Considering that primary cause for this incident has been the engine's asymmetrical acceleration, once A/T was engaged for take-off, a comprehensive check should be performed on A/T system, in order to determine the faulty part;

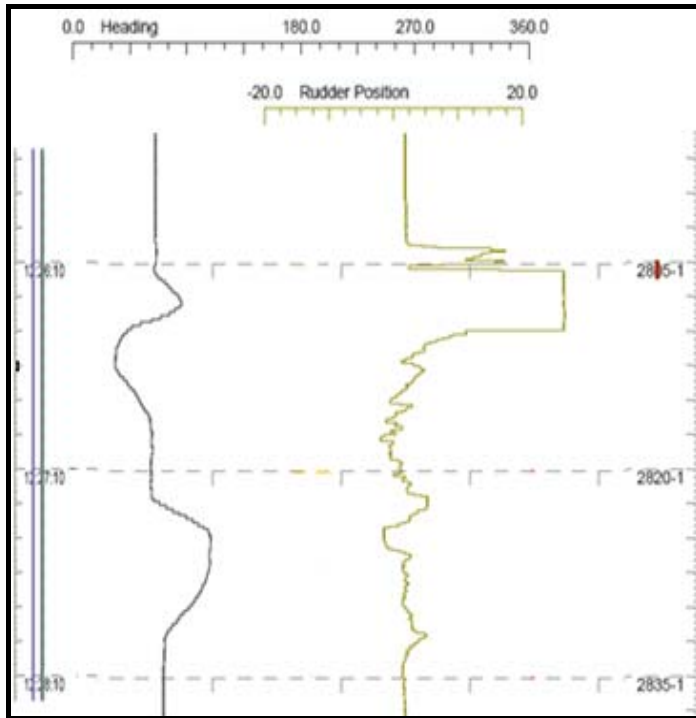
Picture Nr: 7

As soon as take-off was initiated (12:26:00) there was a ruder deflection to the right (17°), returning to neutral and immediately set to maximum right deflection (>20°). Meanwhile aircraft heading increased from 048° to 090° (picture nr. 7). After those 20'' ruder remained more or less neutral but there was heading excursions from 090° to 030°, back to runway heading (045°) and to the right again (110°), before regaining heading 048° at 12:28:00 (frame 2832).

Despite all those heading variation, aircraft track remained more or less straight until the aircraft came to a halt.

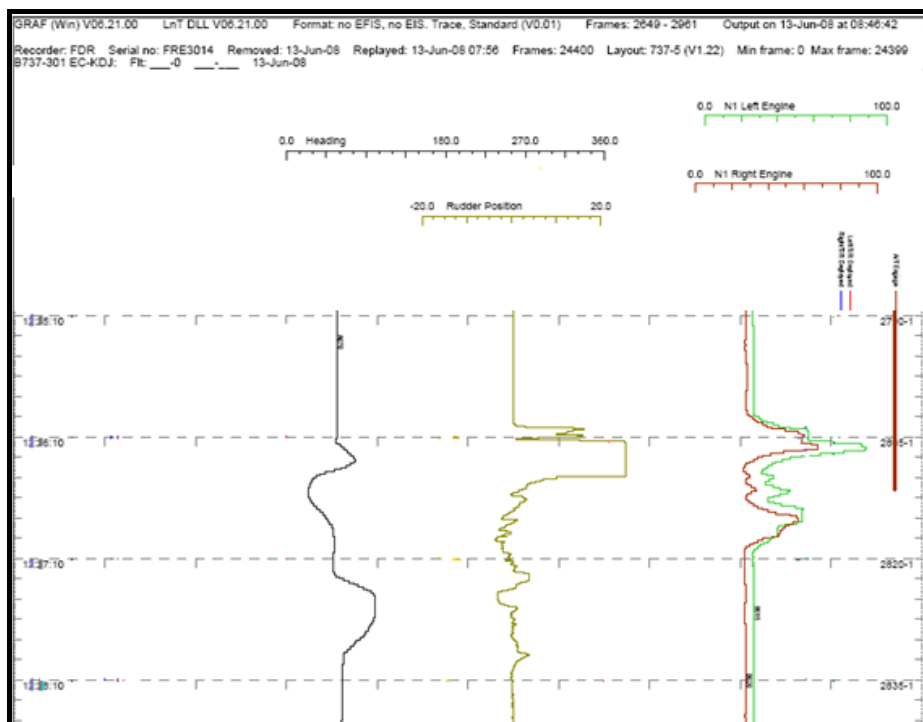
Picture N: 8

Almost simultaneously ruder deflected to the right (17°) and aircraft heading started to increase towards 090°. Pilot reduced engines thrust (20%N1) but A/T remained engaged and power increased again (40%N1) until A/T has been disconnected and thrust levers returned to "idle" (*picture nr. 8*).

At the very moment the aircraft started moving and heading increasing, it initiated a slide that took it on a straight 30° track to the right, leaving the runway, until it stopped on runway safety shoulder. All along that track there were heading significant changes, power variation and assorted ruder actuation. Even if there is no registry of nose wheel steering actuation it is supposed to have been used by the PIC, but without any effect, as the aircraft was skidding.
