FINAL INCIDENT INVESTIGATION REPORT

BOEING 777-328 ER

F-GSQT

In-flight engine failure

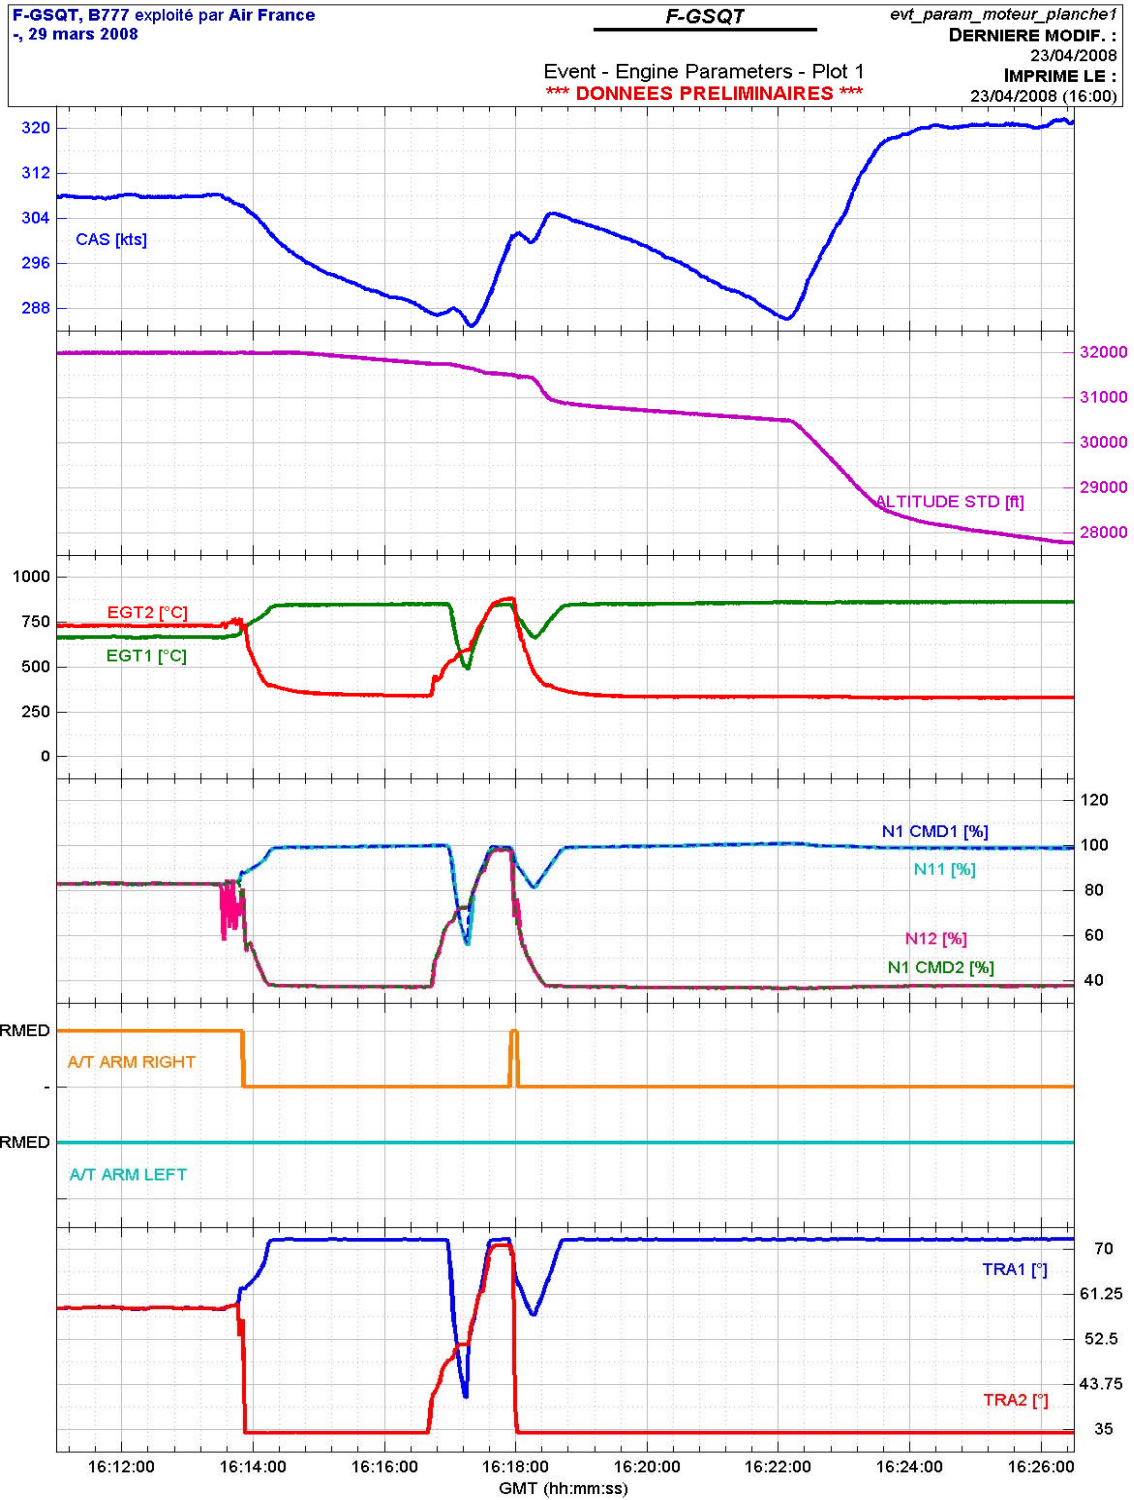
Engines' parameters – Plot 1

2- When engine #2 vibrations and loud bangs were noticed, the crew retarded the thrust lever to the idle position for a while. Once advanced beyond 60%N1, the engine #2 indications became unstable again, returning to vibrations and loud bangs. Information from the DFDR showed that there was no significant change in other engine parameters.

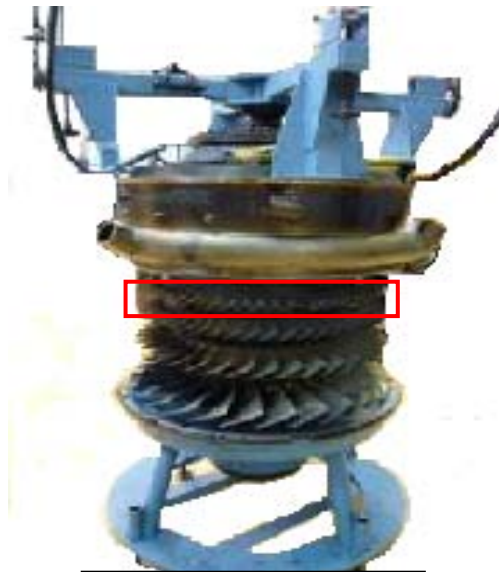
Engine #2 HPC Stage 4

- Stage 4 HPC blade set found heavily damaged (some blades found with airfoils missing, - #44 blade with airfoil missing just above the platform - some others with tip corner loss on trailing edge and on leading edge);
- One stage 4 Vane found with missing airfoil;
- Stage 5 HPC blade set found heavily damaged on leading edge (all blades found with nicks, tears and missing material, consistent with secondary impact distress);
- Stages 6 to 9 blade set found with nicks and tears, also consistent with secondary impact distress.

All stage 4 HPC damaged components have been examined. Presumably the origin of the problem was on the stage 4 HPC #44 blade airfoil separation, although the root cause of the crack couldn't be identified. The detached fragment came into contact with Stage 4 Vane Segment, releasing one airfoil and bending another one impacting on the remaining blades and starting other components distress.

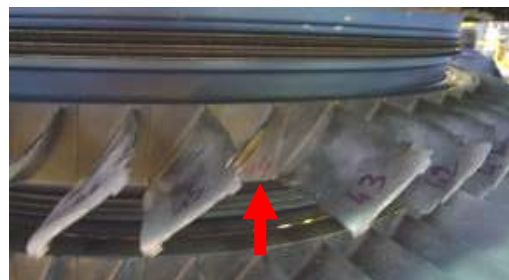
Stage 4 HPC #44 blade with airfoil missing, (separated just above the platform).

Accordingly, the Laboratory investigations concluded that the Stage 4 blade #44 airfoil separation resulted from High Cycle Fatigue, having the crack initiated at mid-chord on pressure side close to airfoil-to-platform radius. SNECMA suspects that this blade already lost Tip Corners that changed its vibratory response mode. HPC stage 3 or 4 tip corner loss due to rubs has also occurred in 45 other engines to date.

The investigation concluded that the incident on F-GSQT had its cause in the #2 engine HPC due to the stage 4 HPC blade #44 airfoil separation. The debris impacted a stage 4 vane segment causing successive damage on other HPC components. These circumstances caused HPC loss of efficiency with increasing distress resulting in a stall.

In the sequence of this incident GE established a relevant Control Program and a SB (# 72-0270) was issued in July, 2008, which recommends that Operators carry out a periodic inspection of stage 3 and 4 HPC blades for tip corner loss.

As closing action, GE and SNECMA decided to increase the HPC stage 3 and 4 blade tip clearance to reduce the potential for rubs which lead to tip corner loss. This is to be

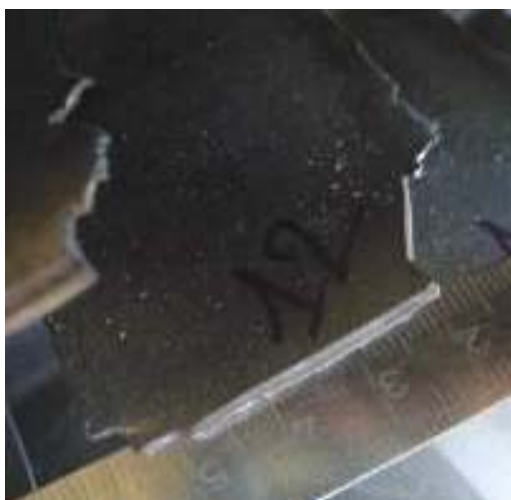
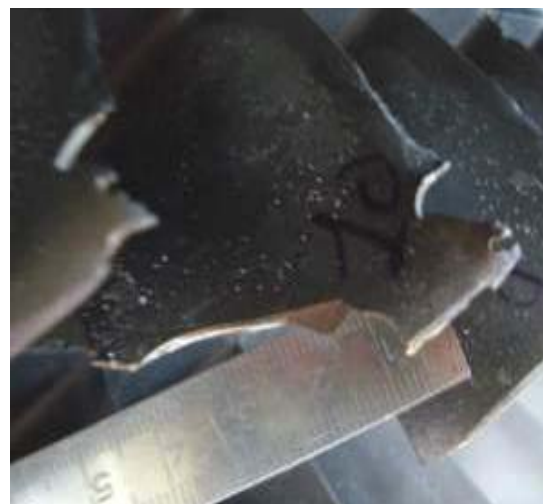
Stage 4 HPC:

- Four of the blades (#12 shown) were found with tip corner loss on trailing edge (left hand photo);
- Blade #10 found with tip corner loss on leading edge (right hand photo).

- Stage 4 HPC components had the correct microstructure, no blade dimensional deviation and the manufacturing marks were within limits;
- Several stage 4 HPC blades revealed tip corner loss on leading and/or on trailing edge;
