MINISTÉRIO DAS OBRAS PÚBLICAS, TRANSPORTES E COMUNICAÇÕES
GABINETE DE PREVENÇÃO E INVESTIGAÇÃO DE ACIDENTES COM AERONAVES
GPIAA

FINAL AIR TRAFFIC INCIDENT REPORT

BHP-1914 - BLUE-83
Boeing B-767/3Q8 - Boeing KC-135

FINAL INCIDENT REPORT Nr. 01/INCID/2008

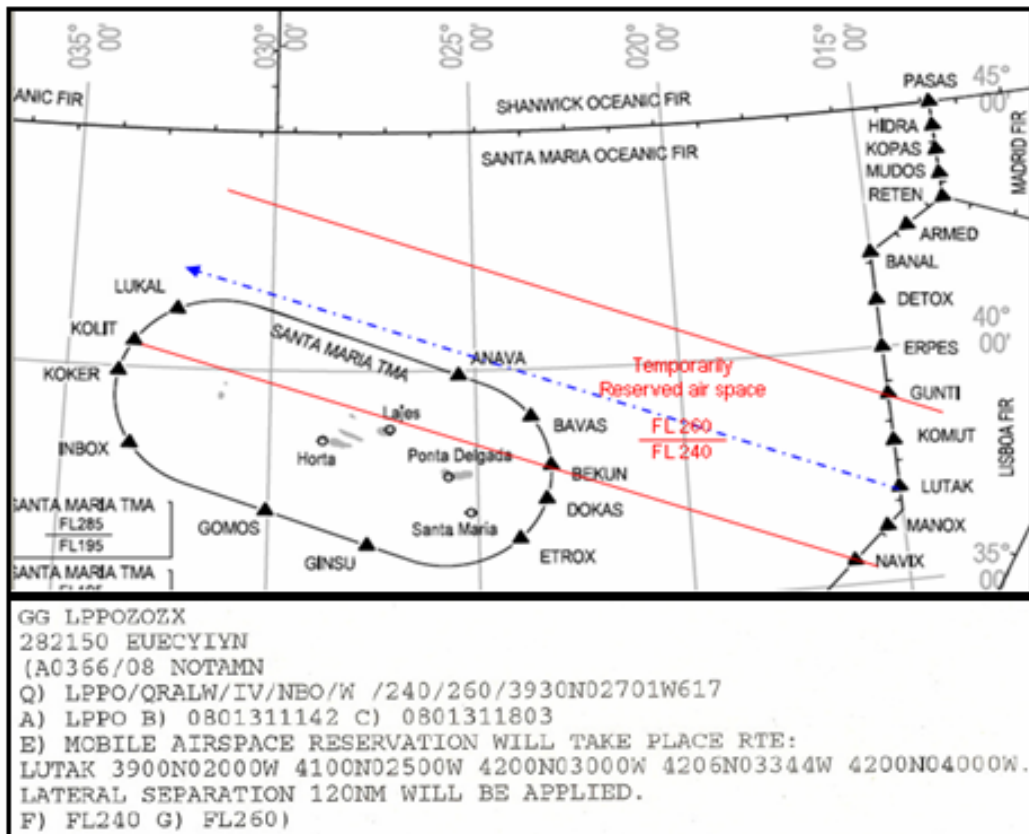
Picture Nr. 1

On the 31st of January, 2008, there were military operations in course north-easterly of Azores islands, with a special airspace reservation (a corridor of 240NM width along a centre line joining positions LUTAK – N39W20 – N41W25 – N42W30 – N42W40), between 11:42 and 18:03 and FL240 / FL260 (picture nr. 1).

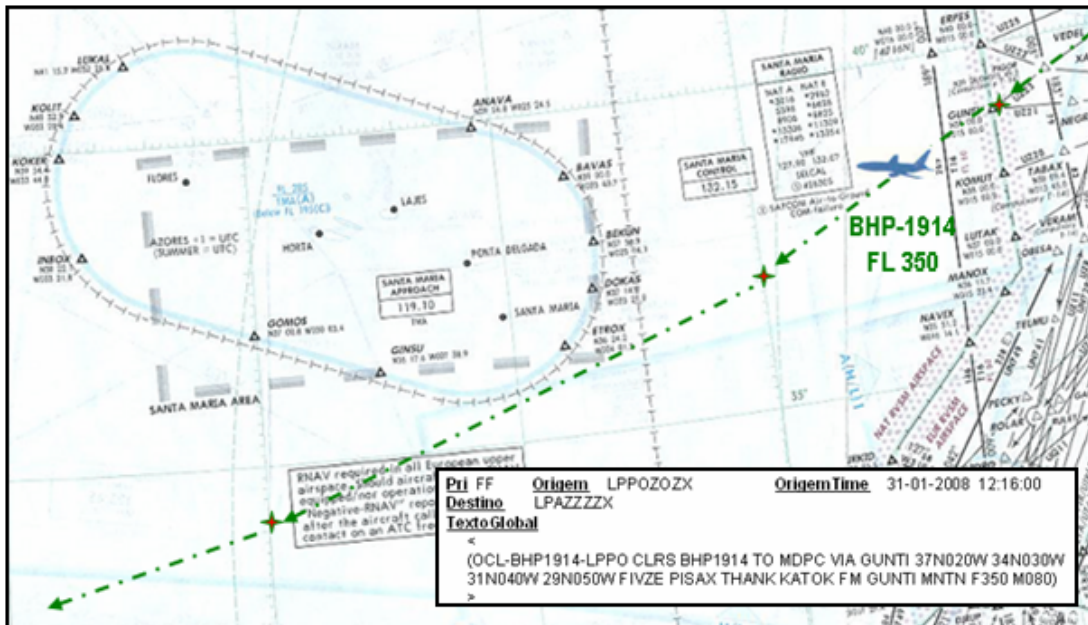
Picture Nr. 3

Swiss operator **BELAIR AIRLINES, AG** flight, BHP-1914, from Zurich to Punta Cana, has been cleared to fly Sta. Maria FIR, maintaining FL350, from “GUNTI” to “FIVZE”, via N37W20, N34W30, N31W40, N29W50 (*Picture nr. 3*).

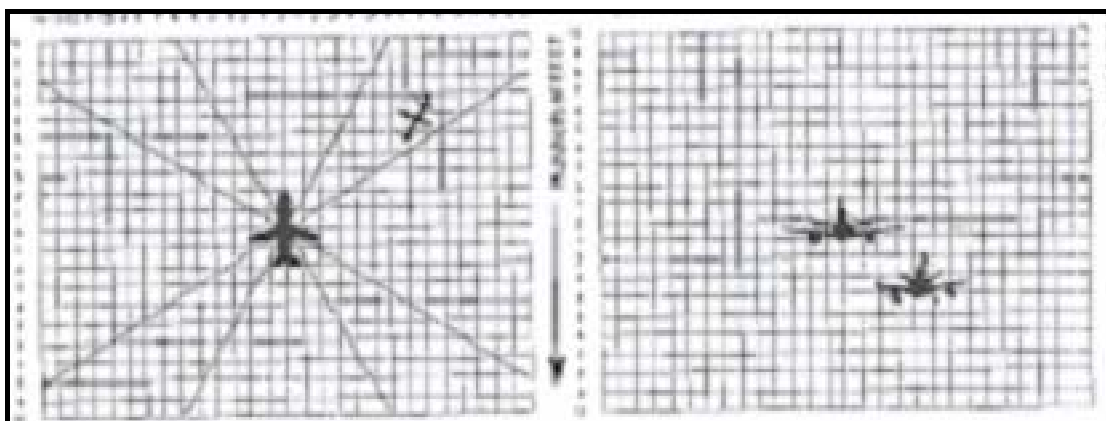
Picture Nr. 4

According BHP-1914 report, at 13:29, both aircrafts crossed at a horizontal distance of 1NM, approximately, and a vertical separation of 1000' (*picture nr. 4*).

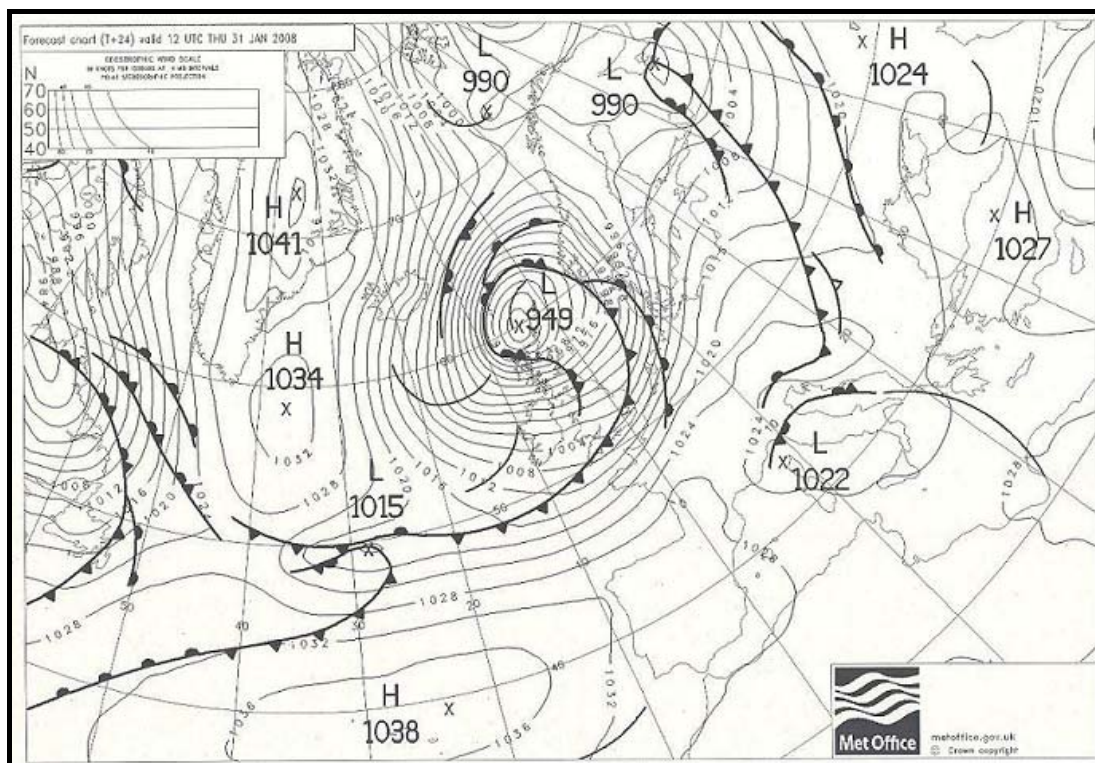
Picture Nr. 5

To the north, the situation was influenced by a Low Pressure, over British Islands, with vertical development clouds formation and strong westerly winds, associated with moderate to heavy turbulence (*picture nr. 5*).

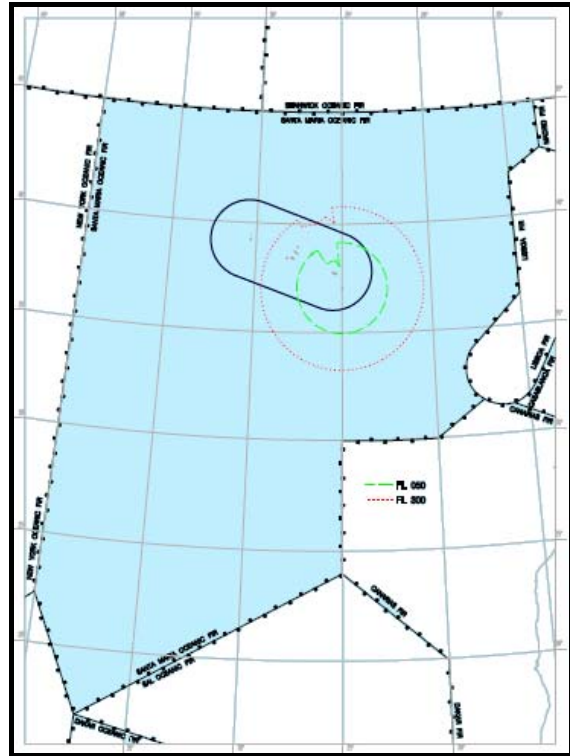
Picture Nr. 6

Sta. Maria Oceanic FIR covers a huge area over North Atlantic Ocean, limited by parallel N45° (north boundary) and N17° (south boundary), and meridians W014 (east boundary) and W040 (west boundary) (*picture nr. 6*).

Radar coverage was limited to a maximum 250NM radius (*red circle*), at FL300, reducing for lower altitudes (*green circle*) at FL50.

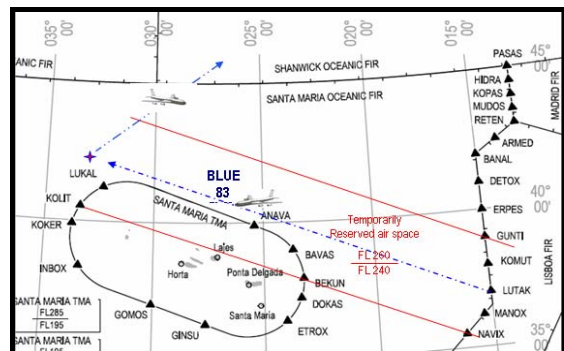
Picture Nr. 7

BLEU-83, was part of a group of six air refuelling platforms and eight fighters, involved in an air refuelling mission, inside a special air-space reservation area (as defined before) and was expected to leave the operation area through point 42°06'N 033°44'W, proceeding northerly to destination Mildenhall Air Force Base (EGUN) in UK (*picture nr. 7*).

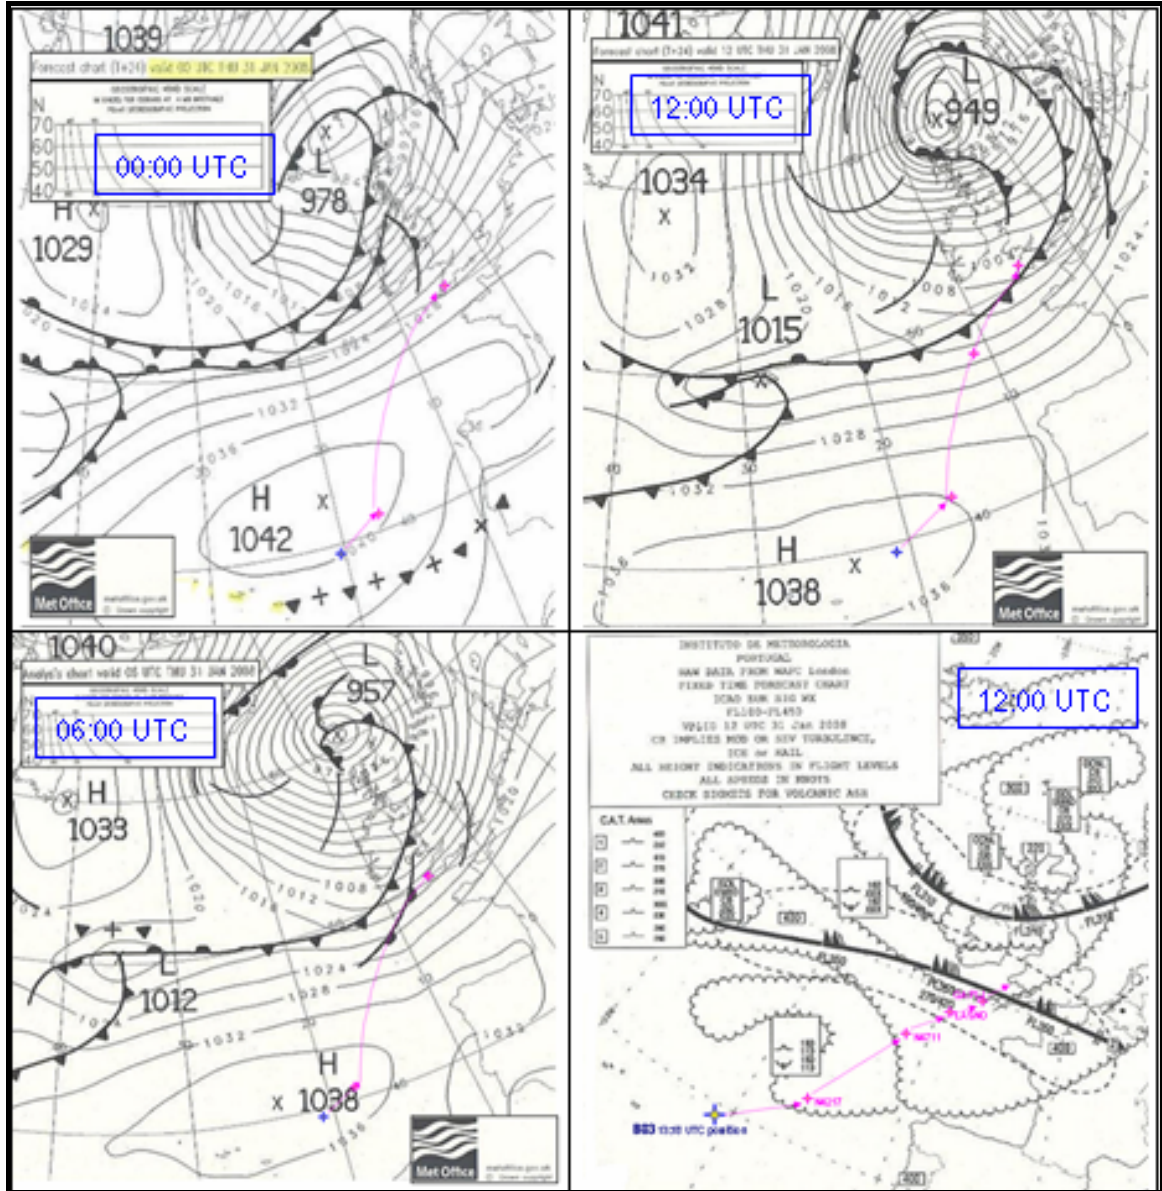
Picture Nr. 8

Due meteorological conditions (which have been deteriorating in the mean time) prevailing in the area along the expected exit route (*picture nr. 8*), BLEU-83 opted for an alternative routing and flew back to the entry point (LUTAK), proceeding than along standard routes to destination.

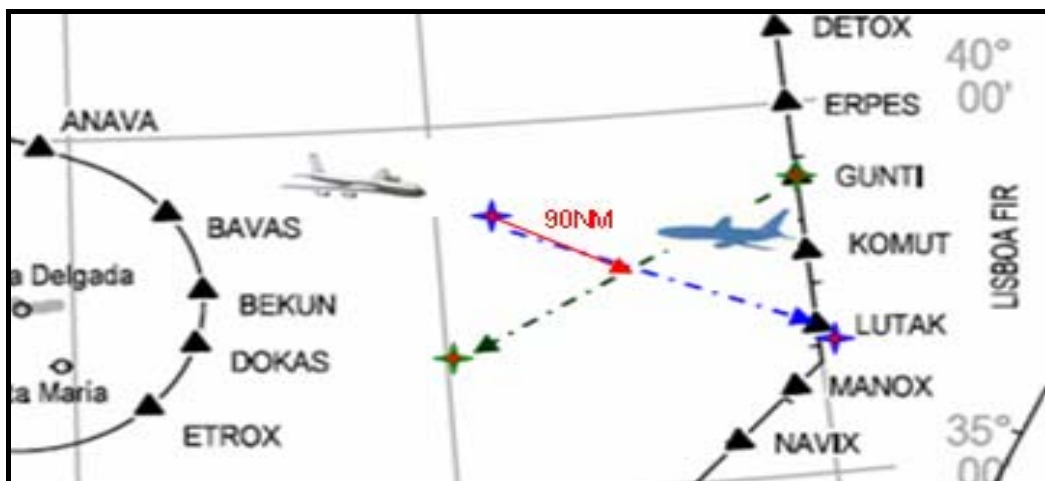
Picture Nr. 9

By the time of first contact with Sta. Maria, BLEU-83 was ± 90 NM far from interception point with BHP-1914, same level (*picture nr. 9*).

When RO contacted ATC, both aircraft were coming inside traffic advisory area.

When ATC issued descent order for BLEU-83, both aircrafts were coming inside resolution advisory area.

When RO transmitted ATC order to BLEU-83, both aircraft were recovering from conflict avoiding action commanded by TCAS.
