FINAL ACCIDENT REPORT

PRIVATE
COLOMBAN MC-15

F-PYNN

FINAL ACCIDENT REPORT Nr. 38/ACCID/2009

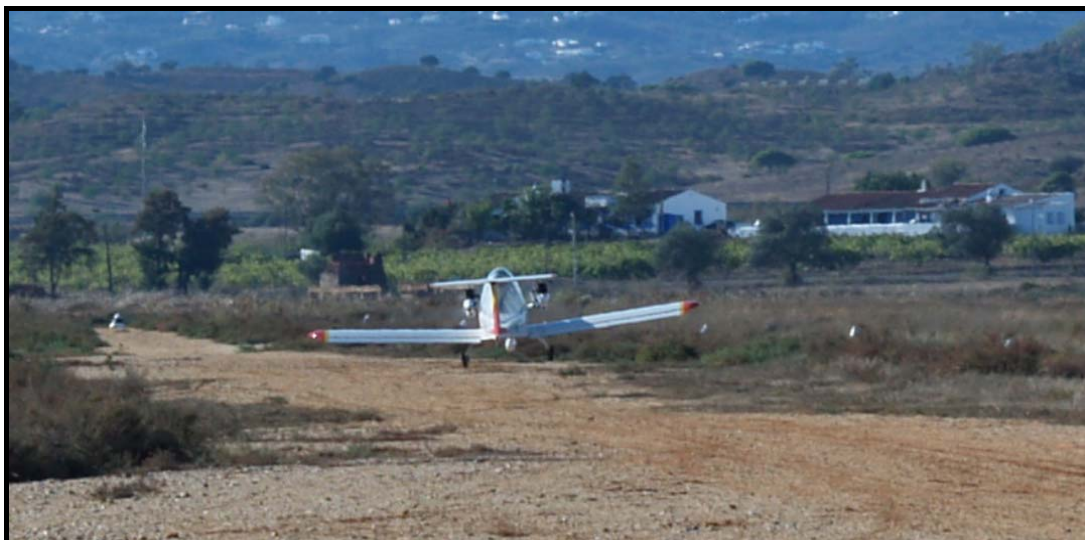
Picture Nr. 1

Airplane ground acceleration seemed to be slow, being airborne only after $\pm 400\text{m}$, approximately half runway, and starting to veer to the right heading 330° (*picture nr 1*).

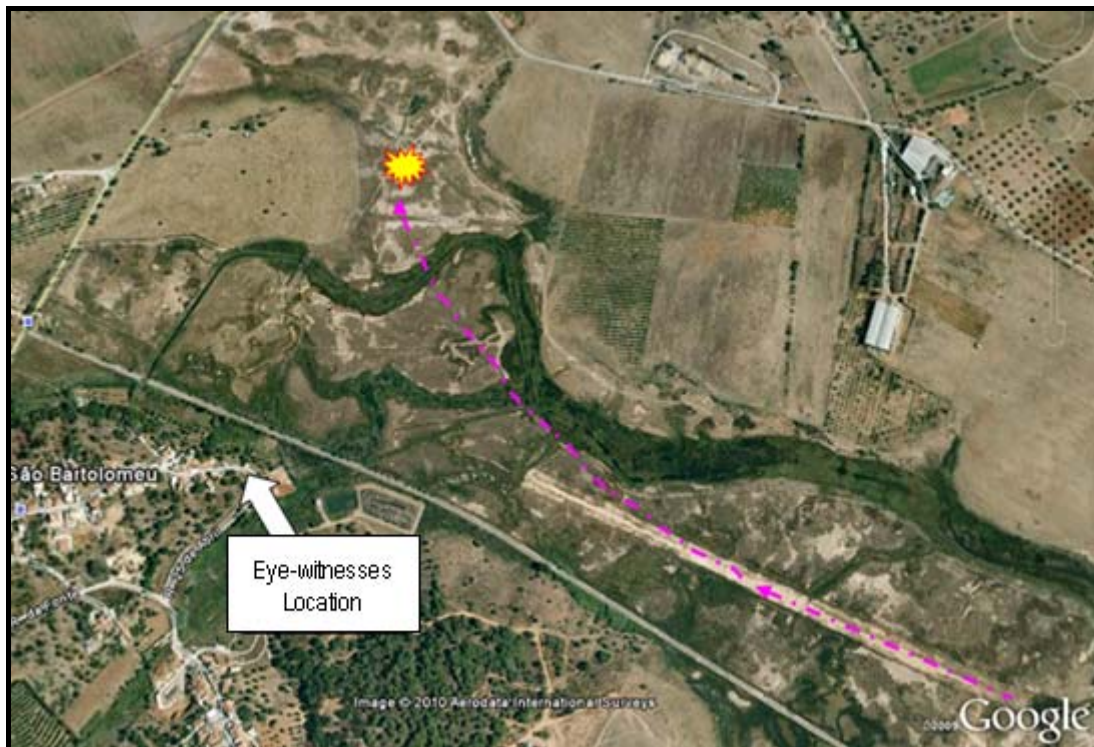
Picture Nr. 2

The aircraft flew for 700m (*picture nr 2*) maintaining a reduced climb rate ($\pm 300\text{ft}/\text{min}$) without increasing speed significantly.

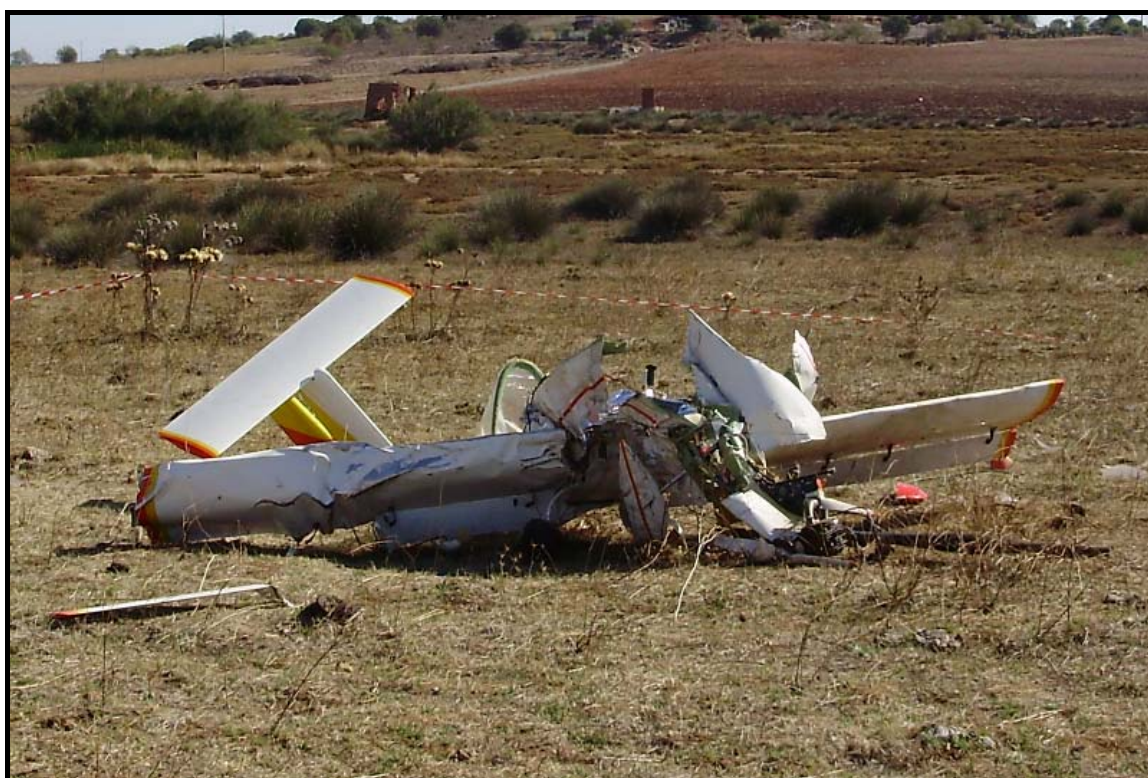
Picture Nr. 4

The aircraft suffered substantial damage being considered total loss (*picture nr 4*).

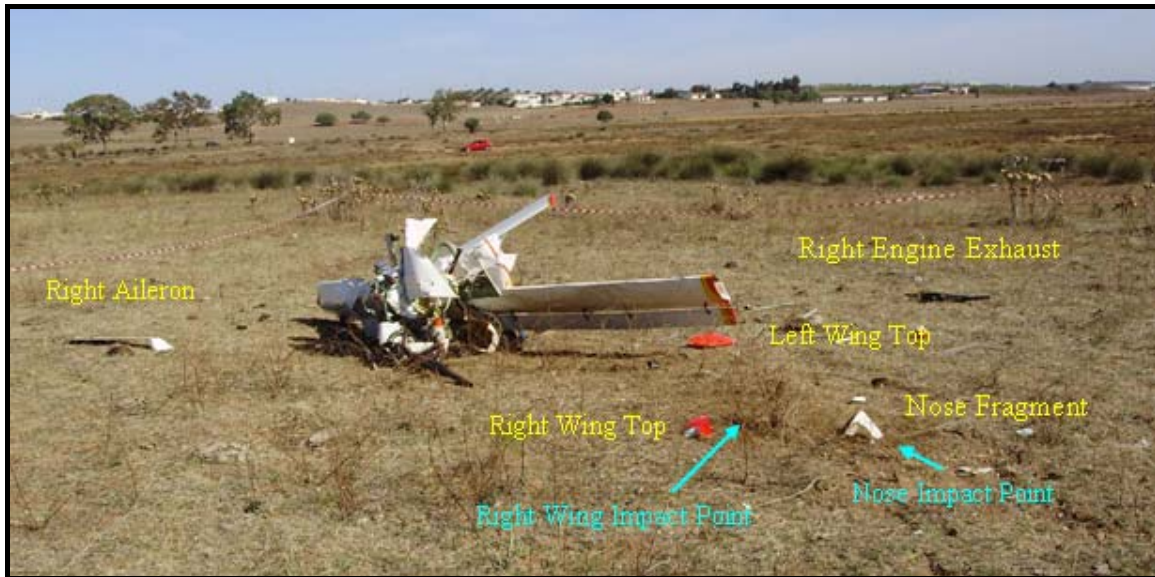
Picture Nr. 7

Wreckage was assembled in a small perimeter of less than 5m radius, being all main components connected to each other and only a few small pieces were apart (picture nr 7). Left wing, rear fuselage, tail section and main landing gear suffered no heavy damage. Flight deck was destroyed. Right wing was dislodged from its root, wrinkled along its surface and respective aileron detached. Forward fuselage was smashed until main spar's station, with nose gear and engines' supports pulled out.

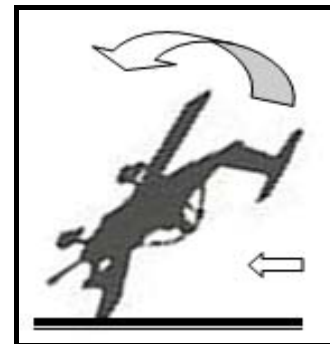
Picture Nr. 8

First ground impact occurred on right wing tip (with nose down and the aircraft on a twisting movement to the right) followed by the nose (on an inverted position). Right wing main spar absorbed major impact forces and penetrated the fuselage, assisting with cabin destruction, which meanwhile hit the ground (*picture nr 8*), breaking nose gear leg and engines' supports. Then the plane flipped over and came to rest on its belly pointing backwards.

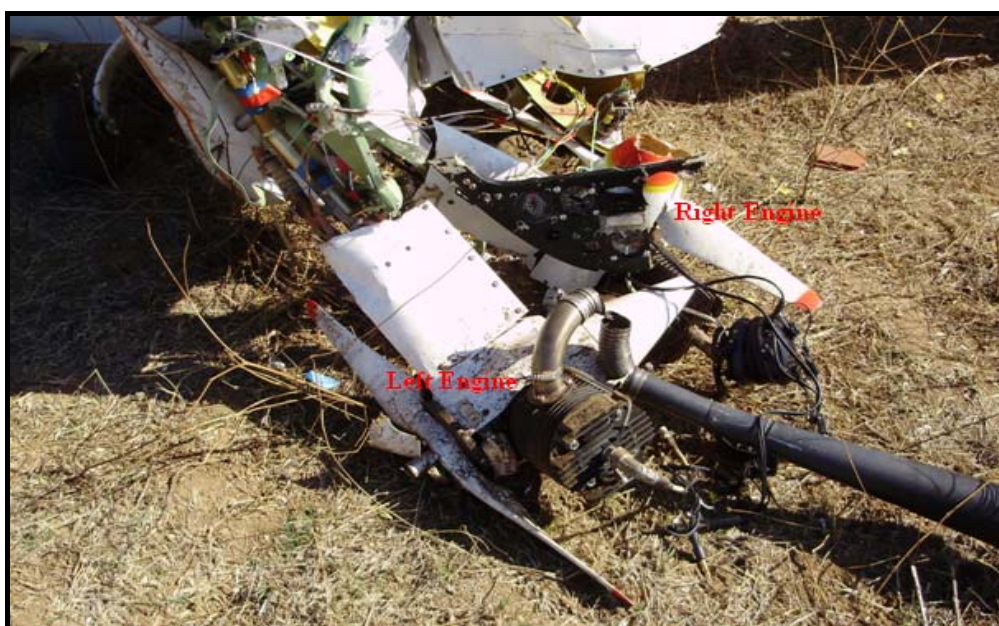
Picture Nr. 9

Both engines showed no significant damage and both propellers were complete, with only some splinted blades and cracked domes (*picture nr 9*).

Right engine presented its ignition spool broken but, once exchanged with the one of the other engine it started and run normally. Left engine was perfect but propeller shaft was found bent. A borescopic examination was performed to both engines and cylinders appeared clean and no irregular wear was noticed.

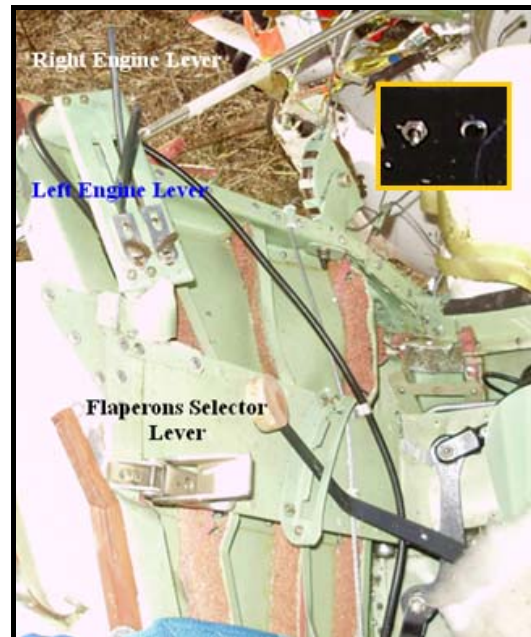
Picture Nr. 10

Flaperons selector lever (picture nr 10) was selected to first notch (12°), as recommended for take-off.

Engine power levers were in extreme positions:

- Left one full back and
- Right one full forward.

Engine ignition switches were selected:

- Left one to “OFF” and
- Right one to “ON”.

Considering that wreckage evidence confirms both engines were not delivering power when the aircraft crashed and left engine controls were found selected to an engine shut-down position, we may suppose that left engine failed with right engine still running, inducing pilot to perform engine shut-down procedures.

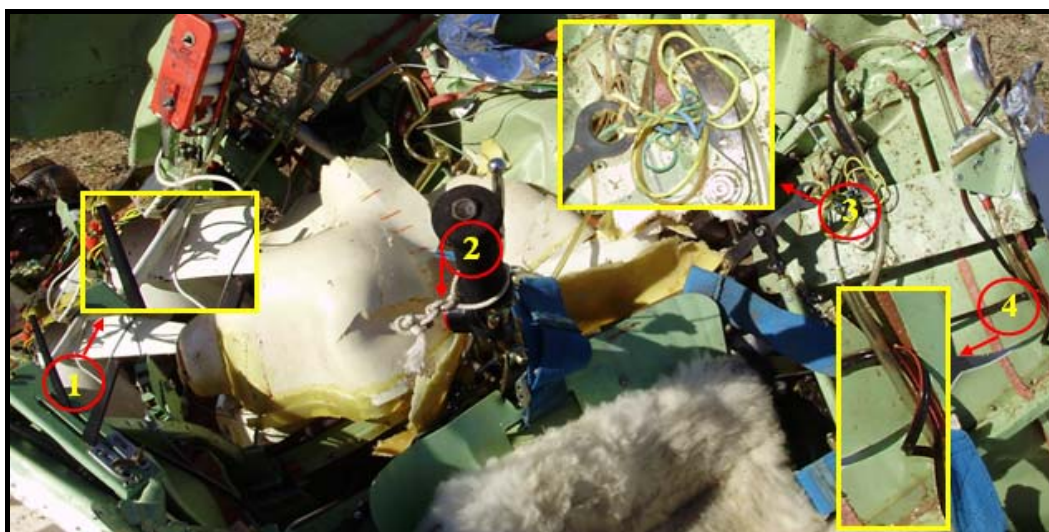
Picture Nr. 11

Although a significant destruction of forward part of the cabin made difficult the evaluation, some details showed a lack of exigency and amateurishness, with the use of uncommon materials and processes (picture nr 11).

To point out only a few, let's refer the missing power lever's extremity identification balls (1), the engine's starter rope hanging on control stick (2), rubber rings confusion on pitch feeling & trim system (3) and the strange way electric wires were installed and secured (4).

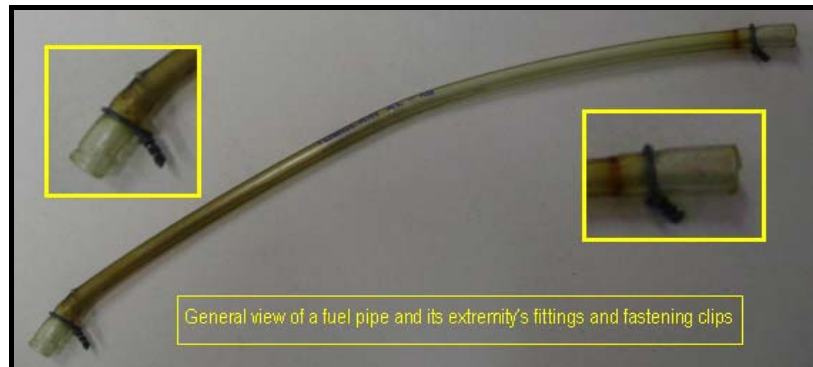
Picture Nr. 12

The same could be seen on fuel system installation, not only regarding the hardness of plastic materials used, but the way their fittings and connections were achieved (picture nr 12).

Some fuel lines were hardened and, most probably, with leakage and/or solid deposits deriving from old fuel rotting.

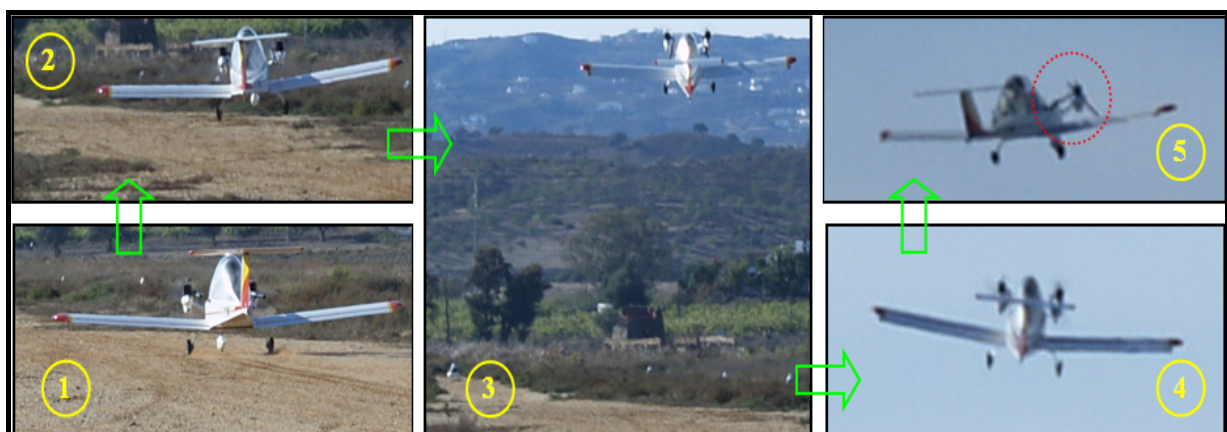
Picture Nr. 13

Those pictures confirm the flaperons were set to take-off position and they were maintained at that mark until the crash, as they were found. According recommended normal procedures, flaperons should have been retracted to cruise position (3°) 50m above ground and 110km/h speed.

As soon the aircraft lift-off, it showed a deviation to the right (*picture nr 13 - 2 & 3*), contrary to what should be expected, once the wind was blowing strong from the left and the aircraft should point to the wind.

At a certain point, it seems the right engine stopped and the propeller is not rotating (*picture nr 13 - 5*), which is in contrast with engine controls' settings in the cockpit.

Right engine presumed deficient power output could, by undetermined reasons, take to a full engine stop, as picture 13 – 5 (*page 15*) may induce to believe it happened.

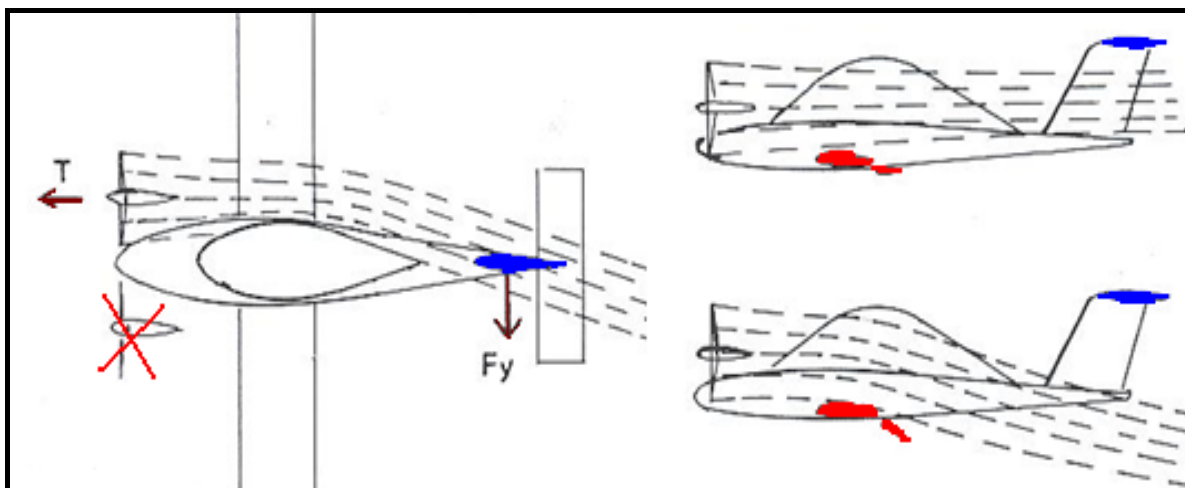
Picture Nr. 14

These flight characteristics result, mainly, from aircraft geometry, which allows an almost perfect laminar flow and, in *cruise* configuration, there's an air stream incidence on vertical fin, without interference with horizontal stabilizer (*positioned above*). In *take-off* configuration, air stream is deflected downwards and does not reach vertical fin (*picture nr 14*).

Aircraft configuration deflected air stream downwards and there was no incidence on vertical fin. In this case, any asymmetric power would cause the aircraft to deviate to lower power side and so right engine was, probably, providing less power than left one.
