## **FINAL ACCIDENT REPORT**

**AIR TRACTOR 802-F**

**VH-LIH**

**FINAL ACCIDENT REPORT N° 28/ACCID/2009**

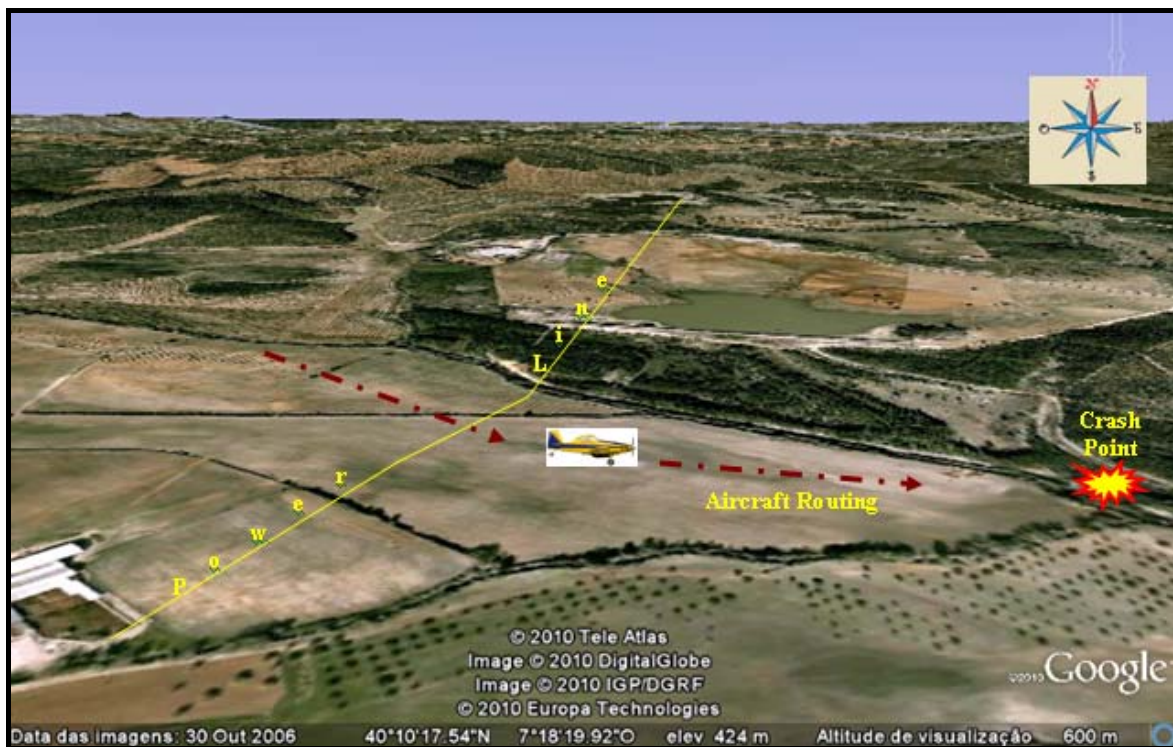
Picture Nr 2

Unsure about the possibility to reach the chosen field, the pilot feathered the propeller (to increase gliding capability) and, after avoiding a power line, he managed to touch the ground but was unable to stop the aircraft in the available distance, jumped over a gully and crashed into a pine forest, the other side (*picture nr 2*).

It was a violent collision, causing the propeller reduction box case to break apart and heavy damage on wings leading edge and landing gear. After the impact, the pilot selected OFF all switches, positioned fuel condition lever to OFF position and left the plane, together with passenger. Aircraft cabin resisted to the impact and both people on board left the plane by themselves and run away the aircraft, which caught fire in engine's front zone.

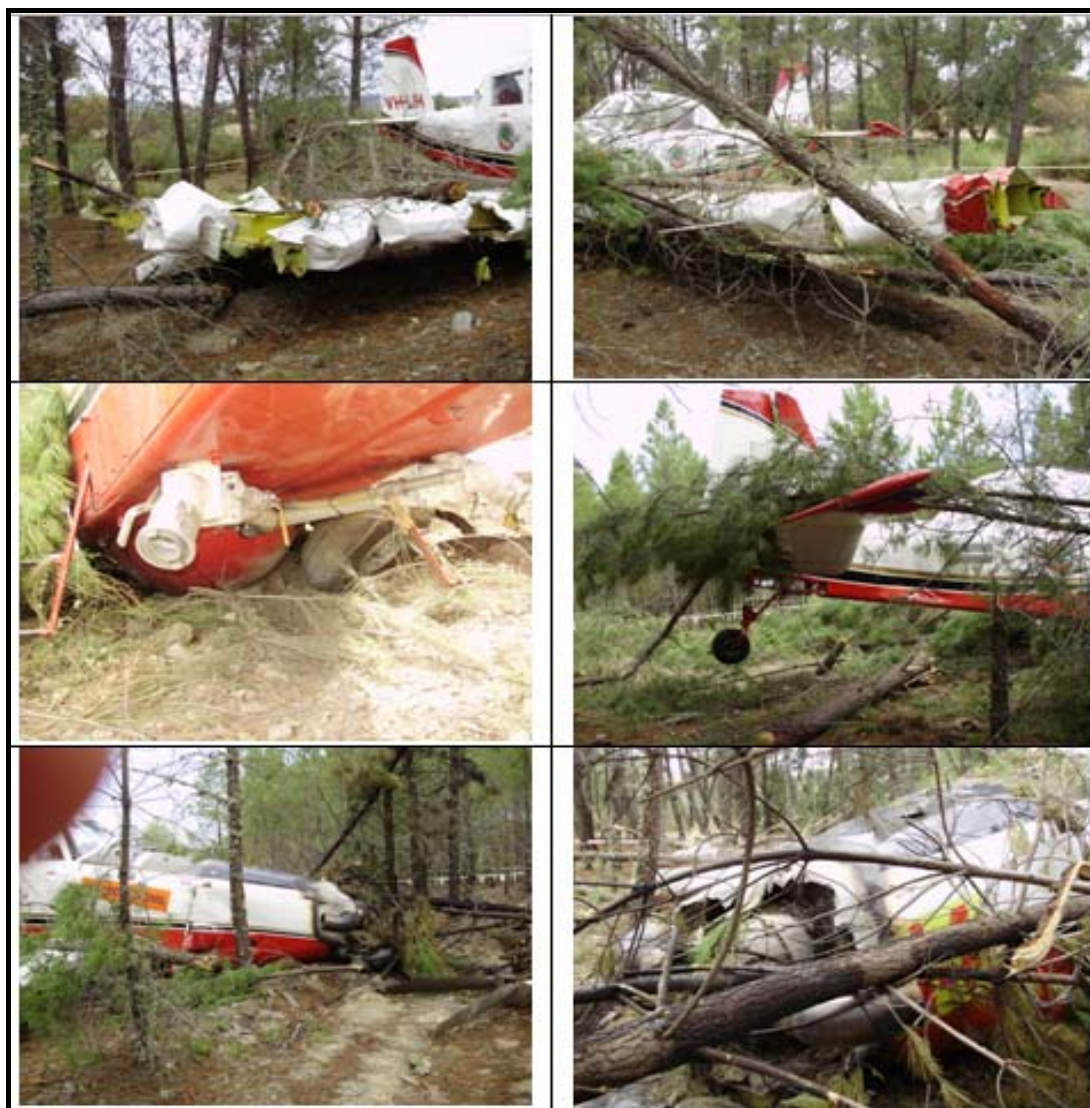
Picture Nr 3

The aircraft suffered light damage on the fuselage and tail, and heavy damage on the wings, landing gear and power plant (*picture nr 3*).

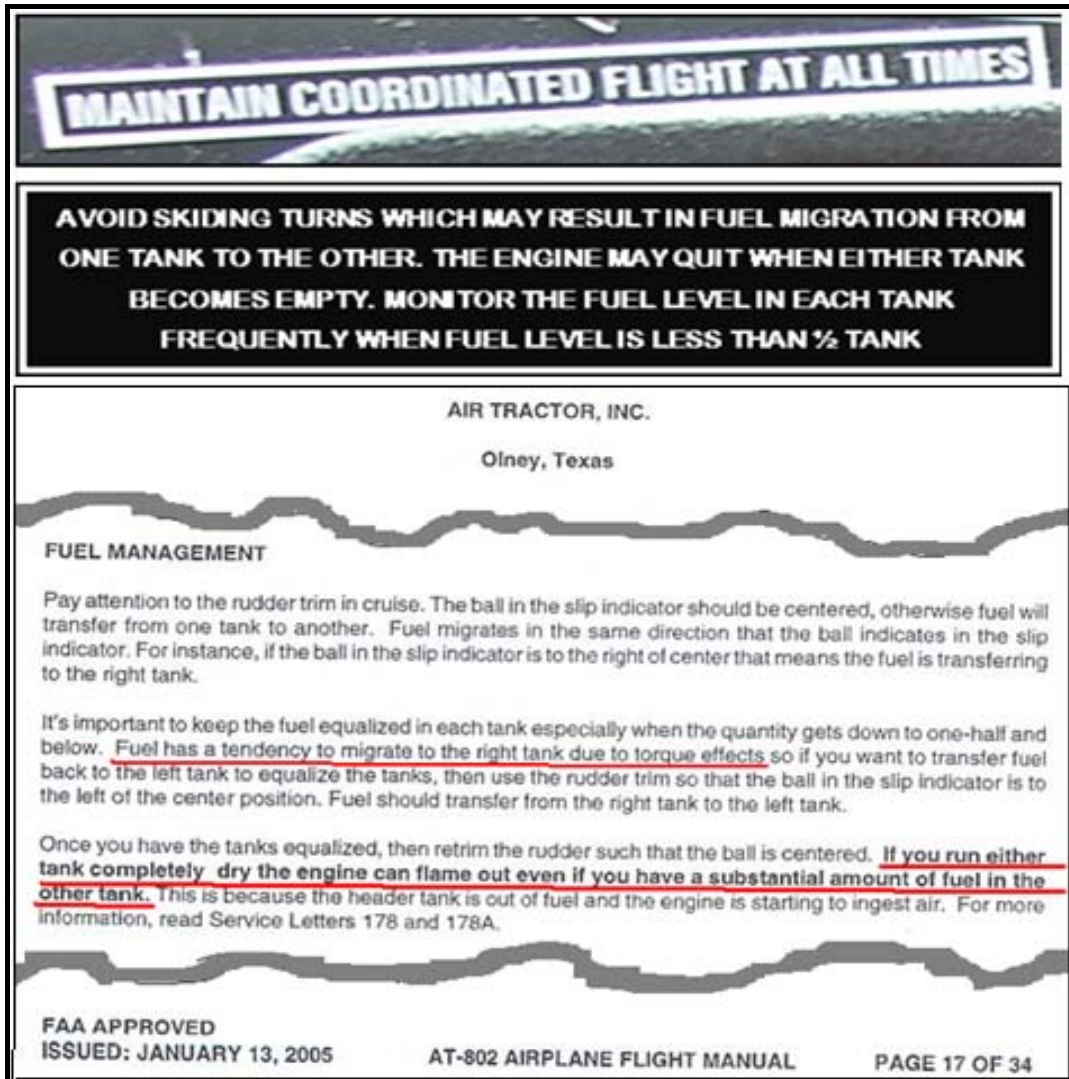
Picture Nr 9

Complementing AFM information, several stickers, relating fuel management procedures, have been spread on instrument panel (*picture nr 9*). Special attention is called for the fact that the high torque force present in this aircraft may force the fuel to migrate from left wing

tank to right wing tank, even with aircraft wings levelled, which could be enough to cause an engine stoppage, even if there is fuel enough in right wing tank.

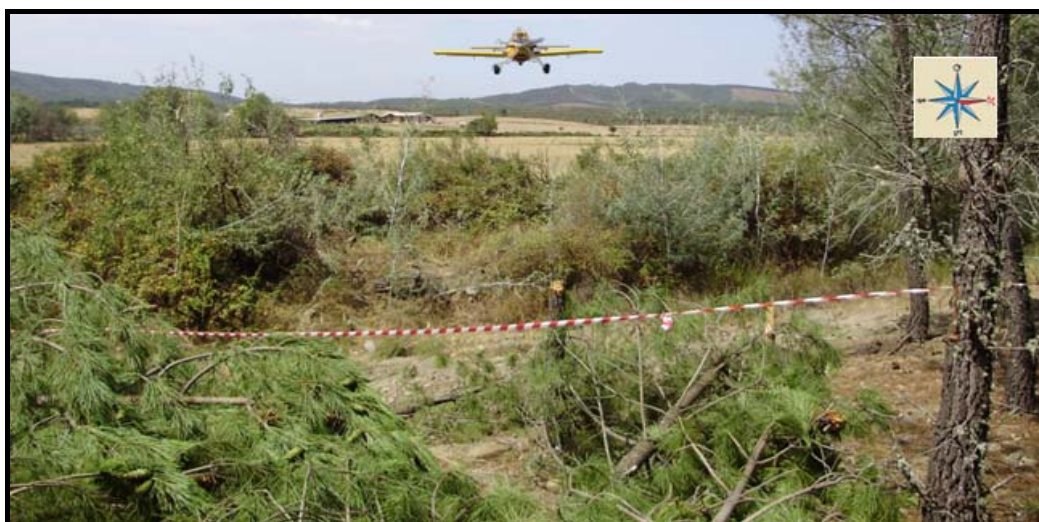
Picture Nr 10

During the manoeuvre he discovered there was a power line across the field, which forced him to perform some avoiding manoeuvres. These manoeuvres delayed landing preparation procedures, specially flap's selection, keeping high speed until the aircraft touched the ground, becoming impossible to stop the plane in the cleared field available, to avoid aircraft nose over, and forcing it to go back to the air, pass over a gully and fly straight into a pine forest (*picture nr 10*).

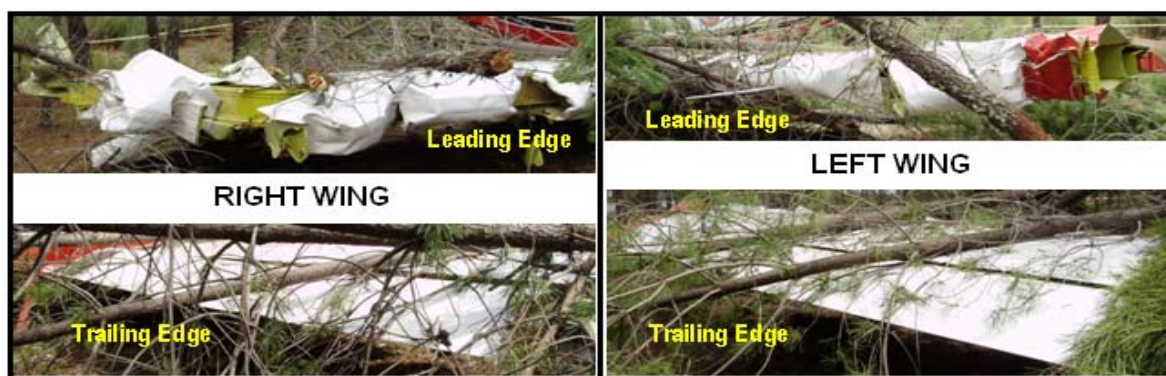
Picture Nr 11

Wreckage observation gives the impression that the aircraft was travelling at high speed when impacted with the trees. It was a frontal collision, the aircraft nose penetrating through the pine trees that wing leading edge was cutting and knocking down as the aircraft kept moving forward. Wing trailing edge suffered no damage (*picture nr 11*).

Wing collision with pine trees caused the leading edge to be destroyed and fuel tanks to rupture. When the investigator arrived in place, a heavy fuel smell could be sensed in the air, there was a big stain on the ground, under right wing, but the soil was clean under left wing, which may indicate that left wing tank was empty or with a minimum quantity of fuel.

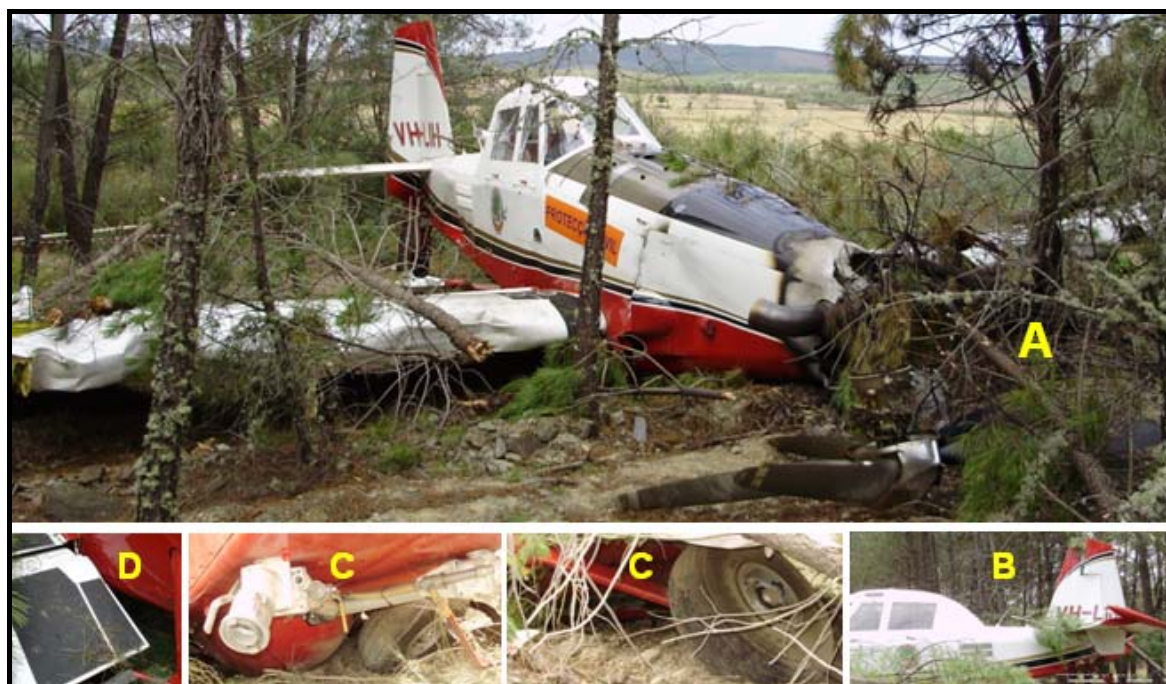
Picture Nr 12

The nose got damaged when impacting the ground, the propeller separated (*due reduction gear box breakage*) and the engine got fire (*picture 12A*). On engine surrounding soil there were no signals of engine liquids spillage, only water and fire-retardant product.

Fuselage and tail section suffered no significant damage, as they never impacted directly with obstacles and were not subjected to forces that could cause heavy deformations or fractures (*picture nr 12B*). Landing gear failed when it contacted the ground vertically, without presence of horizontal movement marks on the soil (*picture 12C*).

Propeller reduction gear box was found fractured and separated from the engine due the propeller blades collision with the ground. Reduction gear and shafts showed no damage or cracks.

Fire deflagration on engine front zone (near exhaust) suggests there was fuel in engine feeding line, together with an ignition source. The way it was promptly extinguished shows it was a small quantity and under low pressure. No other fuel spillage evidences were found in the vicinity of the engine.

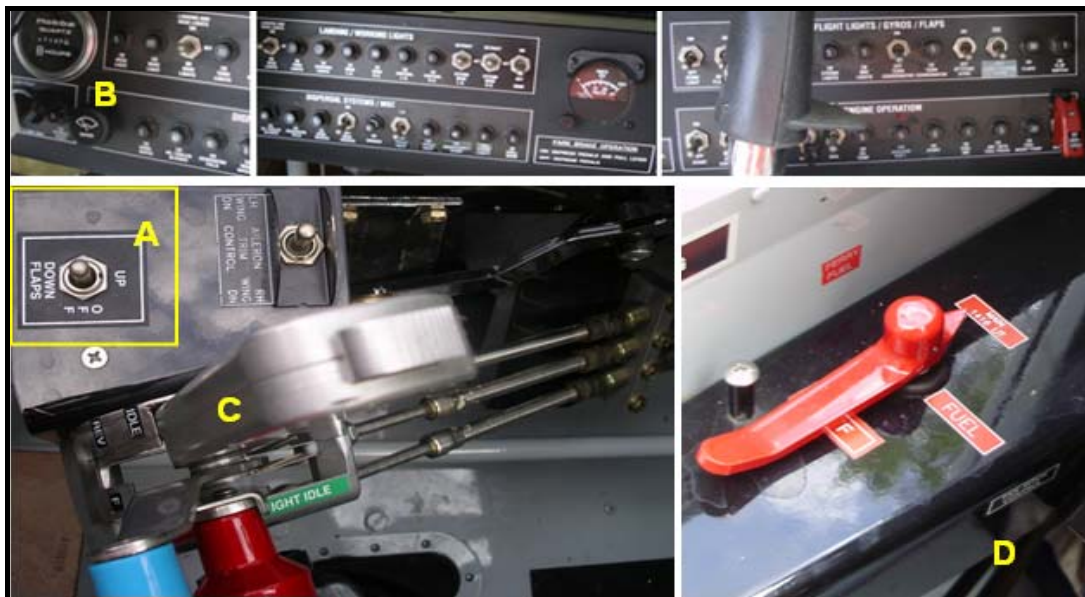
Picture Nr 13

Flaps were extended to 10° position (*picture nr 12D*) and Flap position selector switch (inside cockpit) was selected OFF (*picture nr 13A*). Inside forward cockpit all switches were selected "OFF" (*picture nr 13B*), engine & propeller control levers set to engine shutdown and feather position (*picture nr 13C*), but fuel selector valve was selected to wing tanks and not to OFF (*picture nr 13D*).

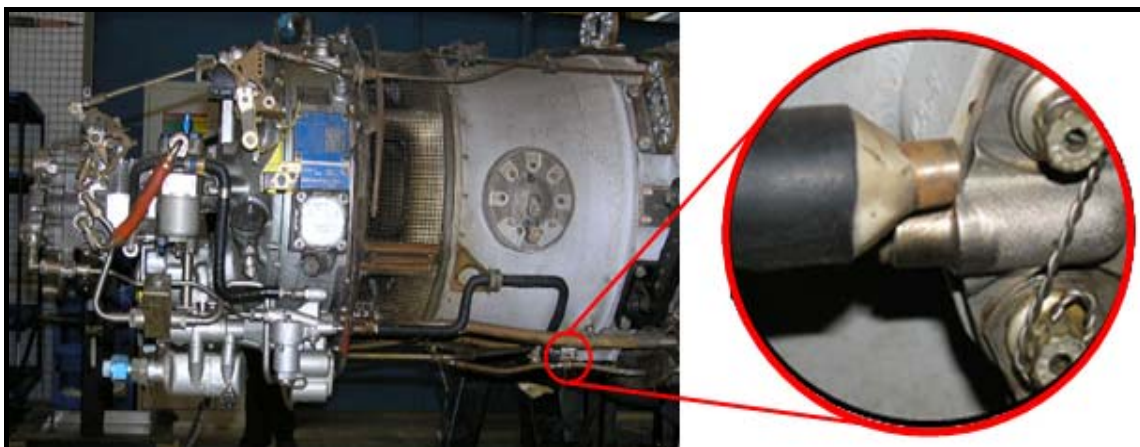
Picture Nr 14

Engine exterior detailed inspection revealed a "P3" (*compressor outlet pneumatic pressure*) line fractured adjacent to the juncture to the tube and gas generator case fitting, at the brazed joint (*picture nr 14*).

Analysis of this fracture surfaces indicated it has been produced by low stress forces acting for long periods, with a low propagation rate, until total rupture was attained. It could not be established with certainty the fracture causes, once the parts and the braze joint met drawing requirements.

Fracture microscopic examination showed there was a hammering process between mating surfaces, which could indicate there was a fissure previous to the event but parts were maintained together and granting the pressure inside the line.

Anyway, it was found that the installed line (p/n 3031829-A) didn't correspond to the last manufacturer specification, referred by P&WC SB Nr 14269, from 23-11-1999, which recommended the line to be replaced by a more durable one (p/n 3123019-01) as soon as the subassembly was disassembled and access to that part was available. Checking engine records, last heavy work was done in June 2006, but that SB was not incorporated.

Tests carried on FCU concluded it was operating according expected field selected values and, on engine examination, only "P3" line was found cut, preventing compressor outlet pressure signal to reach FCU. That pressure information was fundamental for the unit to calculate fuel amount to be delivered to fuel nozzles. Loosing that information and receiving atmospheric pressure value, instead, FCU would meter a fuel quantity appropriate for a lower regimen (consistent with that equivalent compressor outlet pressure), independent of throttle selection.

Microscopic analysis of fracture surfaces showed hammering marks between both surfaces, denouncing there was a fissure prior to the event, but parts were kept together, allowing compressor pressure to reach FCU. With part's separation, due to any manoeuvre or vibration, pressure feeding stopped and FCU ceased to deliver throttle position required fuel.

Fracture of pressure line from P3 to FCU could be the probable cause for the engine to loose normal power control and revert to idle power, forcing the pilot to try an emergency landing on unprepared terrain, which was not well succeeded.

- 1<sup>st</sup> Non compliance of P&WC SB Nr 14269, from NOV-23-1999, recommending to replace pressure line p/n 3031829-A by p/n 3123019-01, when subassembly was disassembled and access was available to the part;

It was considered to be neither relevant nor opportune to issue any safety recommendation, so much so that P & W Canada has advised that they plan to revise SB 14269, increasing compliance code from 6 to 3, establishing that part to be exchanged after a certain time interval.

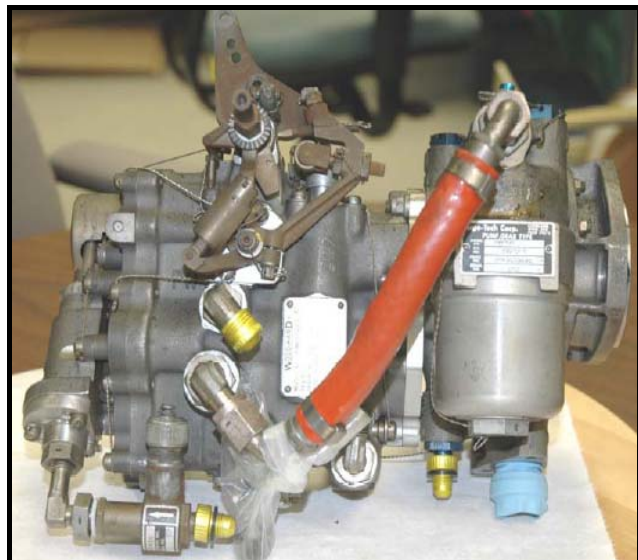
Picture Nr 15

In face of pilot in command (PIC) information, declaring that throttle forward and back movement caused no change on engine RPM, fuel control unit and fuel pump (picture nr 15) were disassembled and examined.

In fuel filter inlet screen some metallic debris were found, but fuel pump body and outlet filter showed no solid contamination or water mixed with fuel. Fuel pump performance was considered normal.

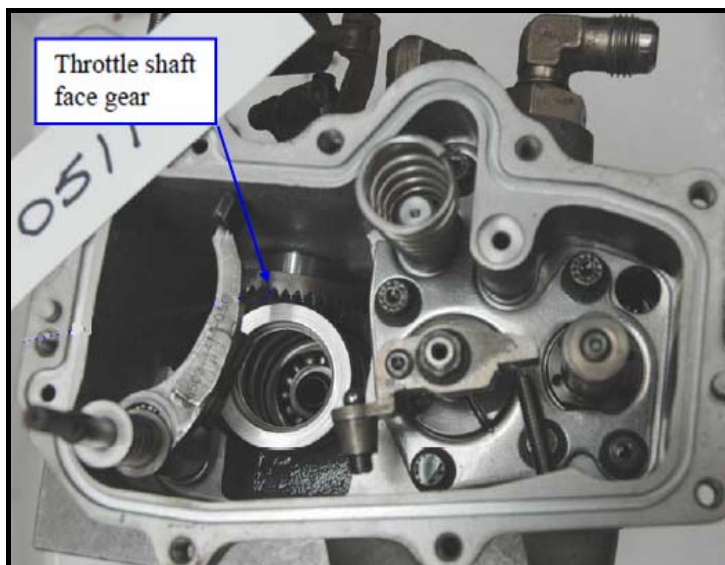
Picture Nr 16

Fuel control unit (FCU) was tested and a significant disagreement was noted between reading values and factory settings.

FCU was disassembled and, besides a lack of tightness of cover screws and some wear on fly-weight toes, it was discovered that throttle shaft face gear had jump a tooth on the 3D cam gear surface (*picture nr 16*), which could be caused, most probably, by the impact with the ground.

A new FCU test was performed and a slight disagreement from factory settings were confirmed, attributable to operator's field settings for the aircraft manufacturer recommended values (*idle of 68% instead of 73%*). Once the FCU was re-adjusted to engine manufacturer settings, new values were found, with a disagreement of 1% or less.

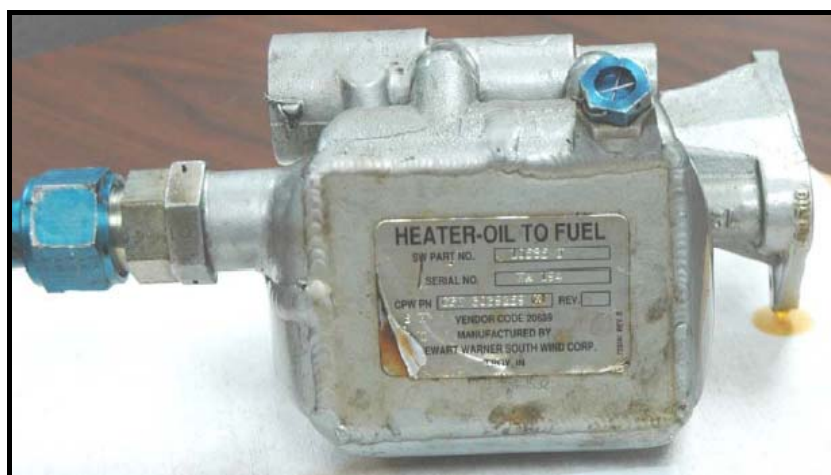
Picture Nr 17

This heater exchange unit (*picture nr 17*) was sealed and there was some fuel and oil inside its body and connecting pipes. Operational tests carried-out showed nothing abnormal on its performance.

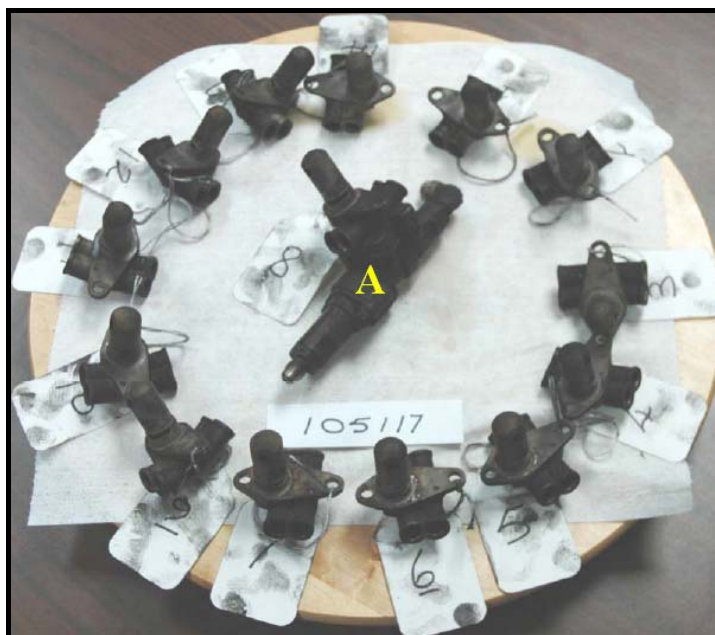
Picture Nr 18

Flow divider valve (A) presented a fuel leak considered to be a consequence of the fire declared after the incident, which destroyed the seals near discharge valve and check valve rubber stop. As a consequence of heat and deterioration in flow divider valve, fuel nozzles became total or partially blocked, as described bellow (*table nr 4*).

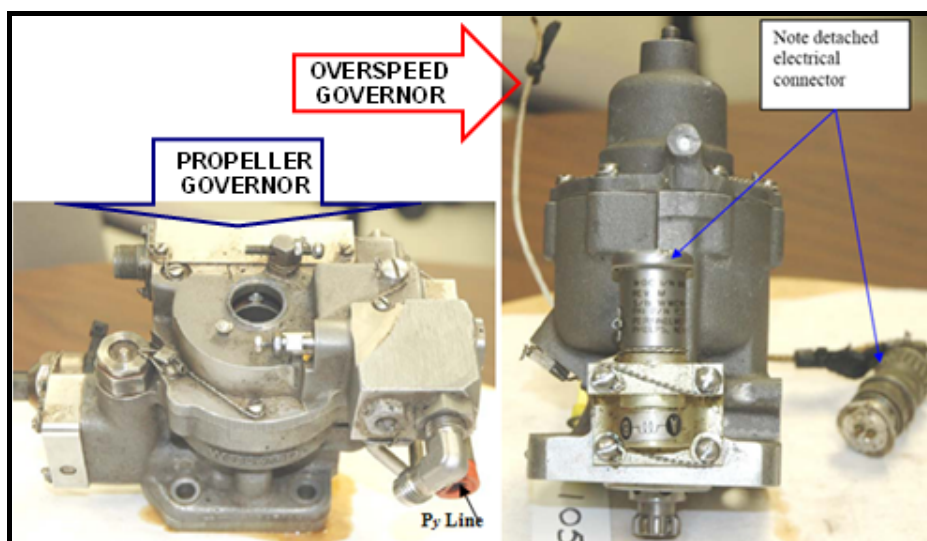
Picture Nr 19

Propeller governor “Py” pressure line was found cut and overspeed governor electrical connector was found detached from the solenoid (picture nr 19).

Examination of these units, regarding their condition and operation, didn't find any defect or abnormality (prior to the event), which could influence engine performance and cause any loss of power.
