MINISTÉRIO DAS OBRAS PÚBLICAS, TRANSPORTES E COMUNICAÇÕES
GABINETE DE PREVENÇÃO E INVESTIGAÇÃO DE ACIDENTES COM AERONAVES

AIRCRAFT INCIDENT SUMMARY REPORT

| Date/Time: 2009 - 07 - 24 @ 16:27 UTC ¹ | Proc. Nr.: 12 / SUM / 09 |
| Id. of aircraft: Cessna 182, Reg. EC-JSZ | |

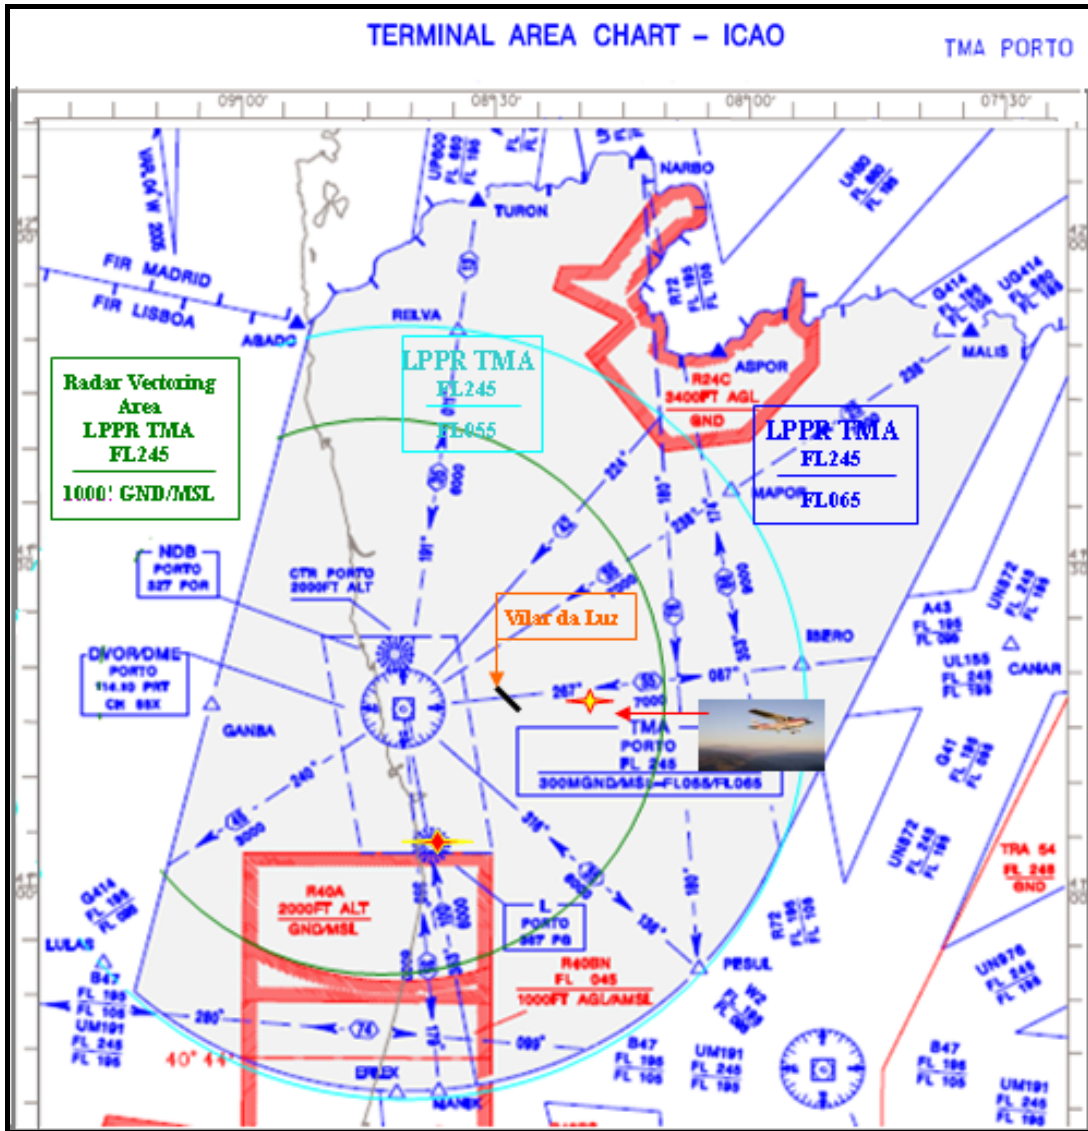
Picture Nr. 1

When it was radar identified, the aircraft EC-JSZ was at FL090, on radial 090° and 18NM (DME) from “PRT” (picture nr. 1).
