FINAL INCIDENT REPORT

Stoddard-Hamilton, Inc.
GLASAIR II RG

PH-EQV

09th of June 2009

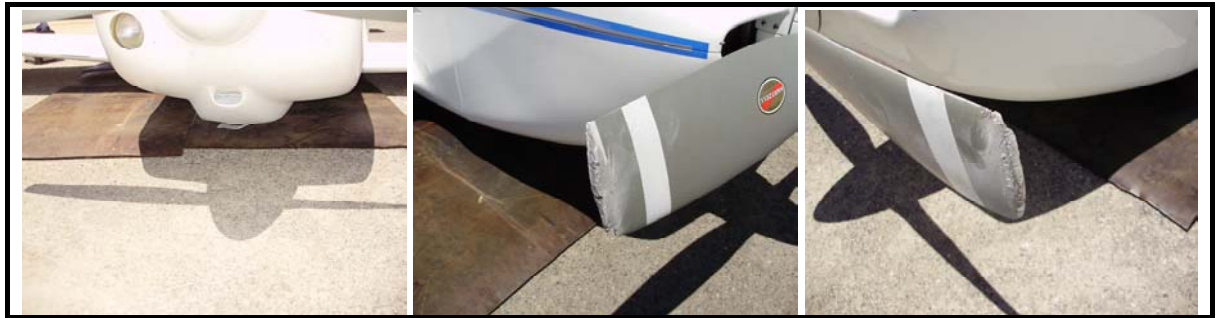
Picture Nr. 1

The aircraft sustained light damage on lower fuselage skin and propeller tips (*picture nr. 1*).

There were no separated parts. The aircraft remained complete with only some abrasion and small deformations on propeller tips, which is normal on such type of occurrences.

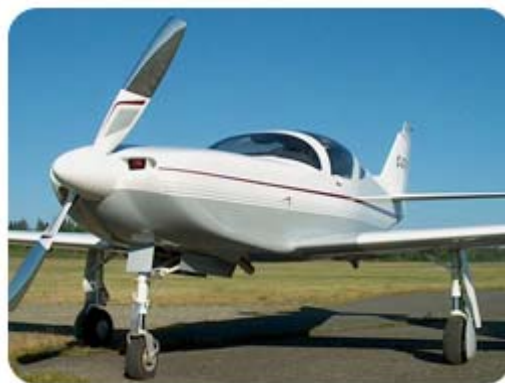
Picture Nr. 2

O Glasair II RG, as specified by its designation (RG stands for Retractable Gear), is equipped with a retractable gear that provides improved performances. Main legs retract inner side, inside the wing, while the nose gear retracts rearwards into a fuselage compartment, under the engine. All legs are provided with gear doors that enclose the gear, when retracted, leaving the wheels in sight only (*picture nr. 2*).
