GABINETE DE PREVENÇÃO E INVESTIGAÇÃO DE ACIDENTES COM AERONAVES
GPIAA

AIRCRAFT INCIDENTE REPORT

Date/time: 26/05/ 2009 @ 08:56 UTC ¹		Proc. N° 15 /INCID/2009
Operator: AERO VIP	Type of incid.: Collapse of the left main landing gear during take-off	
Aircraft: Cessna 180K, D-EGSW		
Local: Portimão Aerodrome (LPPM)		
Flight Type: Transport of Parachutists	Phase of flight/ Take off	
Persons on board: 5	Pax: 4	Injuries: NIL
Damage to aircraft: Propeller blades, left main landing gear and left wing tip.

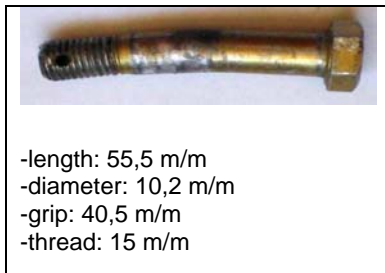
Fig. 2 – Bolt

The original bolt (AN7 20A) does not have any hole; on the contrary, the bolt installed on the aircraft had a hole. The AN365-720C is an all steel self-locking nut; the nut of the aircraft featured a golden colour, lighter, and it was not a self-locking nut.

Bolts characteristics m/m				
Bolt:	Length	Threads	Grip	Diameter
AN7-20A:	53,18125	16,66875	36,5125	11,1125
Installed:	55,5	15,0	40,5	10,2
Difference:	+2,31875	-1,66875	+3,9875	-0,9125

The bending deformation of the bolt indicates that a side load was present during the failure. This side load could have resulted from a hard landing with the airplane moving sideways. We have to note that the incorrect installation of the landing gear can also allow the introduction of lateral loads during normal landings.

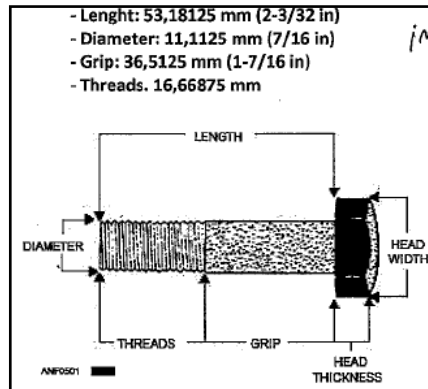
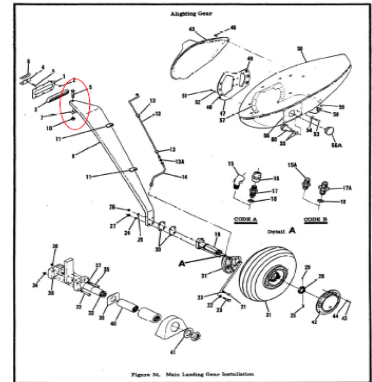
Fig. 1 - bolt and nut

The inspection to the aircraft revealed that the retaining nut on the left main landing gear attaching bolt was missing. The bolt was bent and the threads were damaged.

It was not possible to identify the serial numbers of the bolt and nut installed in the aircraft but it was found that did not have the same characteristics indicated in the catalogue of the Cessna.
