FINAL INCIDENT REPORT

BUFFALO AIRWAYS
CANADAIR CL-215

C-FTXB

FINAL INCIDENT REPORT Nr. 10/INCID/2009

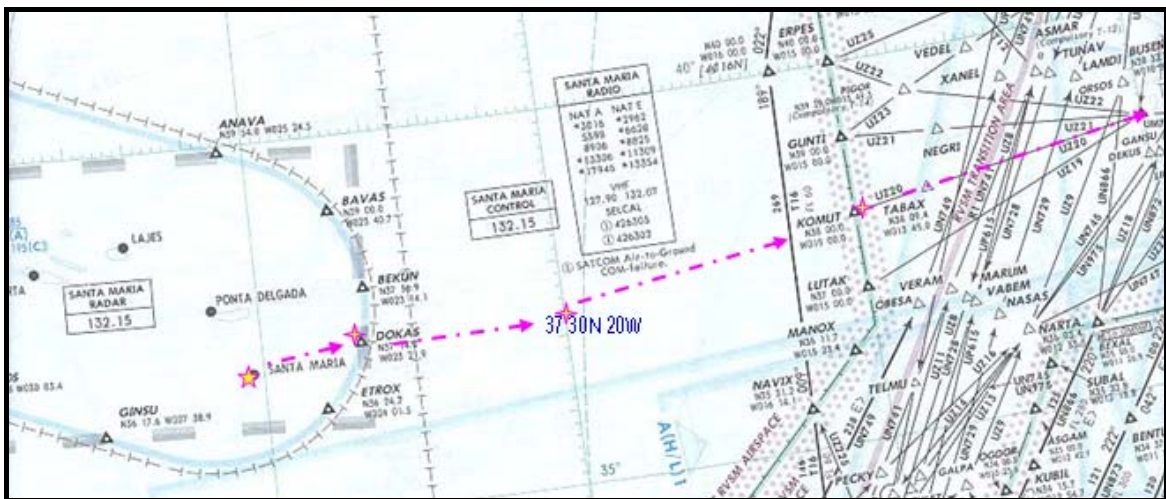
Picture Nr. 1

At 12:45, on the 16th, the aircraft left LPAZ following submitted Flight Plan via “DOKAS” – “37°30’N 20°W” – “KOMUT” – “BUSEN” to destination LPCS, flying at an altitude of 9000ft (FL 090) (picture nr. 1).

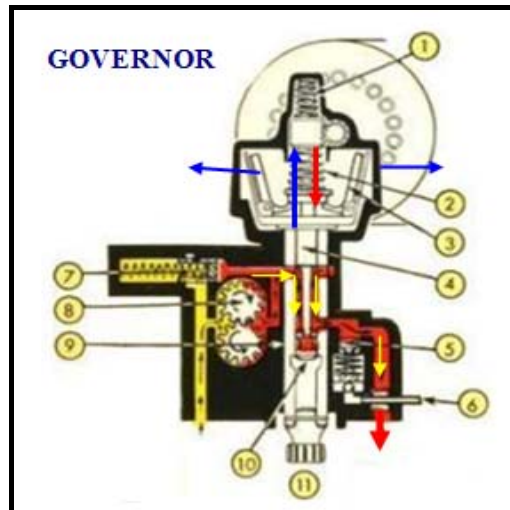
Picture Nr. 11

In consequence, flyweights (3) generated centrifugal force would surpass governor spring (2) force and lift pilot valve (4), allowing governor oil pressure to flow to inboard side of propeller dome, moving the piston outboard and increasing blade pitch.

Blade pitch increase would put more loads on the engine and RPM should decrease, returning to normal operation (**onspeed condition**).

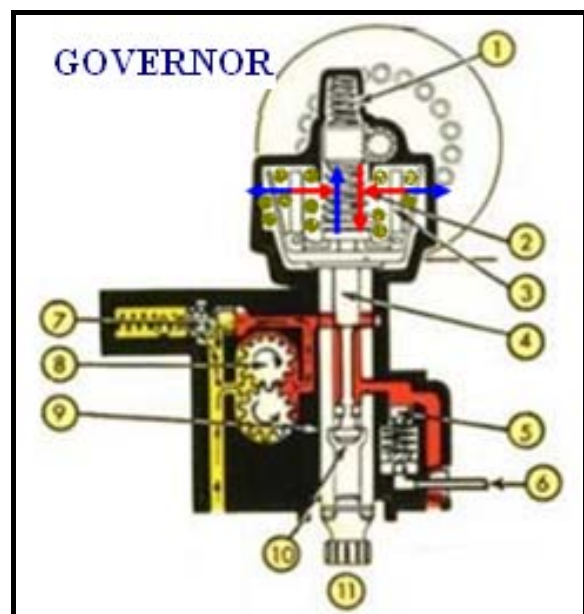
Picture Nr. 12

"Governor was found full of thick sludge preventing correct operation of spool valve plus at O/H the body p/n 321898 was found cracked".

The presence of dirt and other contamination material in the body part prevented the pilot valve to be raised by flyweight's centrifugal force (*picture nr 12*).

Engine oil increased pressure delivered to forward side of actuating piston, added to blade twisting moment, surpassed blocked governor oil pressure in rearward side of actuating piston and moved propeller blades to a smaller pitch angle, thus increasing propeller and engine RPM.

That uncontrollability was presumably due to the existence of sludge inside #1 propeller governor body, which prevented the pilot valve to be lifted and to allow governor oil pressure to be directed to inboard side of moving piston, in propeller pitch control mechanism, increasing blade pitch angle and reducing RPM.
