MINISTÉRIO DAS OBRAS PÚBLICAS, TRANSPORTES E COMUNICAÇÕES
GABINETE DE PREVENÇÃO E INVESTIGAÇÃO DE ACIDENTES COM AERONAVES
GPIAA

AIR INCIDENT INVESTIGATION – FINAL REPORT

Date/time : 27 th January 2009 @ 14:30 Hours (UTC)				Proc. nr: 05 / SUM / 09	
Operator: HiFly		Owner: International Lease Finance Corp.			Type of incid.: TECN
Local: 350NM West YPDN			Phase of flight: Cruise		Type of flight: N-S F
POB:	Injuries to persons:	Crew	Pax	Other	Damage to the aircraft:
Crew: 2+9	Fatal	0	0	0	None
Pax: 64	Serious	0	0	0	Other damage:
	Minor/None	0	0	-	None
Aircraft Id.: Airbus A-330-322, CS-TMT, MSN 96, 1996, MTOM 215 000KG					
Pilots	PIC: Australian, Swiss, male, born 1962 F/O: Australian, male, born 1959				
Licenses	PIC: ATPL CH-23733/JAA		F/O: UK JAA ATPL 46682IJ		
Flight Experience (PIC)	Total	14 000 hrs		In the previous 90 days	86 hrs
	On incident type	1 850 hrs		In the previous 90 days	86 hrs
Flight Experience (F/O)	Total	N/A		In the previous 90 days	75 hrs
	On incident type	180 hrs		In the previous 90 days	75 hrs

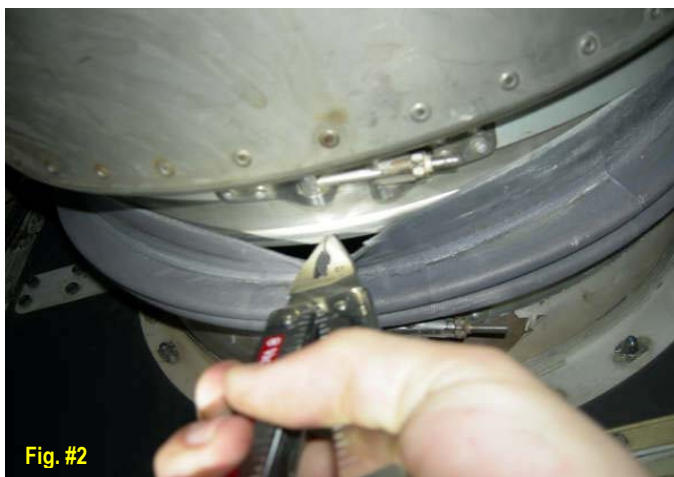
Downstream Pack #2, the seal connecting two duct sections was sealed incorrectly (Fig. #2).

- 2- *Downstream Pack #2, the seal connecting two duct sections was sealed incorrectly.*

The deficient sealing allowed hot air to escape and creating conditions for the related DUCT OVERHEAT.

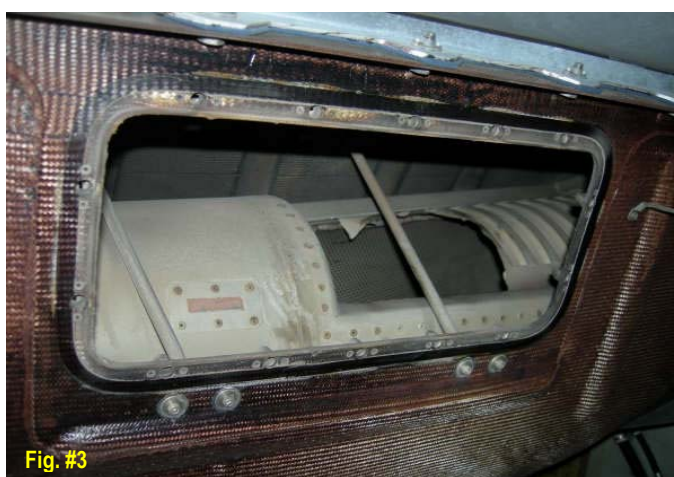
At Pack #1, the plenum was found partially broken, and the missing part was not found (Fig. #3).

- 3- *Pack #1 plenum was found partially broken.*

It is understood that this condition could lead to the Pack instability and, eventually, result into CPC #1 FAULT.
