MINISTÉRIO DAS OBRAS PÚBLICAS, TRANSPORTES E COMUNICAÇÕES
GABINETE DE PREVENÇÃO E INVESTIGAÇÃO DE ACIDENTES COM AERONAVES

INCIDENT PRELIMINARY REPORT

TAAG – ANGOLA AIRLINES

PRELIMINARY REPORT Nr. 18/INCID/2010

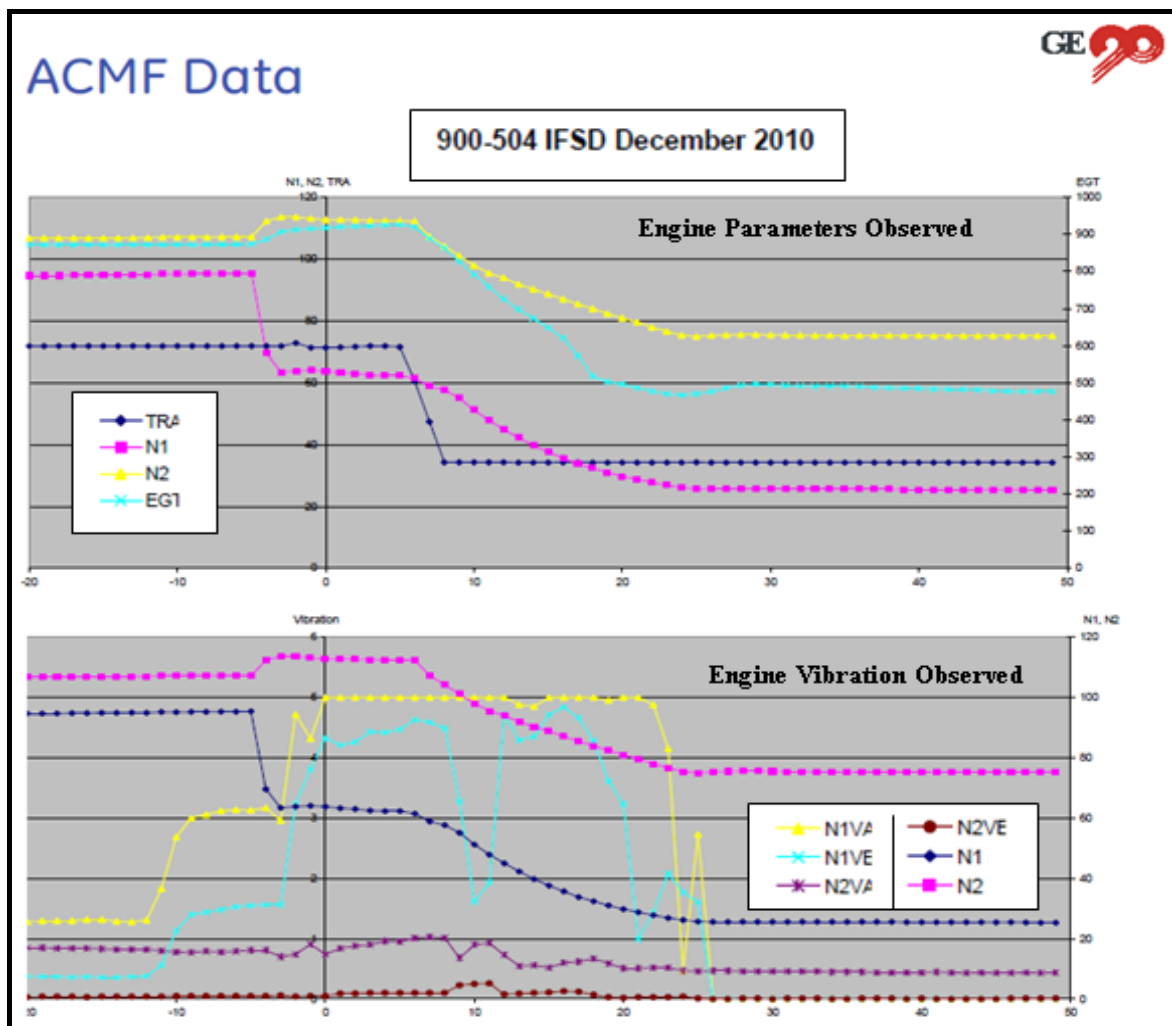
Picture Nr. 2

Using ACM information and GE produced graphs (*based on that information*), a presentation of previous 20s till post 50s of the event, can be analysed (*picture nr 2*).

Looking into these graphs it's possible to confirm that take-off and climb parameters were normal until the event occurred.

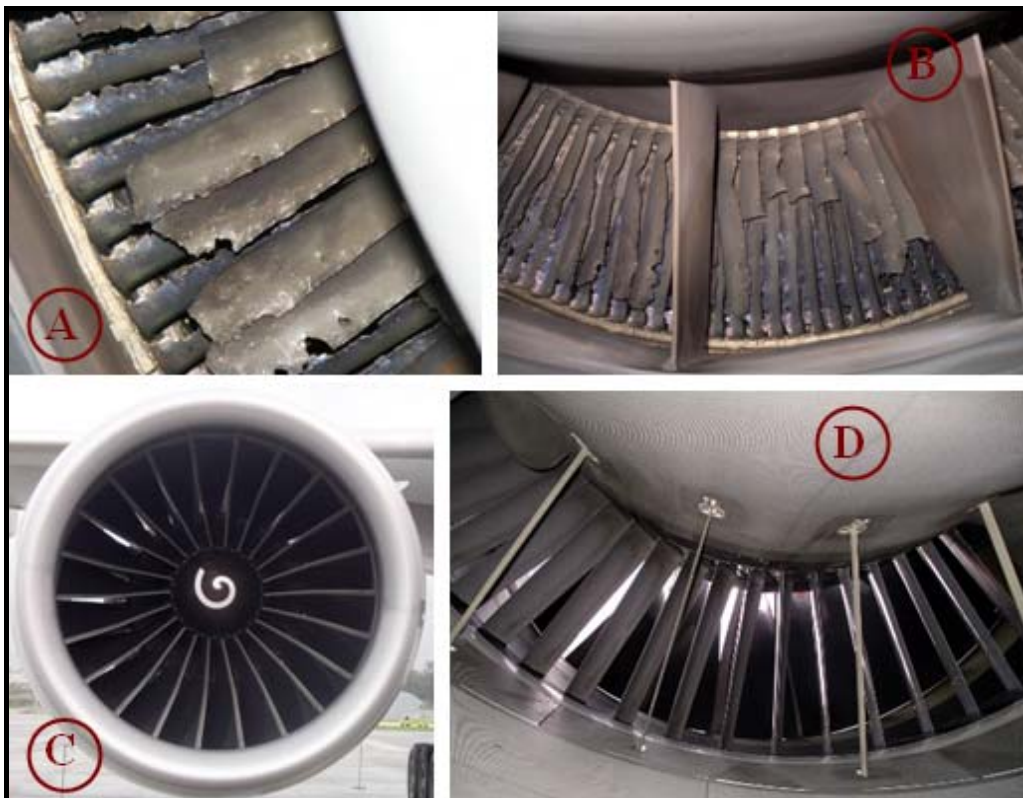
Picture Nr. 3

On the 06-12-2010 an exterior inspection was performed to the aircraft and right hand engine, being detected substantial damage to Low Pressure Turbine (LPT) last stage and "stator", with material loss and heavy deformations in all turbine blades and guide vanes (picture nr 3A e 3B).

Engine inlet and "bypass" outflow areas showed no damages or any other FOD ingestion evidences (picture nr 3C e 3D). The same regarding engine cowlings and linings.

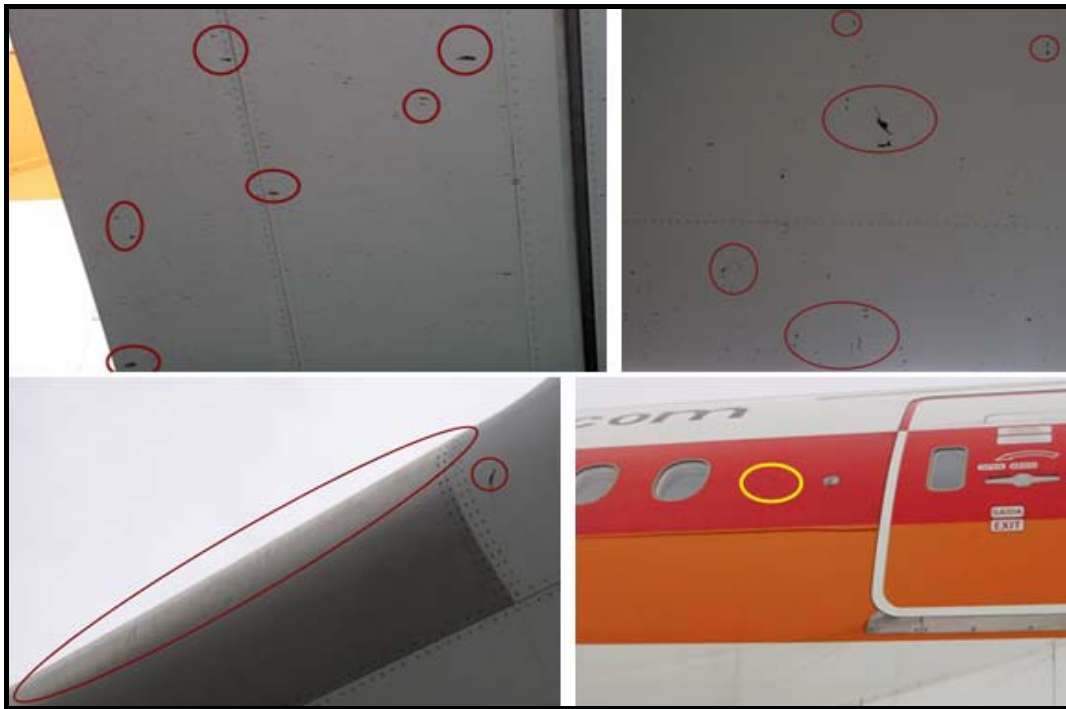
Picture Nr. 4

On the aircraft surface, some impact marks were detected on "flaperon" lower surface, fuselage right hand side and right horizontal stabilizer leading edge (picture nr 4).

No one of these impacts seemed to have caused skin rupture, except on stabilizer root, where the fairing seemed to be punctured.

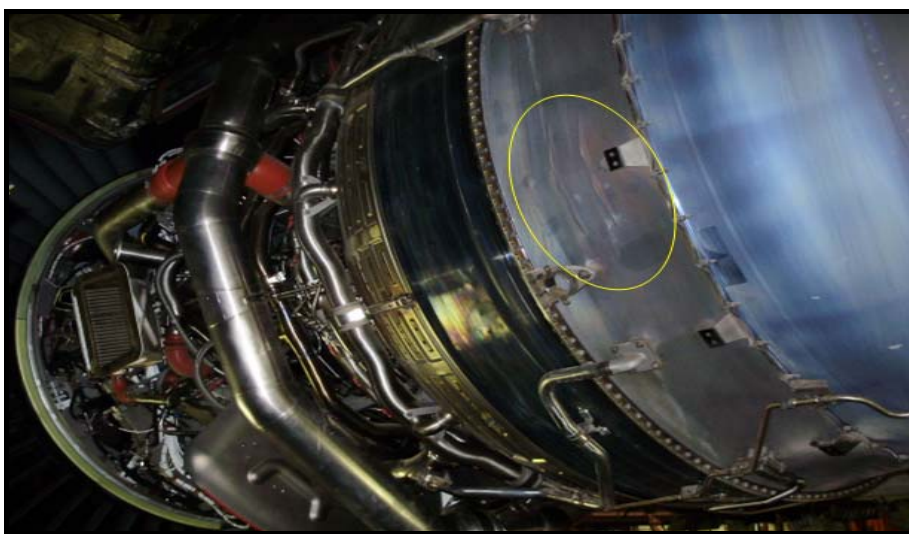
Picture Nr. 5

In a subsequent phase, engine cowlings were opened and all compressor, combustion chamber and high pressure turbine (HPT) areas showed to be in perfect conditions. At low pressure turbine (LPT) area, on both sides, some small dents, only detected by touch or contrasting light, were noticed (*picture nr 5*). Cowling's internal side was clean and showed no impact marks.

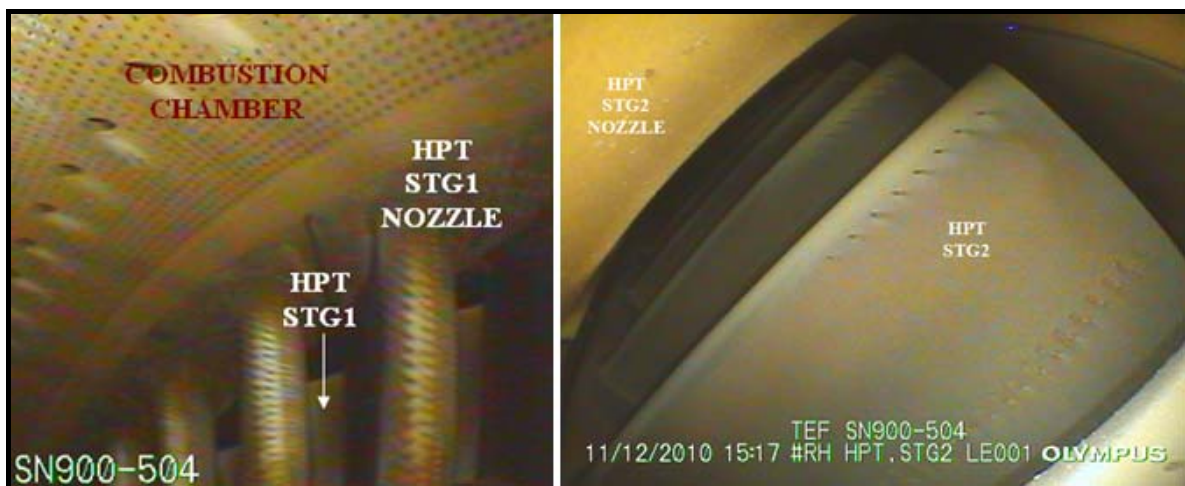
Picture Nr. 6

HPT examination revealed 1st and 2nd turbine stages, like respective nozzles, showing an apparent good condition and presenting a normal colour (*picture nr 6*).

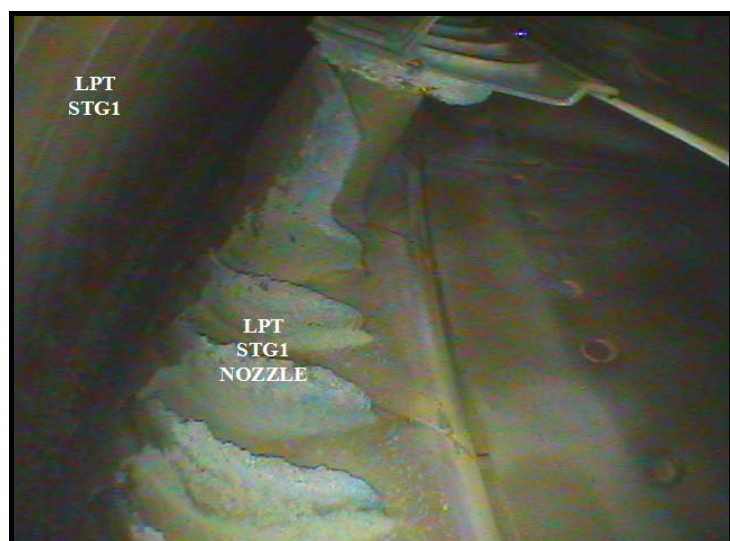
Picture Nr. 7

In LPT 1st stage inlet, several "inlet guide vanes" were chopped off near its roots, and part of LPT stage 1 nozzle external ring was absent.

Its appearance & colour seemed to demonstrate a material failure due excessive heating (*picture nr 7*).

4^a Considering that first damages were found after the combustion chamber, suspecting of an excessive temperature build-up in turbine zone, which could cause LPT "guide vanes" material failure, one or more fuel injectors abnormal behaviour could be suspected. LPT 1st stage nozzle vanes failure and parts separation, may have cause the subsequent unities failure, till the exhaust, with consequent damage progressing.

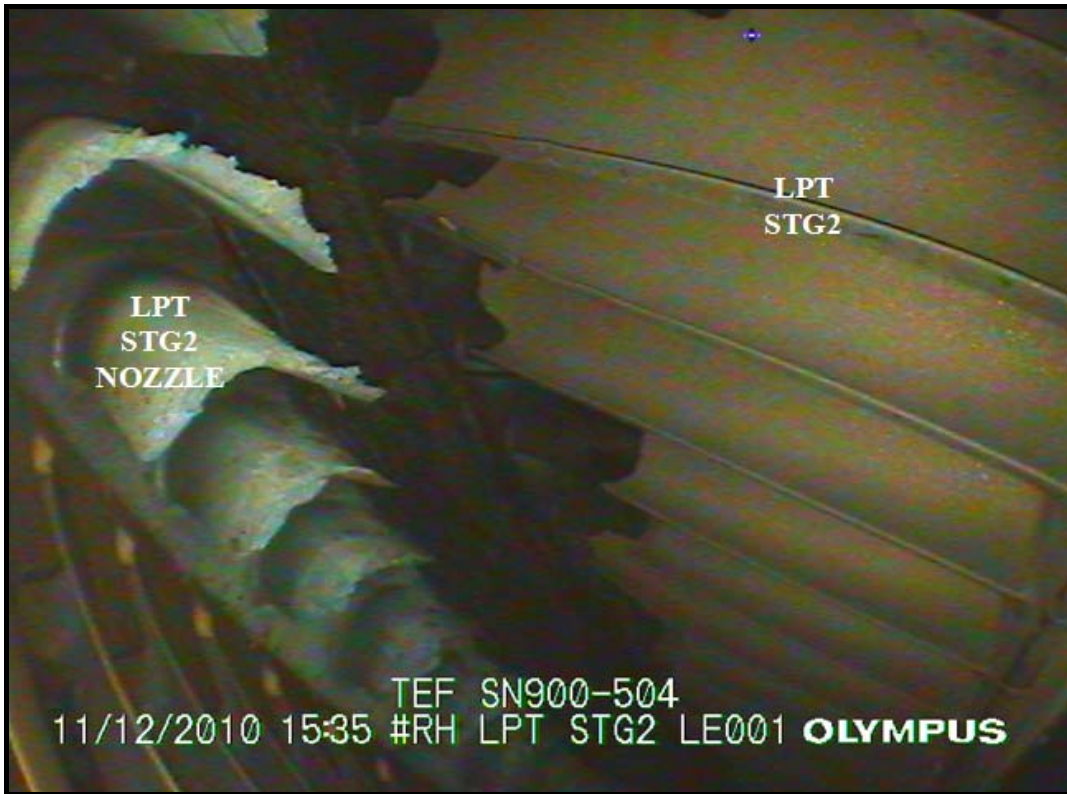
Picture Nr. 8

Progressing to LPT 2nd stage, nozzle vanes continued to show heavy damage and significant parts of turbine blades were missing (*picture nr 8*).

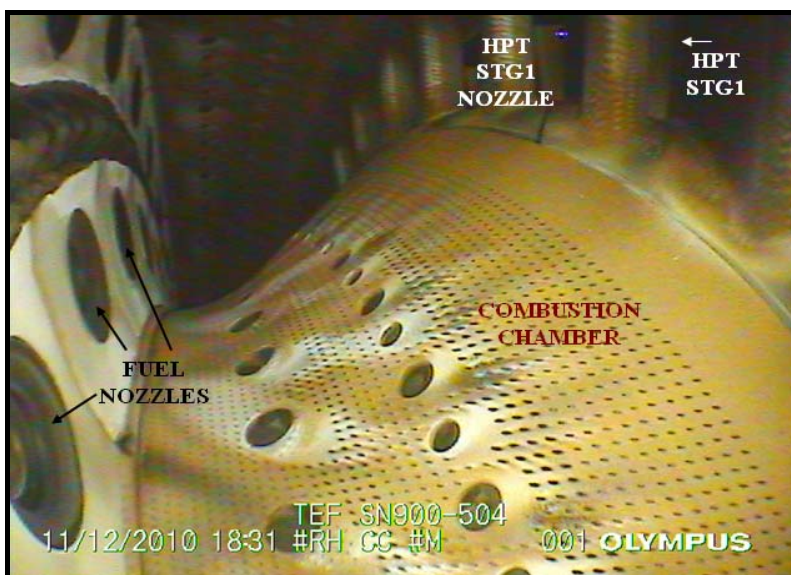
Picture Nr. 9

A complete view of combustion chamber was not possible, being inspected the lower section, from two-o'clock to ten-o'clock position, only.

From what could be seen, the combustion chamber was clean and fuel injector's or fuel nozzle's anomalies couldn't be detected (*picture nr 9*).
