FINAL ACCIDENT REPORT

PRIVATE
CESSNA 182P

D-ENEW

FINAL ACCIDENT REPORT Nr. 15/ACCID/2010

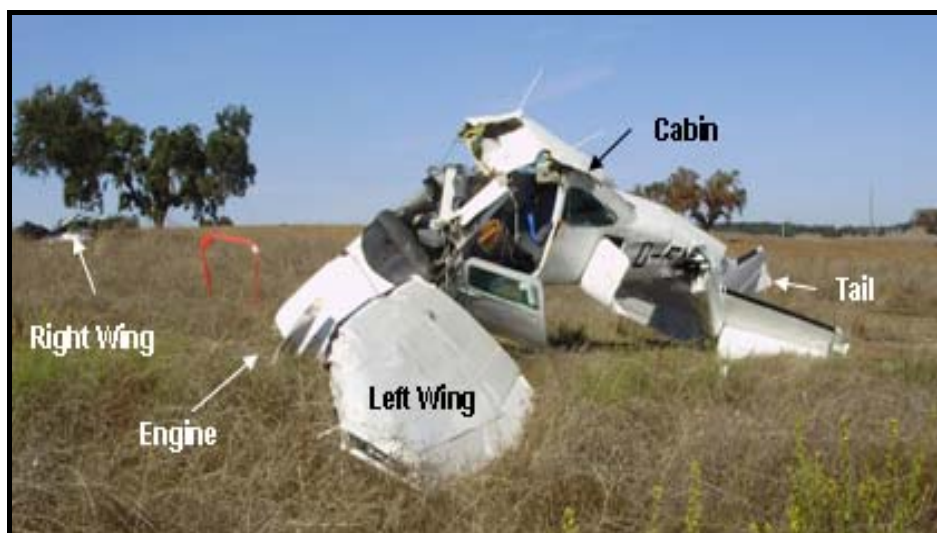
Picture Nr 2

The aircraft suffered heavy damage (*picture nr 2*), with separation of both wings and big deformations of fuselage and tail, cabin roof destroyed, nose gear fracture with wheel detachment and bending & abrasions on engine cowlings and propeller blades. After removing engine upper cowlings it was found a hole on engine block and left magnet out of its seating. It was considered as a total loss.

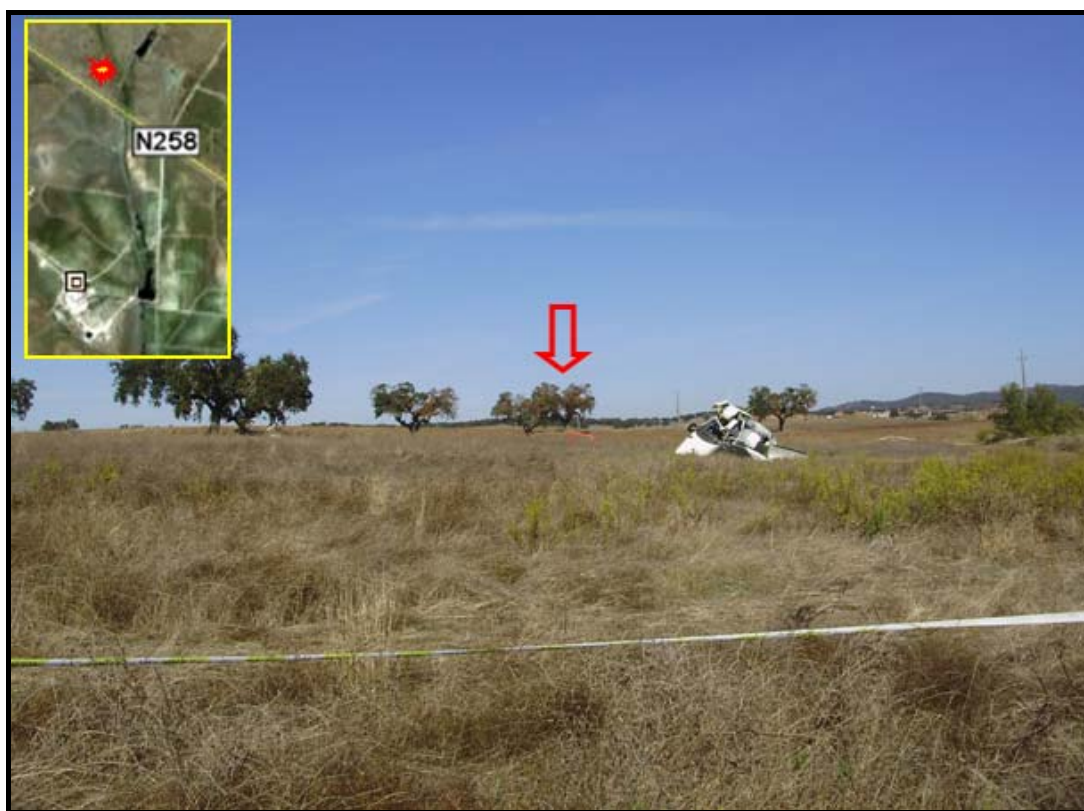
Picture Nr 6

The accident took place on a farmland, with an average altitude of 500ft AMSL (150m), about 900m far from Cortes de Cima house compound (to Northeast), about 9km from Vidigueira, near national road N258 (*picture nr 6*). This land was undeveloped and was covered by grass and shrub. A medium intensity power line ran across the field, almost parallel with the road, and there were only a few, sparse and medium size cork trees as obstacles, making it a suitable place for an emergency land.

As the pilot had not taken the decision to make an emergency landing, still trying to restart the engine, he disregarded the outside looking, lost his height awareness and collided with one of those few trees (*pointed by arrow*), present in the field.

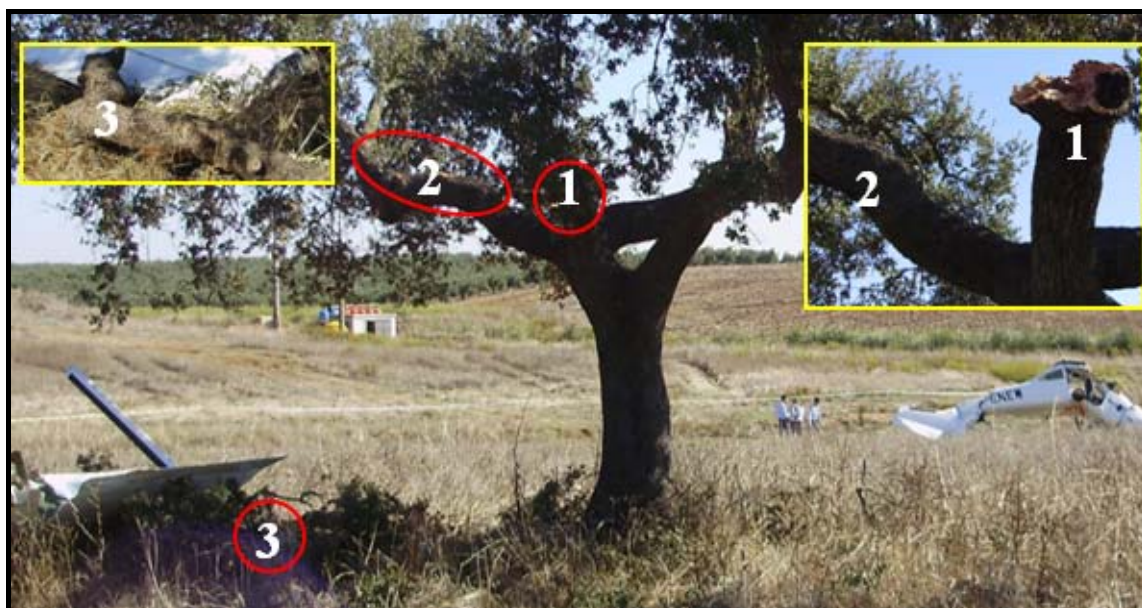
Picture Nr 7

First impact occurred at a speed of 115km/h, when right wing collided with a cork tree branch (picture nr 7), being both (*wing & branch*) separated by their roots (1) and lying together on the ground (3), while the aircraft progressed over the tree (2) and impacted the ground a few metres ahead.

This ground first impact occurred at a speed of 52km/h, in a pronounced nose down attitude, causing the nose gear leg to break, propeller blades to bend and the fuselage and tail to crease and buckle, destroying cabin roof and windscreen, with left wing separating.

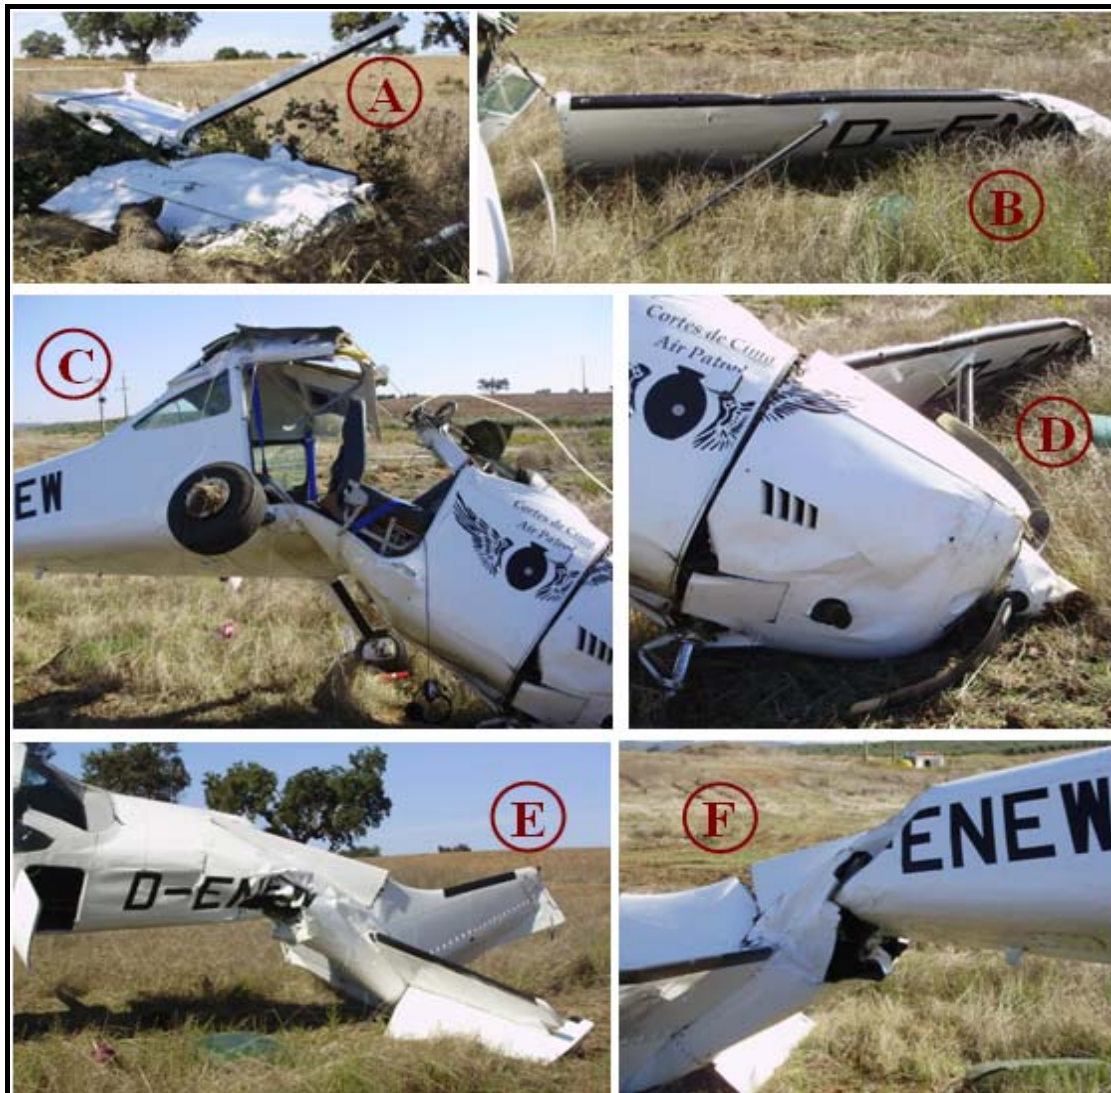
Picture Nr 8

The cracks found on aircraft structures (Picture nr 8) were well elucidative of impact violence. Within five seconds the aircraft had its speed reduced from 115km/h to 0.2km/h, with right wing (A) being the first to collide and absorbing the utmost energy, the aircraft still flying. The

ground impact occurred at 52km/h, enough to cause fuselage break by cabin top and wind-screen, bending by main gear station line (C), with rear fuselage tearing and folding and tail suffering heavy damage (E, F).

Left wing (B) became separated from fuselage but remained connected by flight control cables, being the wing tip the most damaged part, due ground contact.

Nose gear leg strut broke below torque link assembly (D), when it impacted the ground with an angle presumably greater than 45°.

Propeller blades (D) were bent backwards, signalling the engine was not running or producing power, the moment of impact.

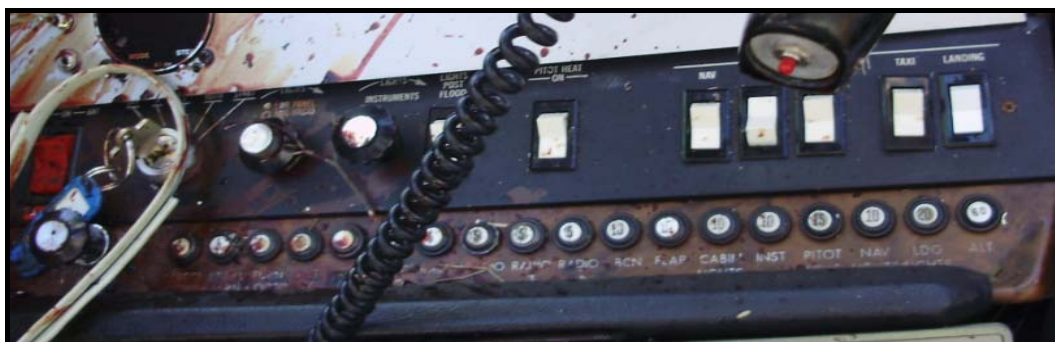
Picture Nr 9

Inside the cockpit it could be seen all circuit breakers pushed "IN" and essential exterior lights switched "ON" (picture 9).

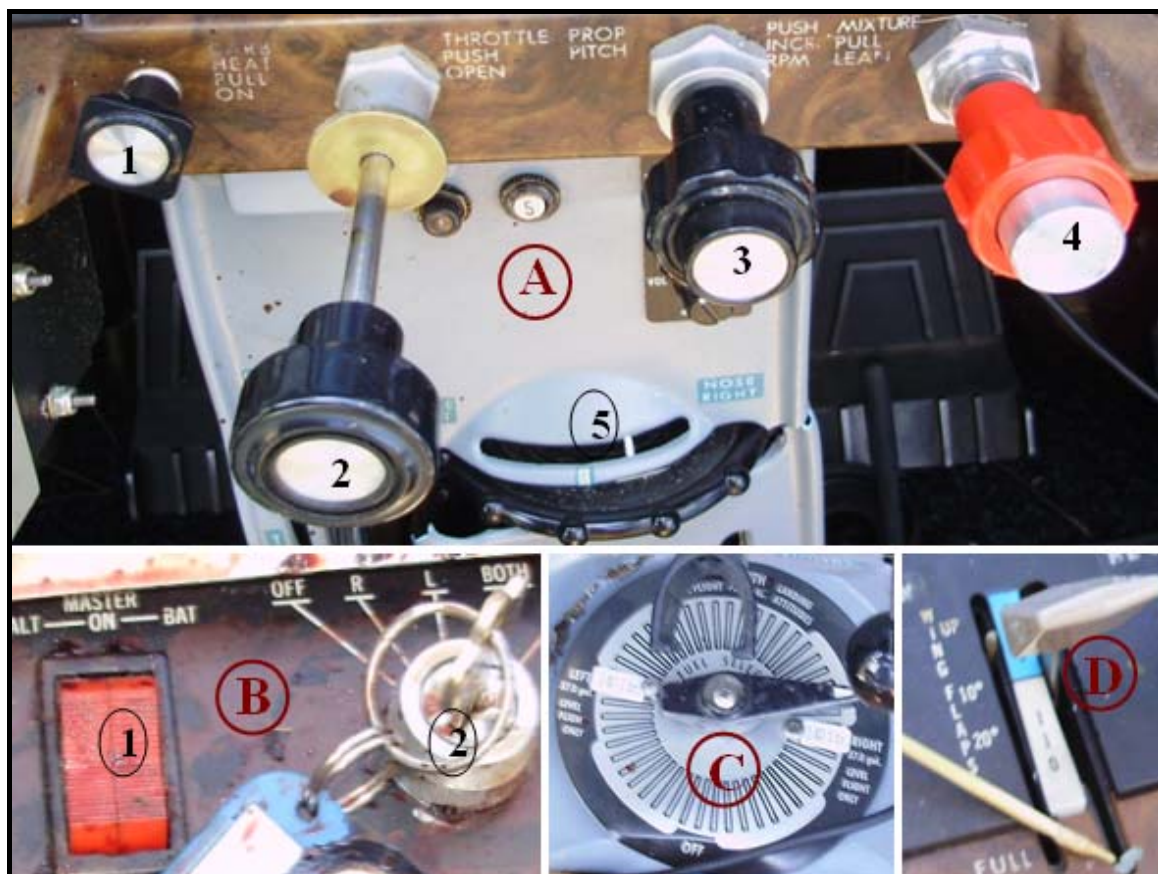
Picture Nr 10

Engine controls (*picture nr 10A*) were positioned for a restart attempt, with carburettor heat (*A-1*) selected “COLD”, throttle (*A-2*) to “IDLE”, propeller pitch control (*A-3*) selected “FINE PITCH”, mixture control (*A-4*) positioned to “RICH” and magnet switches (*picture 10B-2*) set to “BOTH” (*default position for the key to revert when released from “START” spring loaded position*). Alternator and Battery switches were selected “ON” (*picture 10B-1*).

Fuel selector (*picture nr 10C*) was positioned for right tank as fuel feeding source.

Wing flaps were selected “UP” (*picture nr 10D*) and flight control surfaces’ trims were out of neutral, with elevator trim 1/4 below “Take-Off” mark (*nose up*) and ruder trim set 1/3 to the right (*picture 10A-5*).

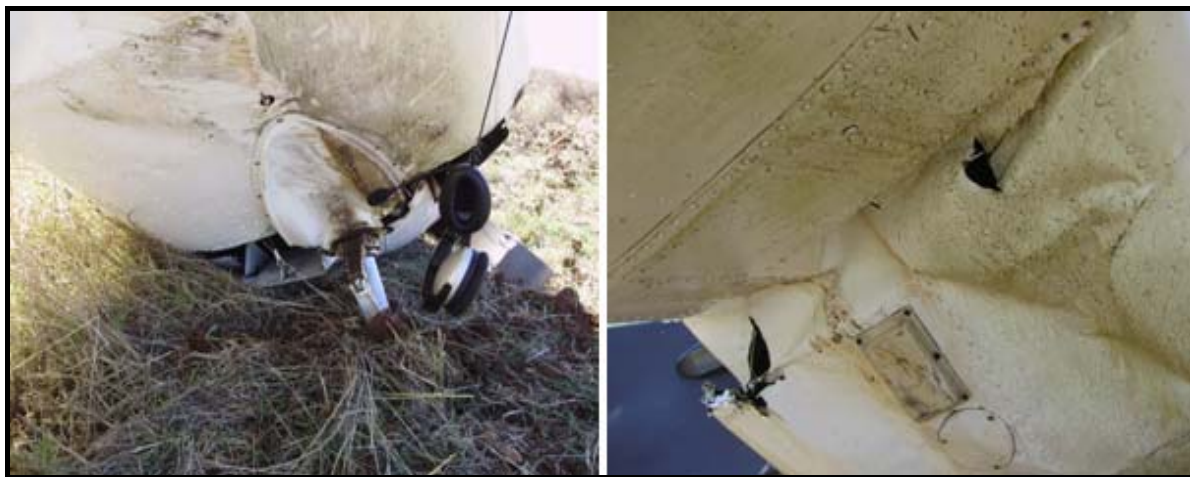
Picture Nr 11

During evidence collecting, in site, it was noticed that right hand side lower engine cowlings and adjacent fuselage showed large dirty oil stains (*picture nr 11*).

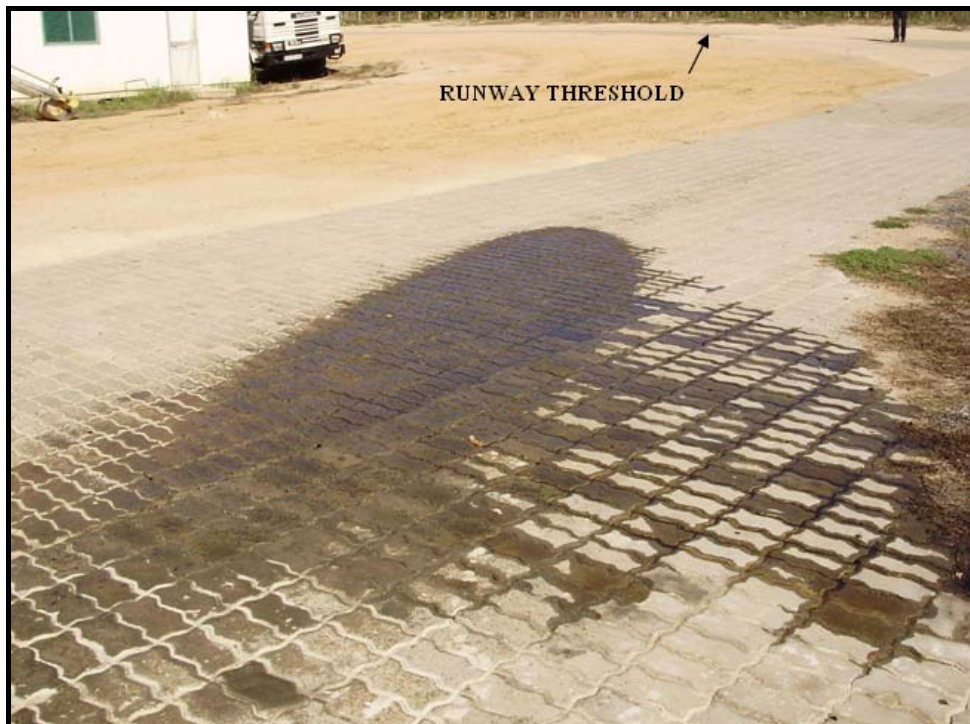
Picture Nr 12

Afterwards, the investigator's attention was called for a large pool of oil (*picture nr 12*) in front of the hangar for aircraft storage, the place where the aircraft engine has been started, inside farm housing complex, a few metres to runway threshold.

The oil stain extension denounced there has been a total leak of engine oil, apparently in pressure line, immediately after engine start, which reinforced the need to proceed with a thorough inspection of the engine, paying particular attention to engine oil system, in order to find the origin of such oil leak.

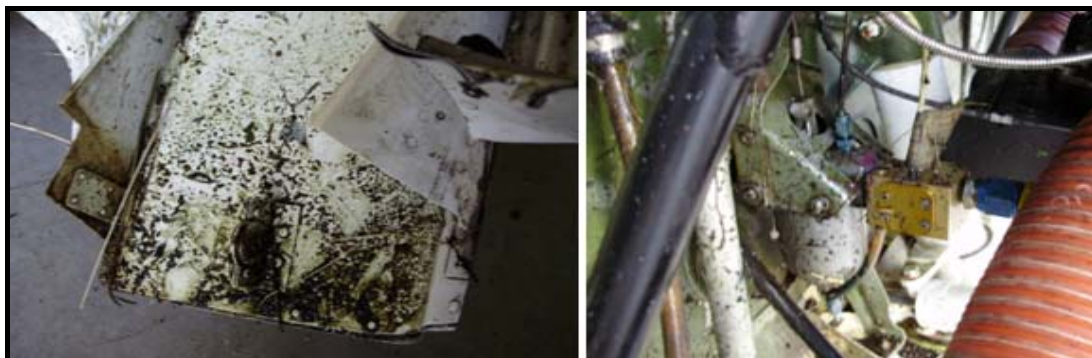
Picture Nr 13

During initial inspection, as engine cowls were removed, it was found a big dirty oil concentration on the right side of the engine, especially on engine cowl flap inner side and fire-wall area (picture nr 13).

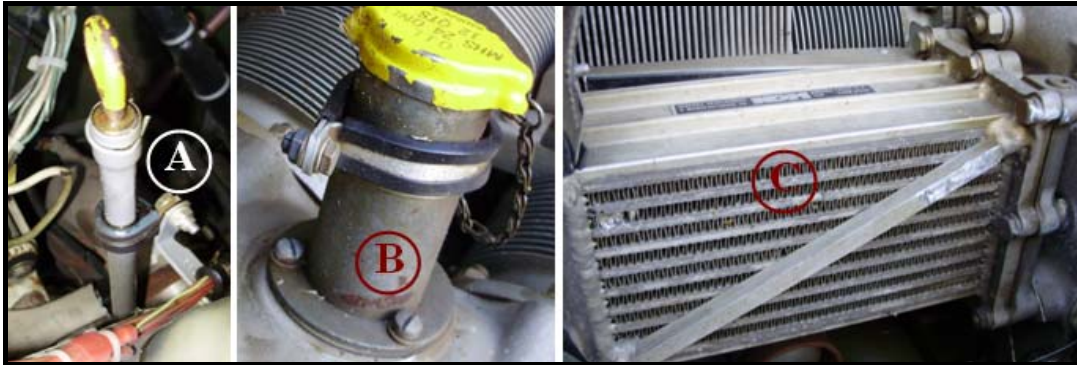
Picture Nr 14

On left hand side engine cowl flap, fire-wall left hand side and other engine areas, namely oil quantity indicator dipstick (A), oil filler cap (B), oil heat exchanger (C) and drain plug were absolutely clean (*picture nr 14*).

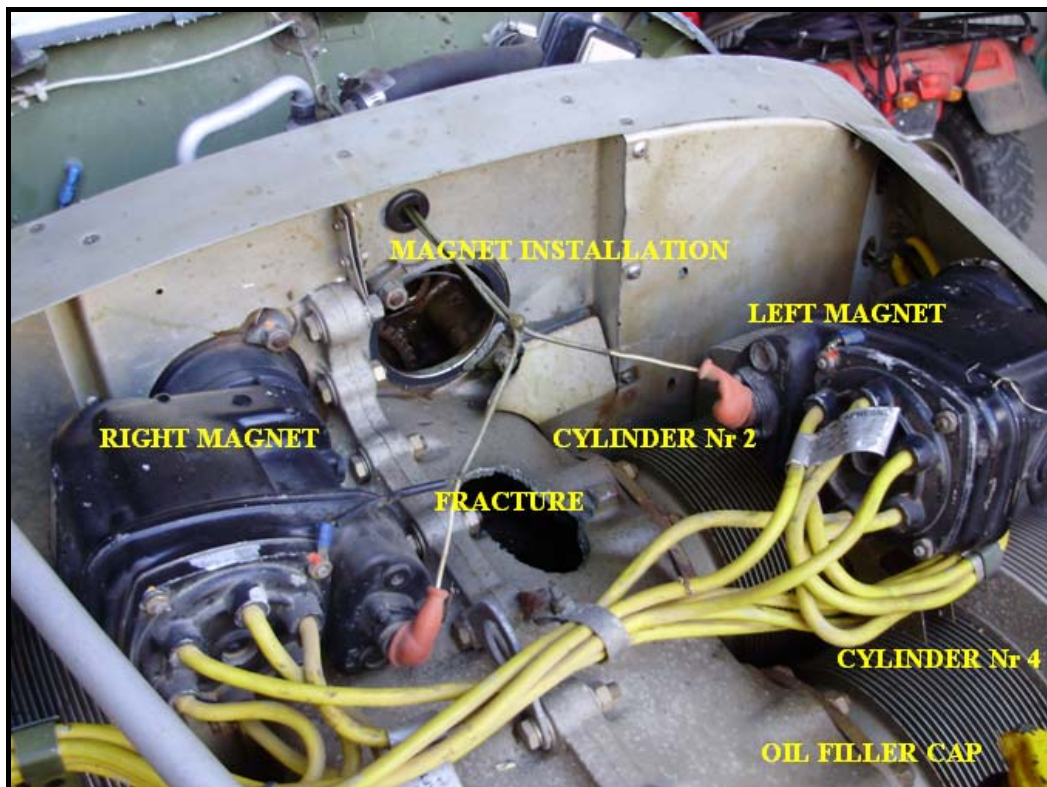
Picture Nr 15

After removing engine upper cowlings, a big hole on engine block, near cylinder nr 2, came to sight, together with left magnet dislodged from its installation and only connected through electric cables (*picture nr 15*).

Oil loss and consequent lack of cooling caused the engine to become flodded. Cylinder nr 2, being the one situated on the rearmost position and having less exposition to cooling air flow, reached the highest temperature (*picture nr 16A*) and led the connecting rod (*picture nr 16B*) to break, causing the fracture of engine block. The engine block fragment was expelled violently and forced left magnet out of its seating.

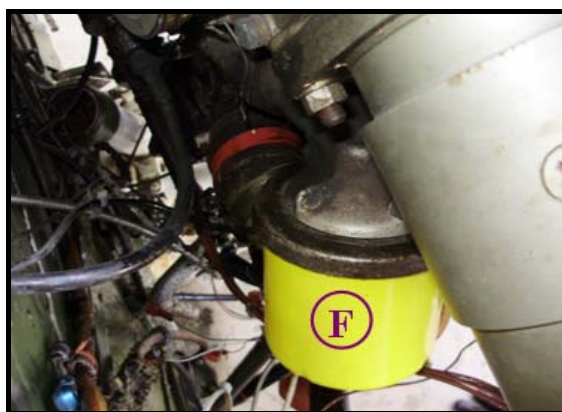
Picture Nr 17

Continuing the search for probable location of engine oil leak, exterior clues guided us to exterior engine oil filter assembly, situated at an engine rear right position, in front of fire-wall (*picture nr 17*).

Externally it looked clean, glossy and viscous, signalling the filter can had been washed by leaking oil, expelled through the top mounting and flowing downwards.

Proceeding with filter assembly dismounting, it was noted that hollow stud was wire locked but the correct torque, as recommended by manufacturer's Aircraft Maintenance Manual, was not applied.

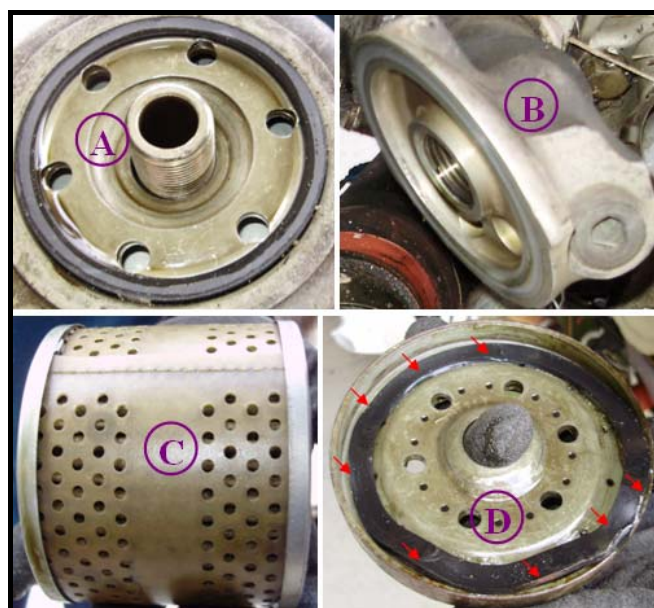
Picture Nr 18

- The filter element (*picture nr 18C*) was in good condition.
- Adapter seating (*picture nr 18B*) was clean, without irregularities and upper gasket (*picture nr 18A*) in good condition, but lower gasket (*picture nr 18D*) had been incorrectly mounted and tightening forces caused its deformation, preventing it to fulfil its job, avoid engine oil from flowing outside filter assembly.

However, when changing filter element, aircraft pilot/owner didn't follow exactly manufacturer recommended procedures. In fact he never used a torque wrench, to apply recommended torque to hollow stud (*paragraph j.*) and skipped engine run-up, after filter change, for leak detection and check for normal pressure values (*paragraph l.*).

"To provide that all aircraft maintenance and repair works be performed by certified Aircraft Maintenance and Repair Organization, complying with all Aeronautical Authority requirements and manufacturer recommended practices". (SR Nr 07/2011)
