**MINISTÉRIO DAS OBRAS PÚBLICAS, TRANSPORTES E COMUNICAÇÕES
GABINETE DE PREVENÇÃO E INVESTIGAÇÃO DE ACIDENTES COM AERONAVES****AIRCRAFT INCIDENT SUMMARY REPORT**

Date/Time: 2010 / 04 / 12 @ 18:52 UTC ¹	Proc. Nr.: 04 / SUM / 2010
Operator: TAP Portugal / RYANAIR	Type of Incid.: ATM - AIRPROX
Id. of aircraft: Airbus A-319 / Boeing B-737/800	
Local: Porto (LPPR) airport	
Type of flight: Transport - Passengers	Phase of flight: Approach
People on board: Unknown / 181	Injuries: Nil
Aircraft Damage: Nil	
Other Damage: Nil	
Synopsys: TAP-1580 (A-319) was flying from Madeira (LPMA) to Oporto (LPPR) and RYR-69VN (B-737) was flying from Birmingham (EGBB) to Oporto (LPPR). In contact with Oporto Approach Control, flights TAP-1580 was cleared for a direct entry to a VOR/DME approach to runway 35, with an initial approach altitude of 3000ft over XAPIM, while RYR-69VN has been cleared to 4000ft, on course to PR633 point and then proceed on heading until instructed to turn left for base. As TAP-1580 was keeping high speed, approaching initial fix, he had to reduce his descent rate, in order to reduce speed and configured the aircraft for approach. This caused a TCAS/TA alert on RYR-69VN, forcing

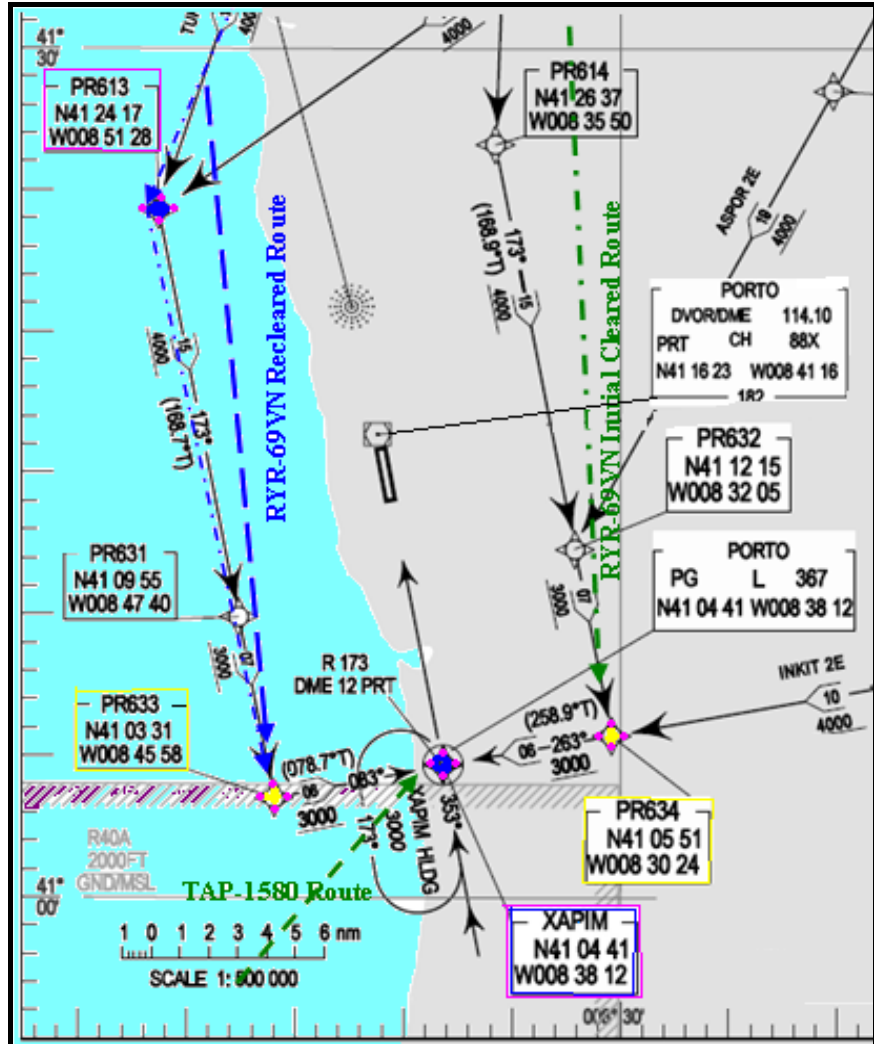
Picture Nr 1

At 18:40:59, Oporto APP Controller contacted Santiago Controller for flight RYR-69VN to be cleared to fly direct to PR613 point (picture nr 1).

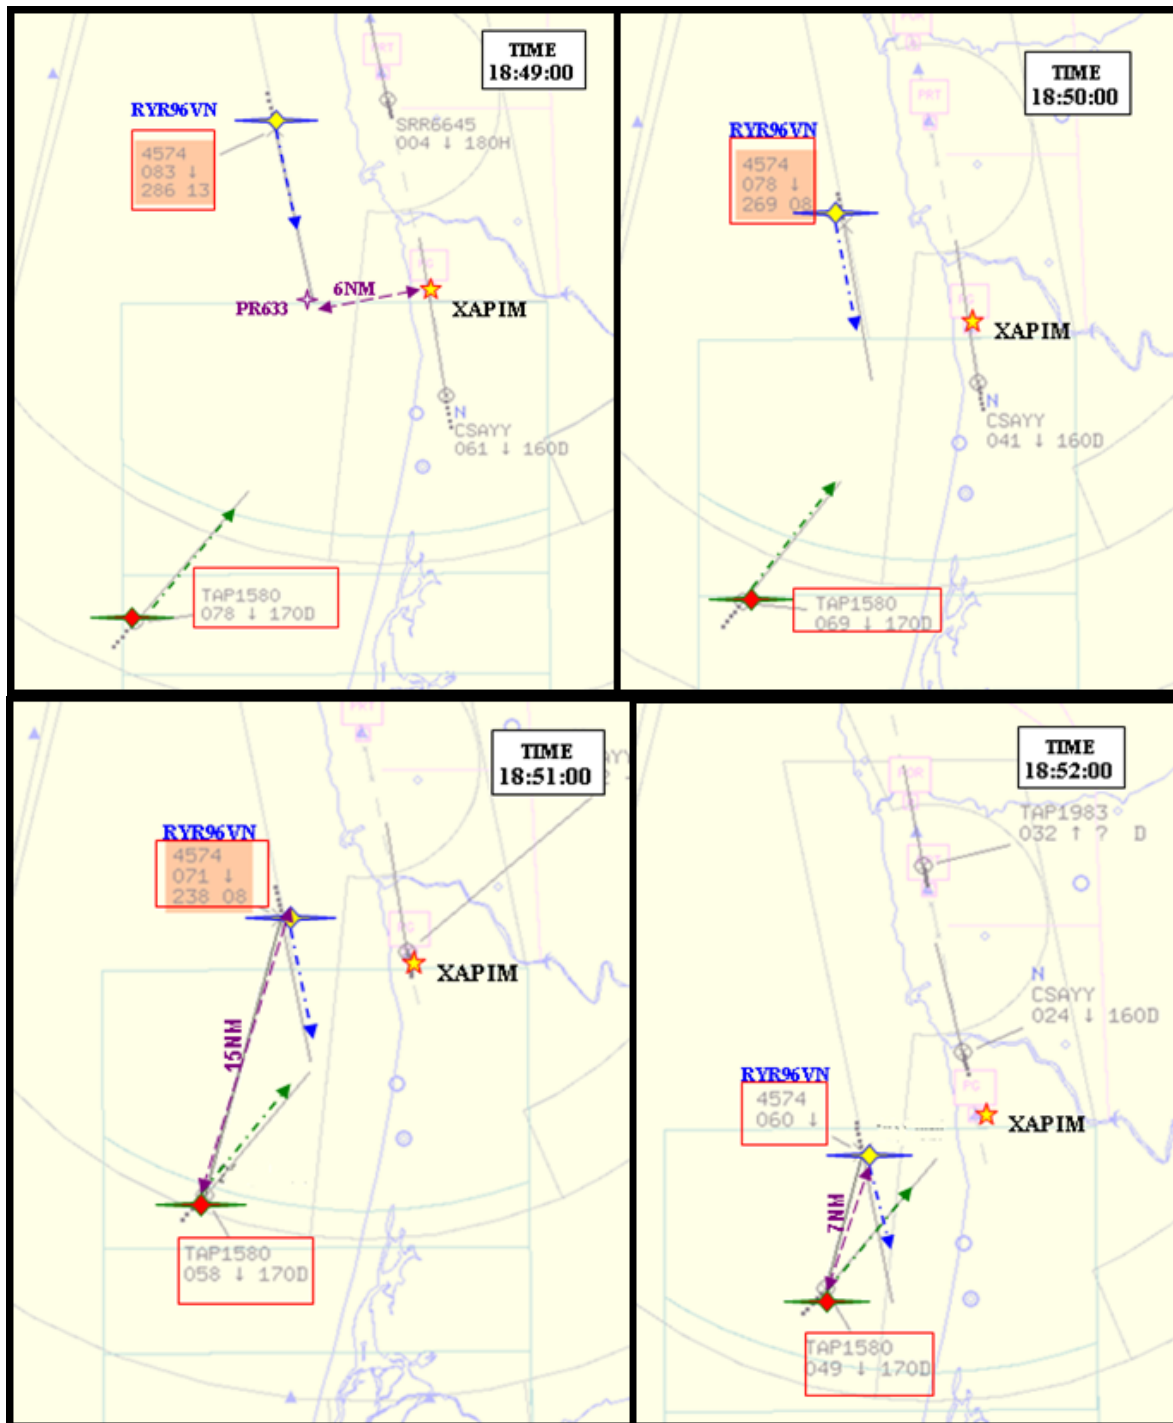
Picture Nr 2

After that answer the CTA decided to give priority for landing to TAP-1580 and, following both flights progress on radar screen (picture nr 2), he issued the following instructions:

Time	To RYR-69VN	Time	To TAP-1580
18:48:52	- To stop descent at FL070 and reduce to minimum clean speed.	18:49:39	- To continue descent to 3000ft, on QNH 1005hPc.
18:50:13	- To continue descent to FL060.	18:50:38	- Cleared for a VOR/DME approach to runway 35.
18:50:48	- To maintain present heading after PR633.		
18:51:38	- To descend to 4000ft, on QNH 1005hPc.

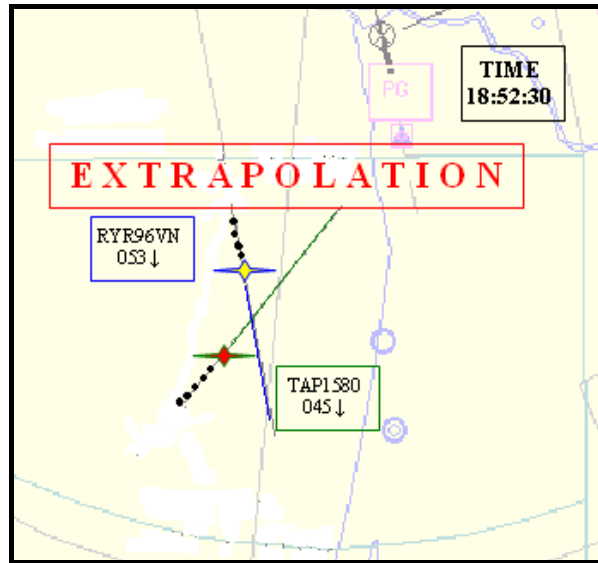
Picture Nr 3

At 18:52:25, with a normal descent rate (1100ft/m), approaching 5000ft and TCAS showing an amber TA, RYR-69VN reduced his rate of descent to 400ft/m and questioned CTA about traffic 800ft bellow, from right to left, if it was the aircraft expected to land in front of him (*picture nr 3*). The CTA confirmed and informed he would call him in a minute, to turn left.

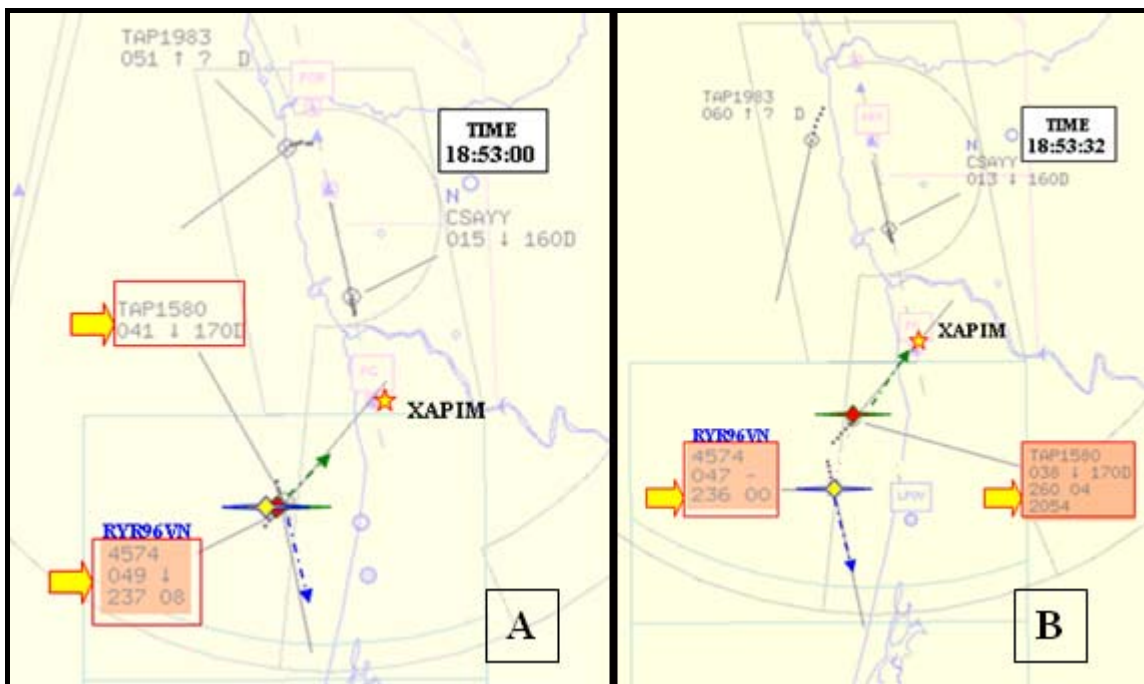
Picture Nr 4

RYR-69VN referred (18:52:54) the other aircraft was 800ft bellow (*picture nr 4A*), being answered that he was 1000ft bellow. Almost immediately there came a voice, in the frequency, saying (in Portuguese): "... uhuuhmm ... it continues descending ... the traffic ...".

At 18:53:18, CTA informed RYR-69VN to expect further descent as soon as TAP-1580 reached 3000ft. By that time TAP-1580 was passing 3900ft and reduced descent rate (400ft/m), in order to reduce speed (*picture nr 4B*).
