# **PRELIMINARY ACCIDENT REPORT**

**KAMOV KA-32A11BC**

**CS - HMO**

**PRELIMINARY ACCIDENT REPORT Nr. 15/ACCID/2012**

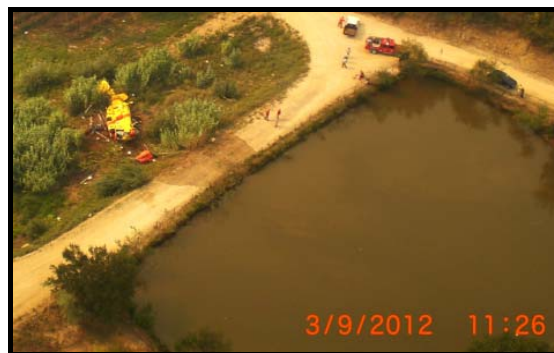
Picture Nr 2

After four water discharge manoeuvres, the pilot returned for another water loading. After restocking, when the helicopter was climbing and started to move forward, the pilot noticed one engine shutting down and the helicopter losing altitude, even with increased rotor collective pitch and the other engine accelerating to emergency power (*Extraordinary Mode*). Without releasing the bucket, the aircraft crashed on the ground, in front (*picture nr 2*), with the other engine automatically shutting down.

The helicopter suffered substantial damage, with both rotors destroyed, front cabin was smashed, the tail became torn and the fuselage got some tears, dents and bruises.

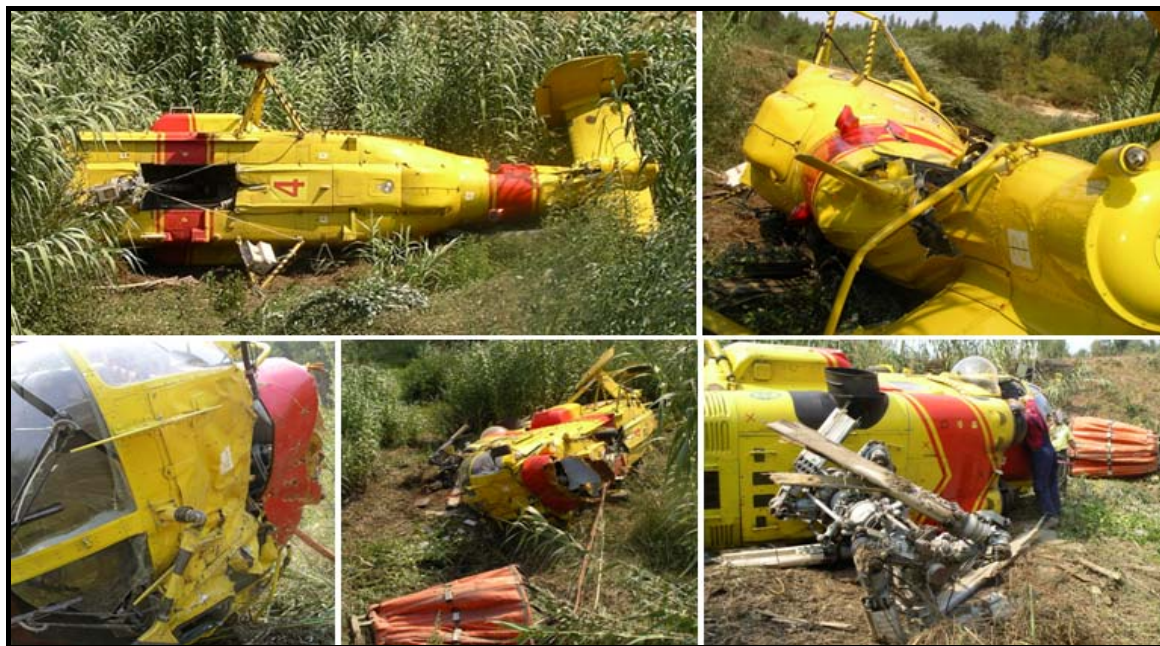
Picture Nr 5

The wreckage was concentrated on the same place, with only parts of rotor blades spread for a larger area around the helicopter, which rested on its right hand side without heavy structure damage, but a broken tail and the front cabin smashed, especially on its right hand side (*picture nr 5*).

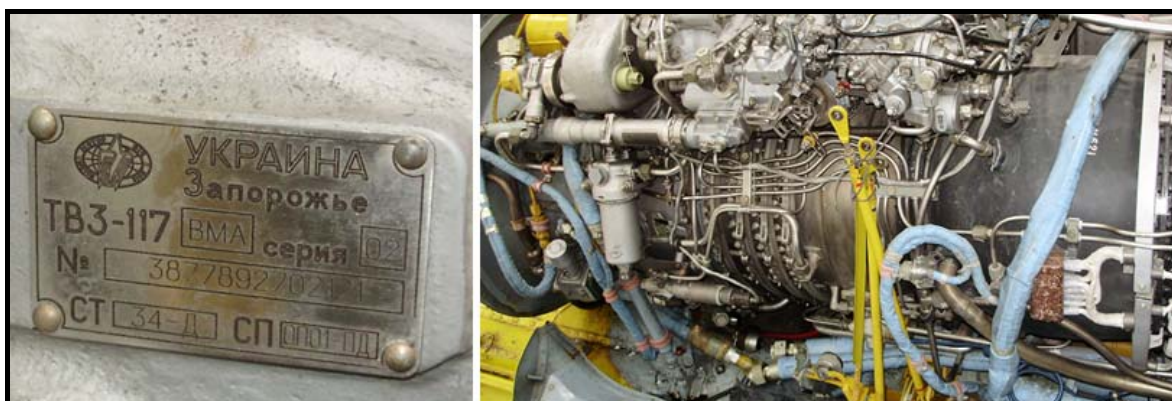
Picture Nr 6

TB3-117BMA series 02, s/n 3877892702121 engine was installed on helicopter left hand side (position # 1) and, externally, it looked proper and clean, with all accessories dully mounted and locking wires in place (*picture nr 6*).

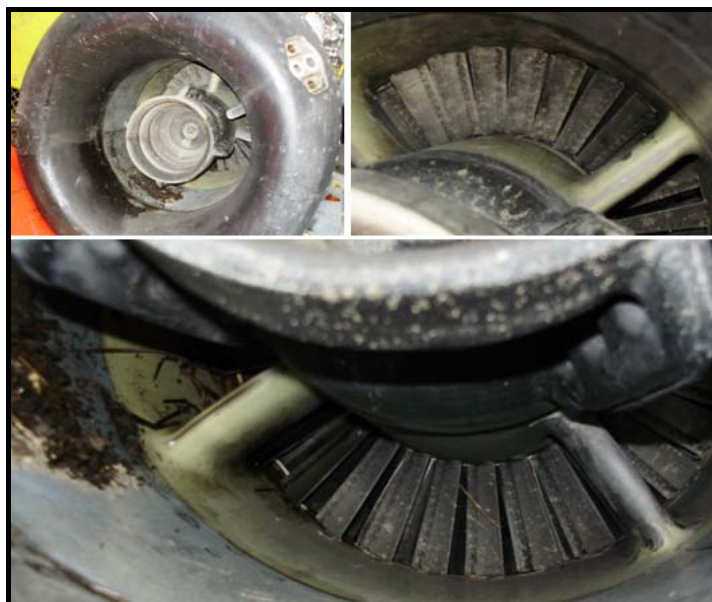
Picture Nr 7

A front looking on compressor 1<sup>st</sup> stage rotor, showed a few blades slightly damaged due foreign objects impact during engine operation, well before the accident (*picture nr 7*).

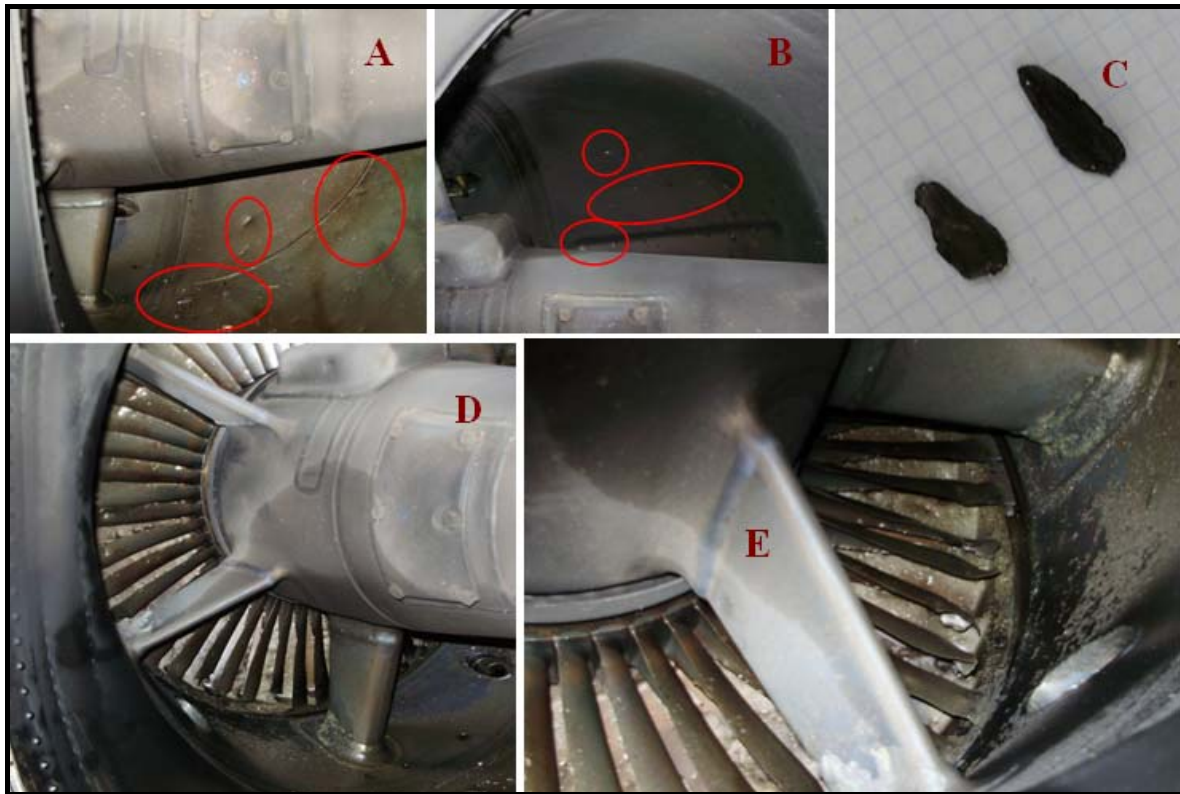
Picture Nr 8

Looking on engine rear side, escape duct linen was punched in a big area and showed to be perforated in some points, especially on the curved right hand side zone (*picture nr 8 A & B*).

On the bottom of curved exhausted duct some small debris (2cm X 1cm) were found, coming from turbine blades breakage (*picture nr 8 C*). In fact, it could be seen free turbine 2<sup>nd</sup> stage rotor and NGV blades damage when looking from rear (*picture nr 8 D & E*).

- 9<sup>th</sup> - The helicopter suffered substantial damage;
- 10<sup>th</sup> - On a preliminary investigation, engine # 1 was found with turbine section destroyed by heat & mechanical breakage, especially on compressor turbine nozzles & rotors and free turbine stage # 1 rotor and NGVs;

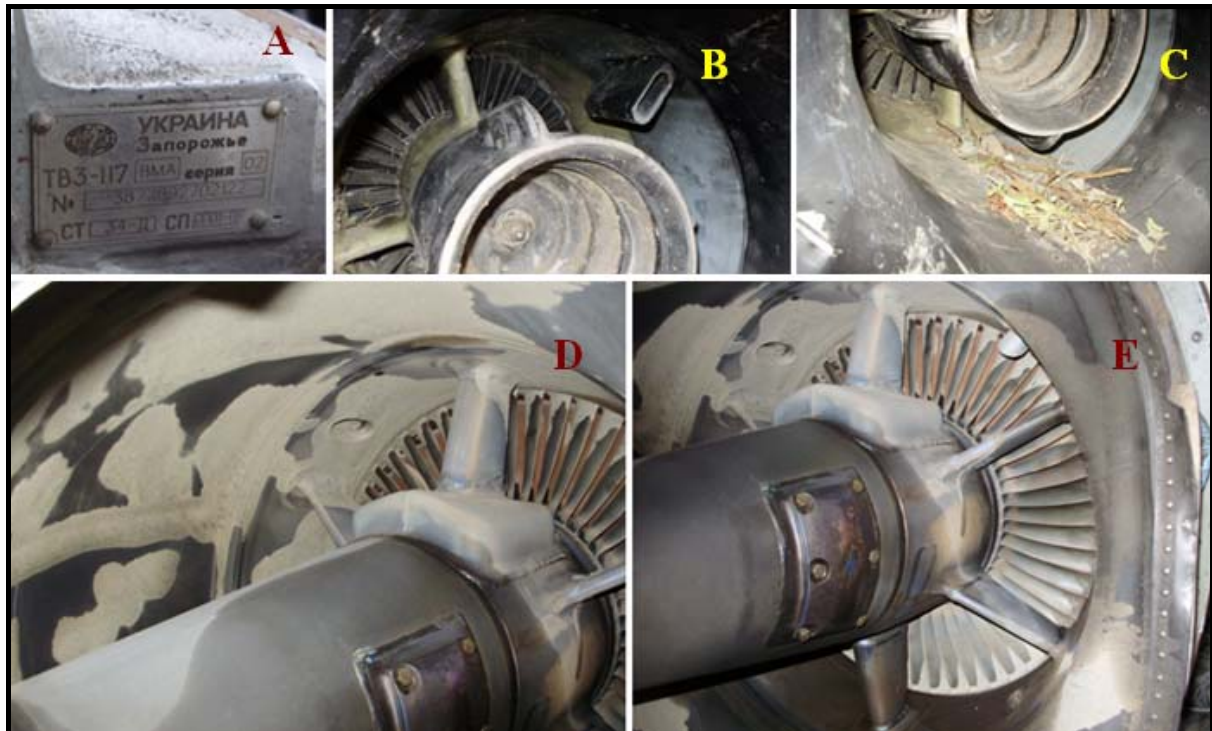
Picture Nr 9

On helicopter right hand side (position # 2), TB3-117BMA series 02, s/n 3877892702122 engine was installed (picture nr 9 A).

Like the other one, it looked proper and clean. From a front view point, after removing dust protection screen, it was noticed a great amount of rubbish, consisting of vegetal waste, laying inside the air intake case, ingested when the engine rested on the ground and the bucket spilled its water. Otherwise compressor 1<sup>st</sup> stage rotor looked in good condition and fit for normal operation (*picture nr 9 B & C*).

Looking from the rear, free turbine looked fit but some stains and mud could be seen inside exhaust duct (*picture nr 9 D & E*).

- 11<sup>th</sup> - Engine # 2 looked in normal condition but with mud deposits inside entire air flow path, from intake to exhaust.

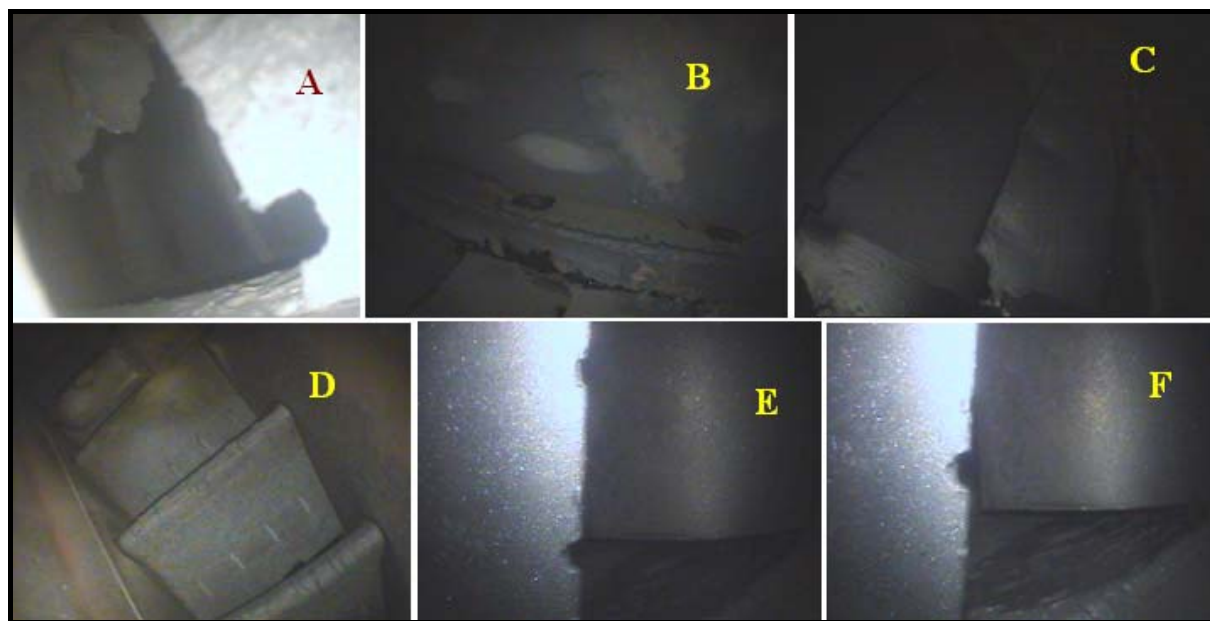
Picture Nr 10

Free turbine second stage showed some fractured blades and nozzle guide vans, but first stage rotor was completely destroyed, with only some blade bits remaining. Compressor turbine stages one and two were absent or showing only some blade root parts, like respective NGV (*picture nr 10 A, B & C*).

Compressor rotors and stators showed a normal condition, considering operating time, with only small marks & dents on some rotor blades (*picture nr 10 D, E & F*).

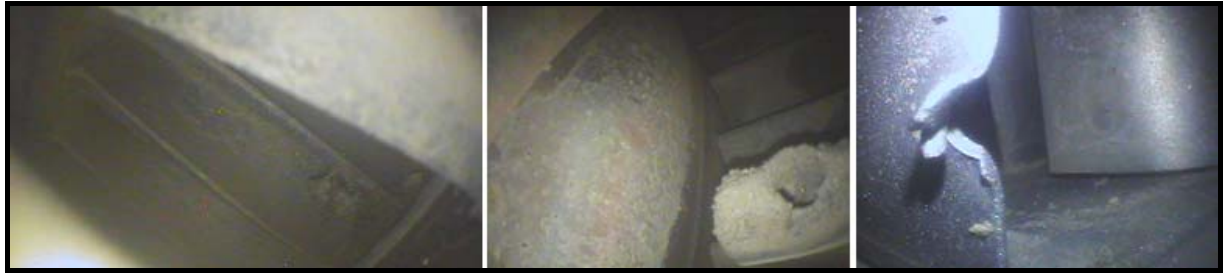
Picture Nr 11

Engine # 2 borescopic examinations showed no abnormal condition at any particular section of the engine, but expected normal wearing and erosion, with one rotor blade showing an abnormal dent, only (*picture nr 11*).

Inside compressor casing, as in all internal airflow path, it was visible a great amount of slush and crystals, most probably derived from the water and dirty ingested by the engine after its crash on the ground.
