FINAL ACCIDENT REPORT

TECNAM P-96 GOLF

CS - UOO

FINAL ACCIDENT REPORT Nr. 19/ACCID/2010

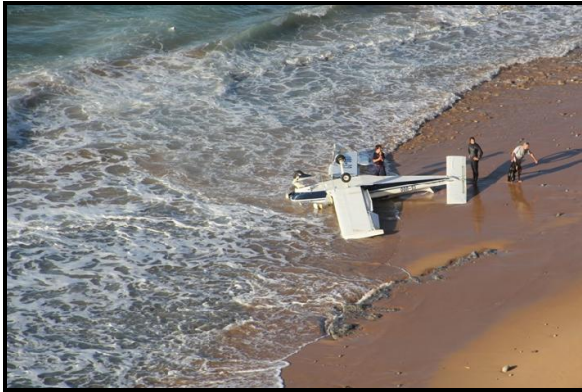
Picture Nr 2

Three of those testimonies tried to drag the aircraft to the shore, into the dry sand zone, pulling through the tail and left-hand flap (*picture nr 2*).

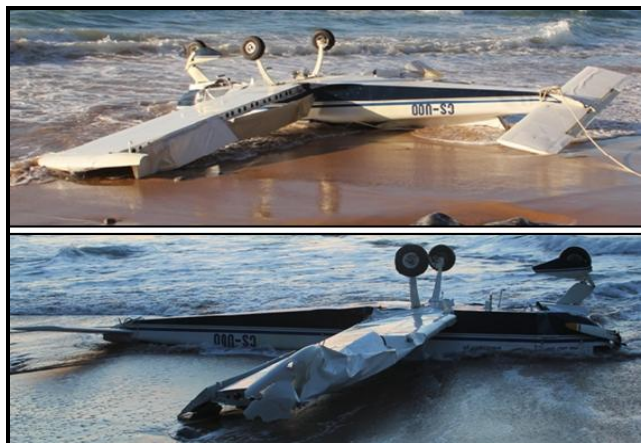
Picture Nr 3

The aircraft impacted directly with the sand and sea waves, which caused substantial damage to its structure, namely the cabin and fuselage, wings, horizontal & vertical stabilizers, propeller, engine & engine mountings and cowlings (*picture nr 3*). When removing it from the sea and pulling it to a recoverable place, more damage was caused and the aircraft became destroyed.

Sea damage was detected on wing and fuselage deformation, while landing gear remained in a good shape. Propeller blades were fractured by cleaving forces acting backwards, one severed by the hub and the other bent rearwards near the hub. Engine mounting was slightly bent with right side retreated against the fire-screen. Fuselage rear cone presented some dents and deformation, but horizontal stabilizer was normal. Cabin top was broken when it collided with the water and sea bed (*picture nr 3*).

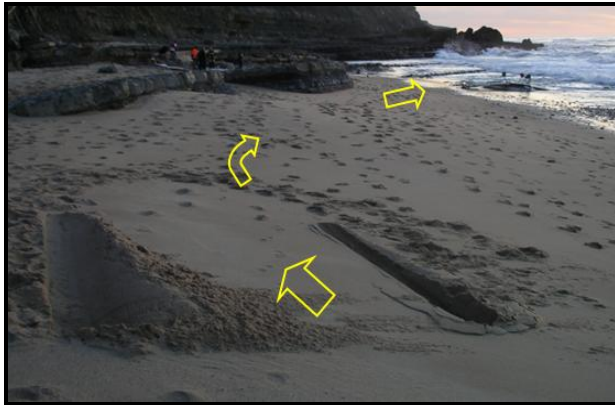
Picture Nr 11

Coming at high speed, the aircraft jumped to the air and flew about 250m prior to touch down again, this time on main wheels only (*picture nr 11*).

At this time we may notice the right wing was slightly down (*deep mark of right wheel*), in an effort to avoid the rocks and starting a deviation to the right towards the sea, the waves breakout area. With landing gear restrained by the water and the waves hitting the aircraft nose, the aircraft capsized and rested on an upside-down position, with nose pointing ashore.

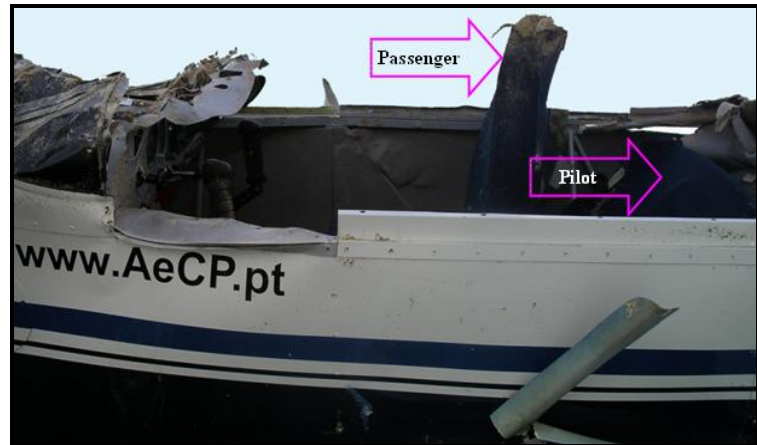
Picture Nr 12

Inside the cabin, after it was moved into normal position, passenger seat back was normal but with some damage on its top caused by dragging on the rocks, but pilot one was folded to the rear into baggage area (*picture nr 12*). Flight controls and respective trim wheels were in normal position and free of movement.

The pilot was unconscious and presenting a great cyanosis² index. He was in a hypothermic condition, with respiratory arrest and feeble heart beating. He was facing down and his body extended, suspended by the seat belts that kept him tied to the seat, which back had been distorted and was leaning backwards (*picture nr 12*).

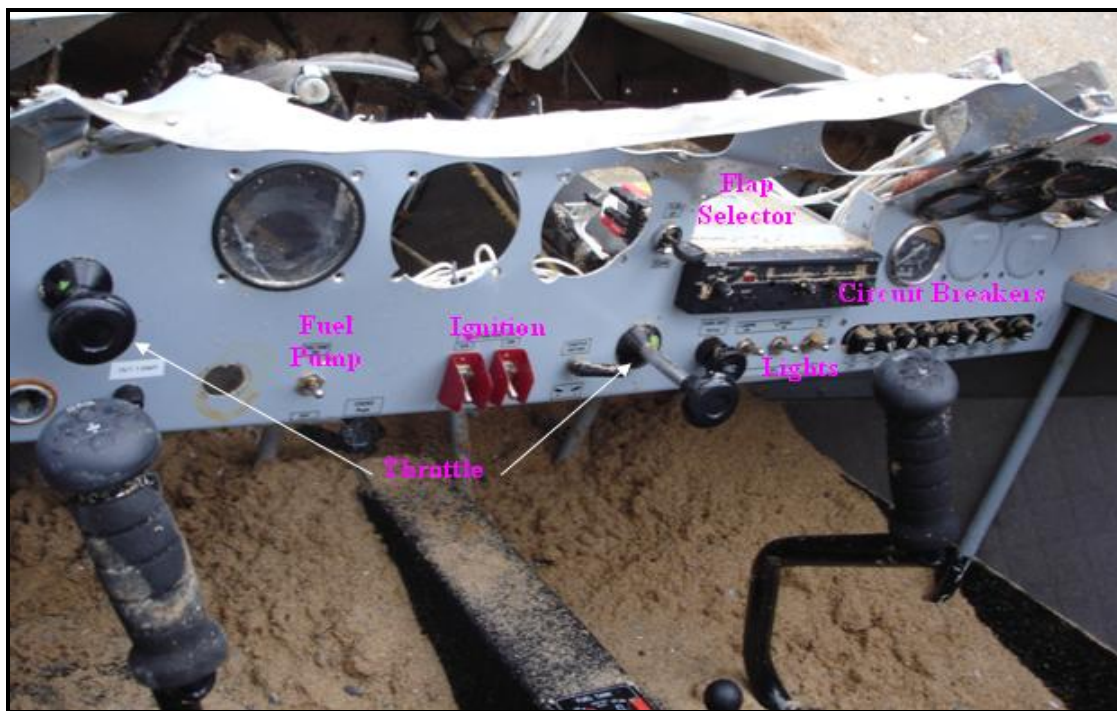
Picture Nr 13

On instrument panel (*Picture nr 13*), flap's selector was in neutral position and position indicator in "UP". Right-hand throttle was pulled full backwards and left-hand throttle pushed full forward. Ignition key and ignition switches were set "OFF", but electric fuel pump switch and exterior lights' switches were switched "ON". All circuit breakers were "IN".

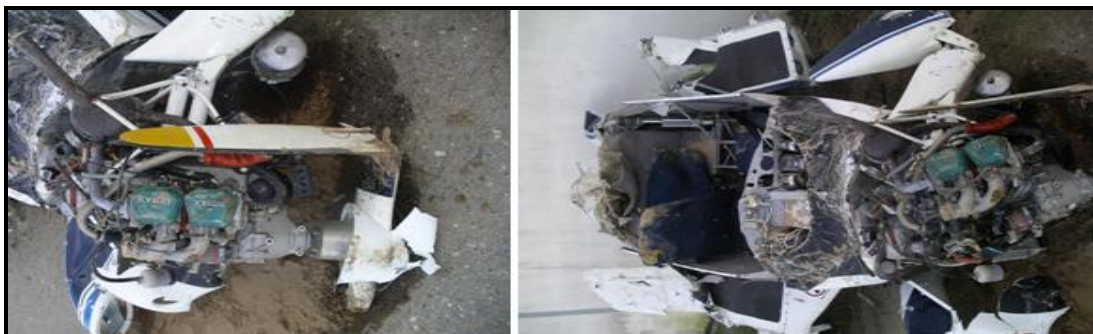
Picture Nr 16

Externally, Rotax 912ULS engine, s/n 5646121, looked normal, without evident signs of deformation or significant damage, but contaminated by sea water and sand (*picture nr 16*).

Propeller shaft was not turning and propeller wooden blades had been fractured, with one bent rearwards, close to the hub and the other missing, chopped off from its root.

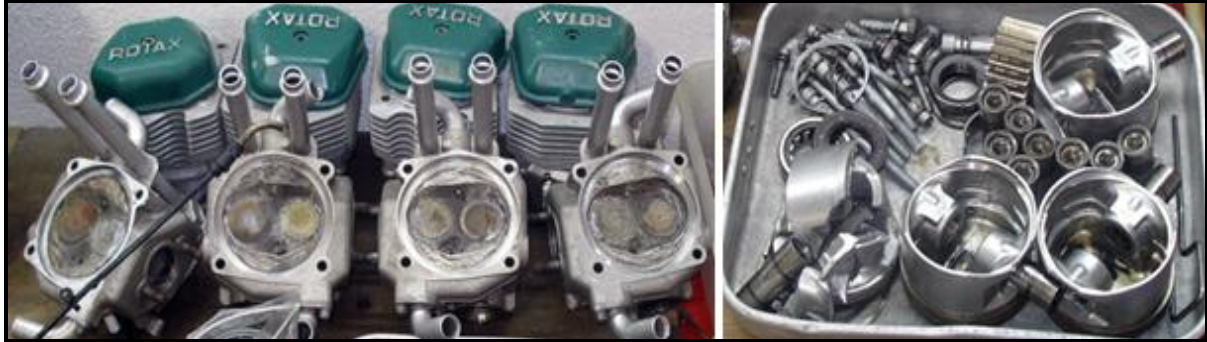
Picture Nr 18

Progressing with engine disassembly it was noted the cleanliness and proper general condition of cylinders, cylinder heads, rocking levers, valves and respective actuating rods, chambers, pistons, piston rings and connecting rods (*picture nr 18*).

Coal and other deposits seen on piston heads and inside cylinder heads may be considered normal for the operating time accumulated by the engine (996 hours).

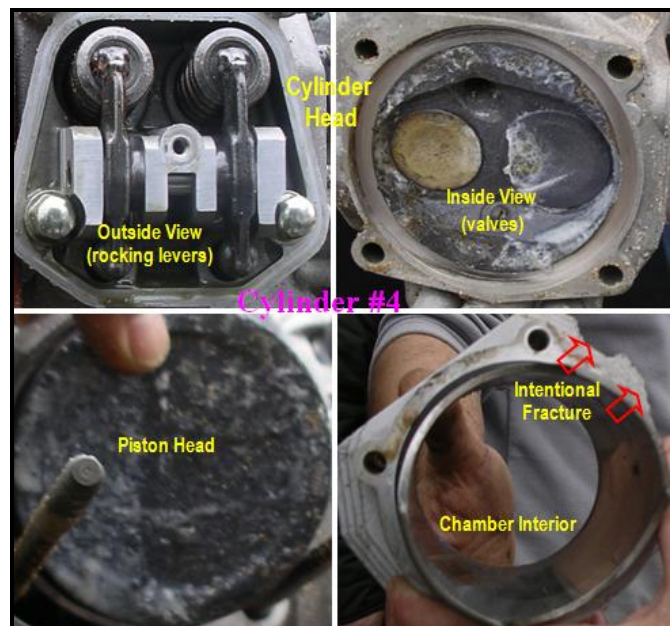
Picture Nr 19

During disassembly process some difficulty was found when dislodging Cylinder #4 chamber, which prevented the separation of crankshaft case halves, being necessary to remove it by force, which caused some damage on it (brim fracture).

On interior wall of cylinder #4 chamber some grazing marks were found, together with large areas of colour variation and glazing, signalling it has been subjected to extremely high temperatures (*picture nr 19*).

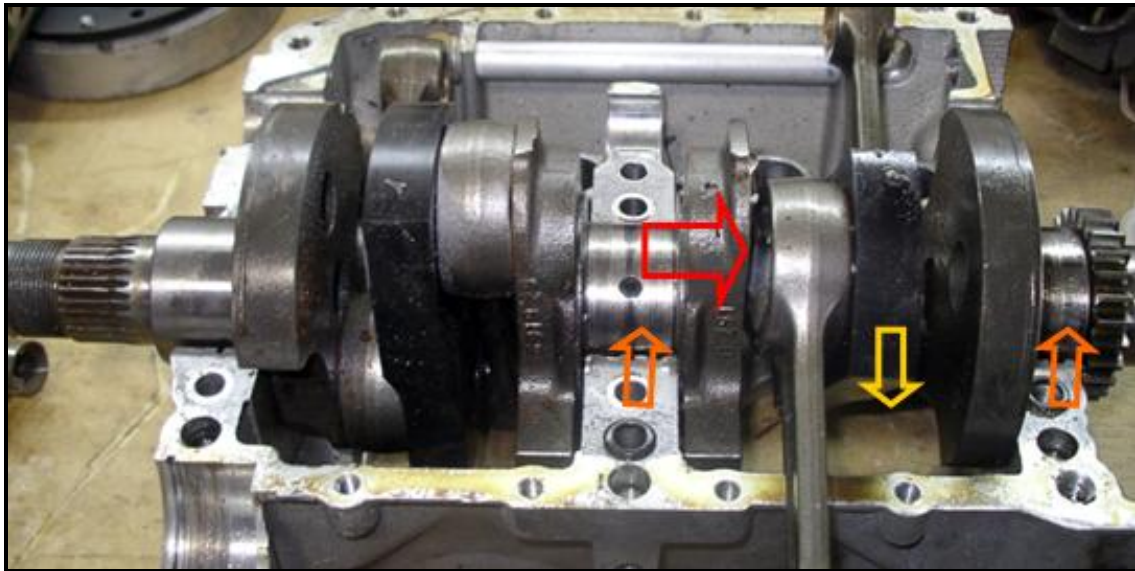
Picture Nr 20

Upon separation of both crankshaft case halves, a catastrophic crankshaft fracture struck the eye, just on cylinder #3 connecting rod bearing and adjacent counter weight coincidence zone (*picture nr 20 red arrow*).

Crankshaft showed some detrition marks, especially on centre and rear journals, probably caused by contaminated oil (*picture nr 20 amber arrows*).

Inside the crankcase a great amount of dark slush was present, impregnated with metallic particles, also present in oil filter and propeller reduction gearbox (*picture nr 20 yellow arrow*).

Slush found in crankcase is a characteristic by-product of lead oxide accumulation in lubricating oil, resulting from intensive use of high lead content fuels, like “AVGAS 100LL” gasoline, without care on reducing oil change periods to 25 hours intervals, instead of the usual 50 hours, when running on low or no lead content fuels, like “MOGAS” gasoline.

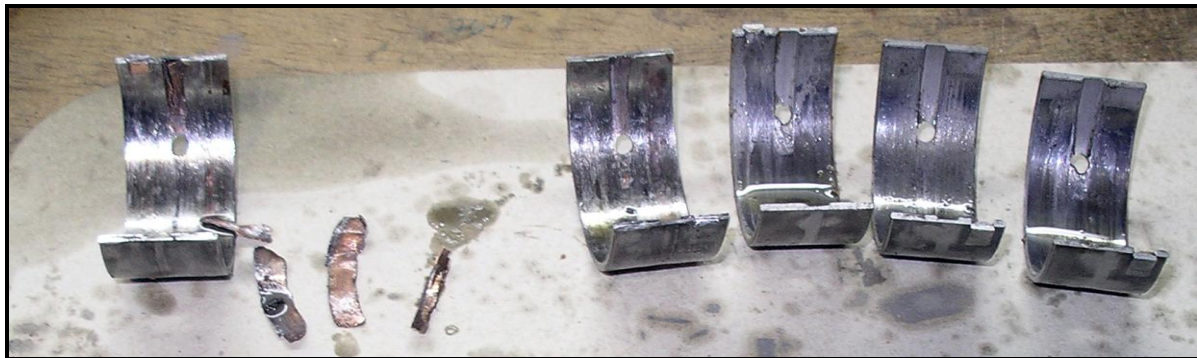
Picture Nr 21

Cylinder #4 connecting rod was stiff and its bearings found practically destroyed. Looking for a probable cause for such damage, its head was cut to see the lubricating bore was unobstructed and oil passage was free.

Detrition marks on crankshaft bearing journals (*picture nr 21*) seem to be the effect of a long lasting erosion by metallic particles carried in lubricating oil, probably deriving from #4 connecting rod destroyed bearing.

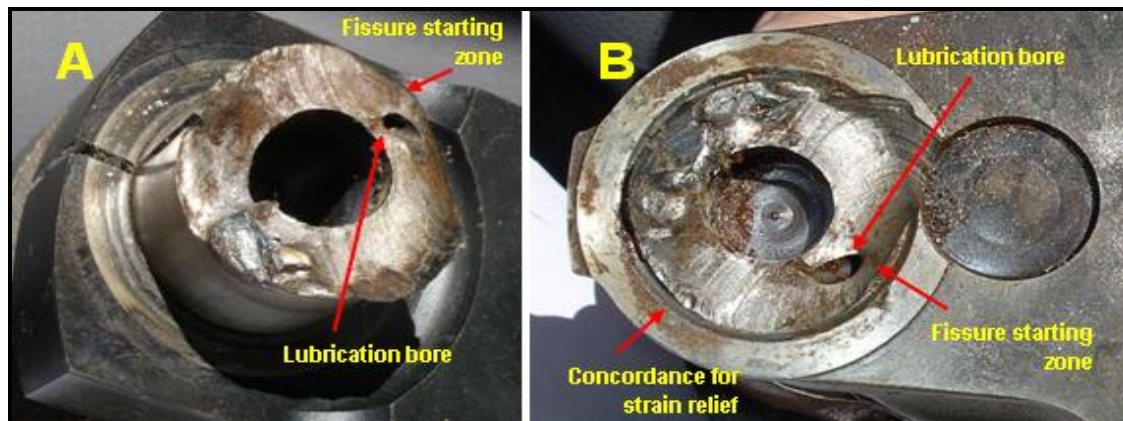
Picture Nr 22

Fracture surfaces on both parts of component have been observed and it was confirmed an integral fracture along a perpendicular plane to connecting rod journal axe (*picture nr 22-A*), in concordance zone with adjacent counterweight web (*picture nr 22-B*).

Even a naked eye can distinguish the evidence of a fissure propagation, compatible with the presence of destruction mechanisms subject to load cycles, starting at concordance in transition zone from connecting rod journal and adjacent counterweight crank web. This concordance is achieved by a machining process, by using a lathe, which drills a groove between connecting rod journal and adjacent counterweight crank web, with primary goal of promoting a reduction on mechanical stress concentration effects on that zone. A lubrication bore can also be seen in the area close to fissure starting point.

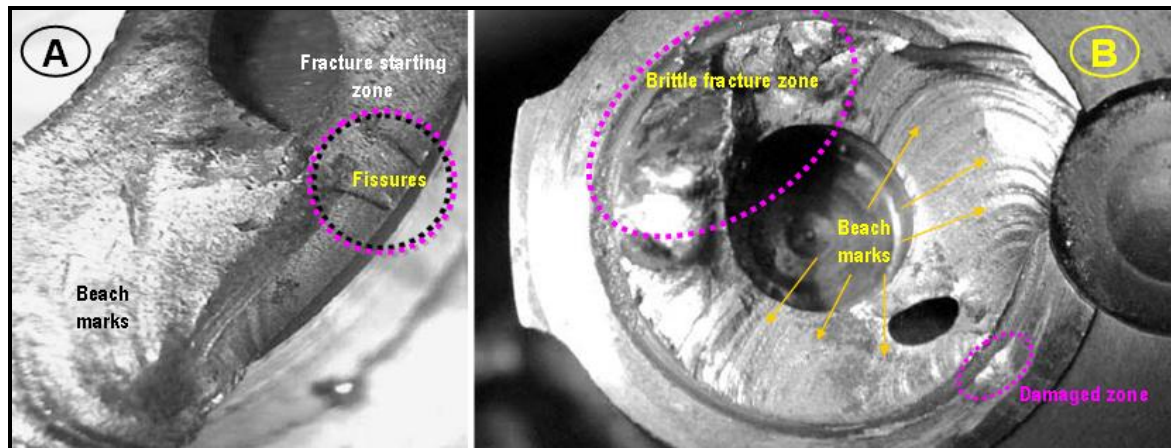
Picture Nr 23

Resorting to an optical microscope, it was possible to detect beach marks on fracture surface (*picture nr 23*), compatible with the occurrence of a material fatigue process. These beach marks are the result of material's surface plastic deformation, due successive component starts and stoppings, imposed by running conditions, and they are a typical morphological characteristic of fractured surfaces, resulting from material fatigue, representing a continuous evolution of a destruction process, by the application of a cyclic load, like the one of a reciprocating engine running.

The presence of these beach marks was seen on both fracture surfaces (A & B), covering almost 2/3 of entire surface. The remaining portion presented a different morphological pattern, characterised by a corrugated surface originated on a brittle fracture process, happening all of a sudden and anticipating component complete separation.

To note the beach marks uniform progress pattern, without change on crack pace direction by torsion effect, which means the fatigue process has been commanded by cyclic bending strains, induced by connecting rod, subjected to the effect of increased cylinder interior pressure on each power cycle.

During this examination a damage mark was noticed on fracture surface (*picture 23-B*) without symmetrical image, with identical characteristics, on correspondent counterpart, reason for considering this damage was not an original effect but probably done during transport or handling of the part and having no contribution, by no means, to the described fatigue process.

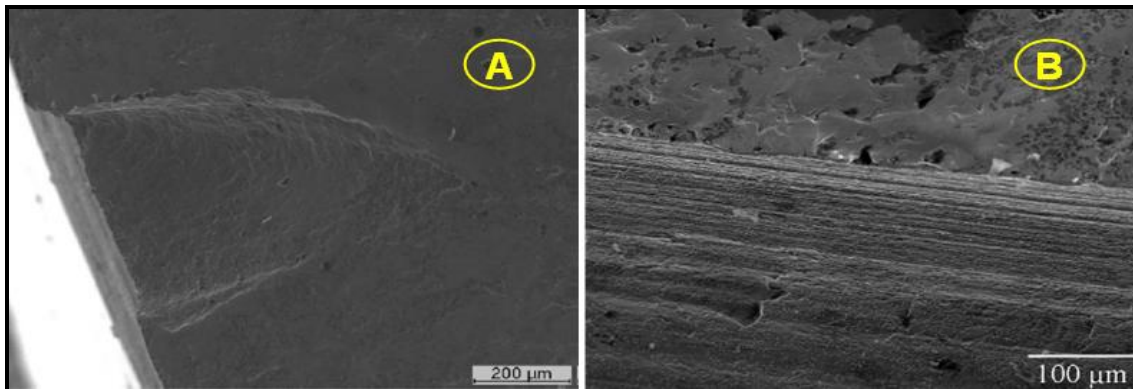
Picture Nr 25

Connecting rod bearing interface with adjacent crankshaft counterweight is a critical zone in terms of strain concentration. In order to reduce the stress concentration factor in that zone, the manufacturer opted for a concordance groove. However, the presence of a lubricating bore in that zone contributed for a significant strain gradient to take place, due cumulative effect, leading to the formation of micro-fissures during the initial stage of fatigue cracking (*picture nr 23-A*), which will, eventually, converge and create steps known as "ratcheting" marks (*picture nr 25-A*).

a) "Ratcheting" mark – This mark, looking like a tooth (*picture nr 25-A*), results from the junction of two micro-fissures propagation plans, originating in the maximum stress region along the concordance groove between connecting rod bearing and adjacent crank web, being associated to the extreme mechanical strain developed in that area. This mark coincides with crack initialization zone corresponding with initial stage of fatigue process.

b) Concordance groove – Having evidence of high concentration of stress in concordance groove zone, that point was examined in detail (*picture nr 25-B*), looking for eventual machining defects. The image shows corrugation marks, aligned in parallel to the groove, developing along the entire journal circumference, near the crank web. These marks are compatible with manufacturing process (lathe work) and do not show any sign of defect resulting from this machining process.

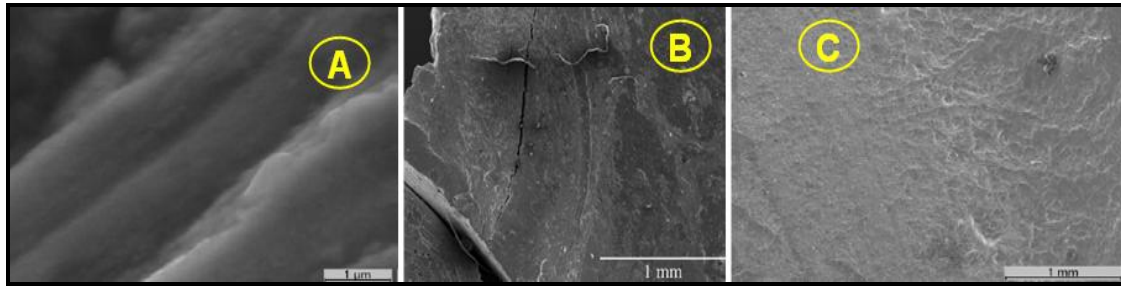
Picture Nr 26

c) Crack propagation stage – This image (*picture nr 26-A*) confirms the presence of fatigue furrows, parallel amongst them and perpendicular to the crack pace direction, supporting the existence of cyclic plastic deformation mechanisms, intrinsic to a fatigue process.

- d) Secondary fissure** – Here (*picture nr 26-B*) we may see some fissures developing perpendicularly to crack propagation plan, which is a characteristic frequently found on fracture surfaces derived from a fatigue process, when the basic material is not able to accommodate completely the entire plastic deformation process, inherent to a fatigue crack propagation.
- e) Transition boundary** – On this transition boundary, between fatigue crack propagation zone and final brittle fracture zone (*picture nr 26-C*), it is evident the increase on fracture surface roughness, which represents, clearly, a typical feature of a fatigue cracking.

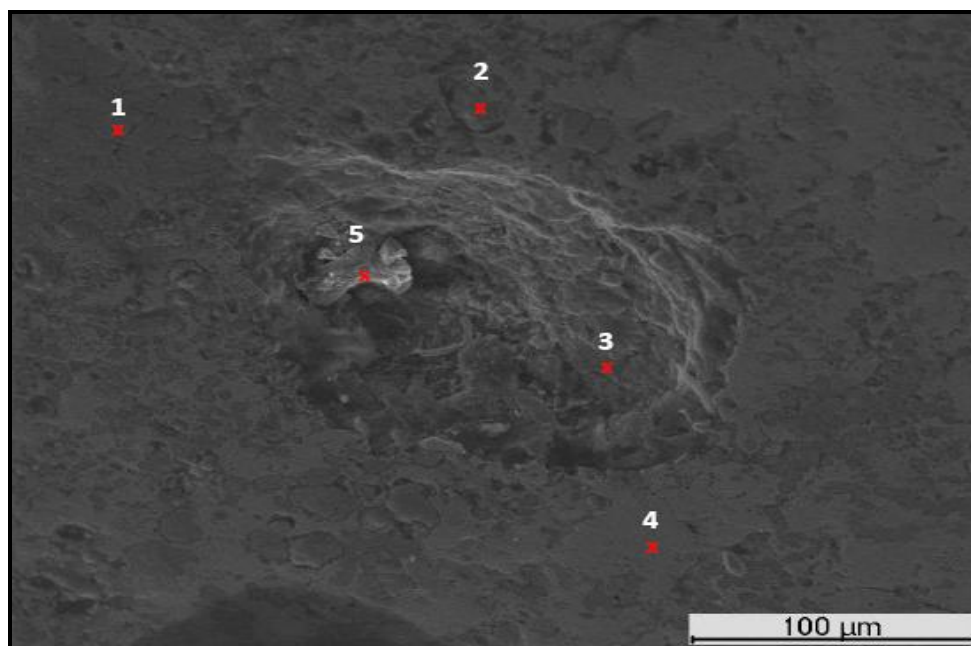
Picture Nr 27

During fracture surface observations, through different optical microscopes and SEM, namely during ratcheting zone examination, a special mark was detected on fracture surface, near fissure initialization point (highest mechanical stress zone), with a morphological aspect similar to a cavity with an average size of 150µm approximately (*picture nr 27*).

A detailed examination of such mark brought to light some superficial areas with distinct morphologic characteristics.

The crankshaft is manufactured, according with manufacturer information, by a conventional forgery process, which may convey, sometimes, different types of defects inside its stuff. To highlight, specially, the formation of micro-cavities, induced by high mechanical stress during forgery process, usually described as “bursts” or “hot tears”. These defects are fomented by the existence of intrinsic weak point in basic material, like pores, inclusions or segregation zones, catalysed by the high temperature conditions during forgery process.

From table analysis it is possible to say that point 4 values are very close to 15CrNi6 alloy reference values, which confirms this is part of crank manufacturing basic material. The other points, however, show a composition substantially different from reference material standard composition, denouncing the presence of inclusion or segregation zones, occurred during crankshaft manufacturing (forgery) process. This fact, together with micro-cavity presence, suggests the referred defect was originated during part's manufacturing, possibly being one contributory factor, cumulatively with lubrication bore, concordance groove between connecting rod bearing and crank web and other strain concentration factors, for the occurrence of a fatigue process, which caused crankshaft catastrophic failure.

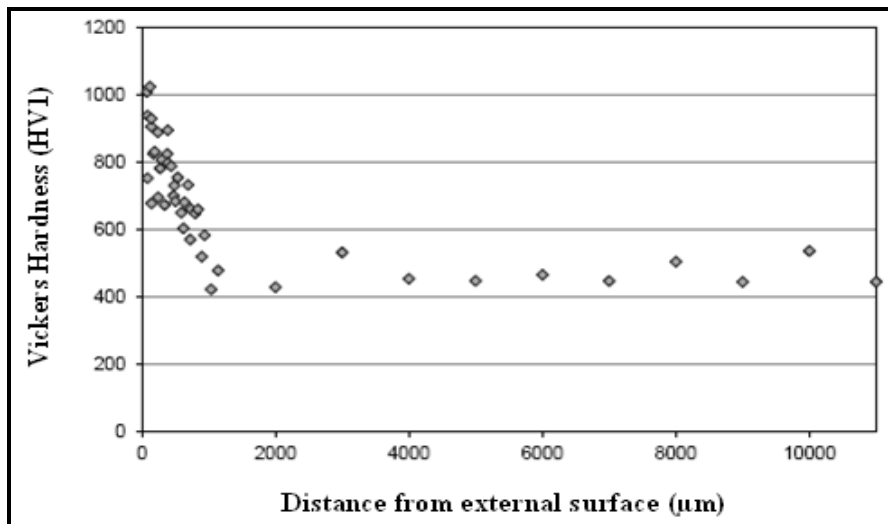
Table Nr 7

During crankshaft fracture surface examination process it was detected what seemed to be an exterior protective layer, with a nominal hardness greater than crankshaft basic material hardness. The manufacturer was contacted and he confirmed the application of a superficial treatment (*case hardening*) to connecting rod bearing, in order to minimize the probability of microfissures development on the peripheral surface of this component, which is subject to high contact pressures.

The outcome of those measurements (*table nr 7*) are well explanatory of hardness variation from component internal zone (where the 472HV1 value is not exceeded) until its outer surface where it was found a value above 1000HV1. Yet to stress the concentration of hardness higher values in a narrow zone in part's periphery, which confirms the application of referred "*case hardening*" process, by the manufacturer.
