MINISTÉRIO DA ECONOMIA E DO EMPREGO  
GABINETE DE PREVENÇÃO E INVESTIGAÇÃO DE ACIDENTES COM AERONAVES

## AIRCRAFT INCIDENT REPORT

<b>Date/Time:</b> 24-01-2012 @ 16:30 UTC <sup>1</sup>	<b>Proc. Nr.:</b> <b>01 / INCID / 2012</b>
<b>Operator:</b> Leiria Flying Club	<b>Type of Incid.:</b> RUNWAY EXCURSION
<b>Id. of aircraft:</b> Cessna 152, Reg. G-CGSP	
<b>Local:</b> Leiria Aerodrome ( LPJF )	
<b>Type of flight:</b> Pleasure	<b>Phase of flight:</b> Landing
<b>People on board:</b> Crew- 1 Pax- 1	<b>Injuries:</b> Nil
<b>Aircraft Damage:</b> Light	
<b>Synopsis:</b> The Cessna 152 aircraft with a British registration G-CGSP, privately owned but flying with Leiria Flying Club, was engaged on a local flight in the vicinity of José Ferrinho aerodrome, Leiria (LPJF). When performing a landing manoeuvre on runway 02, the pilot was unable to maintain the aircraft inside runway, which veered to the right, exited the tarmac and travelled for about 30m on the grass before it came to a stop. The weather was fine, with a clear sky, good visibility and wind calm, being not considered a contributory factor for the incident. Pilot and passenger exited the aircraft unharmed but the aircraft suffered li

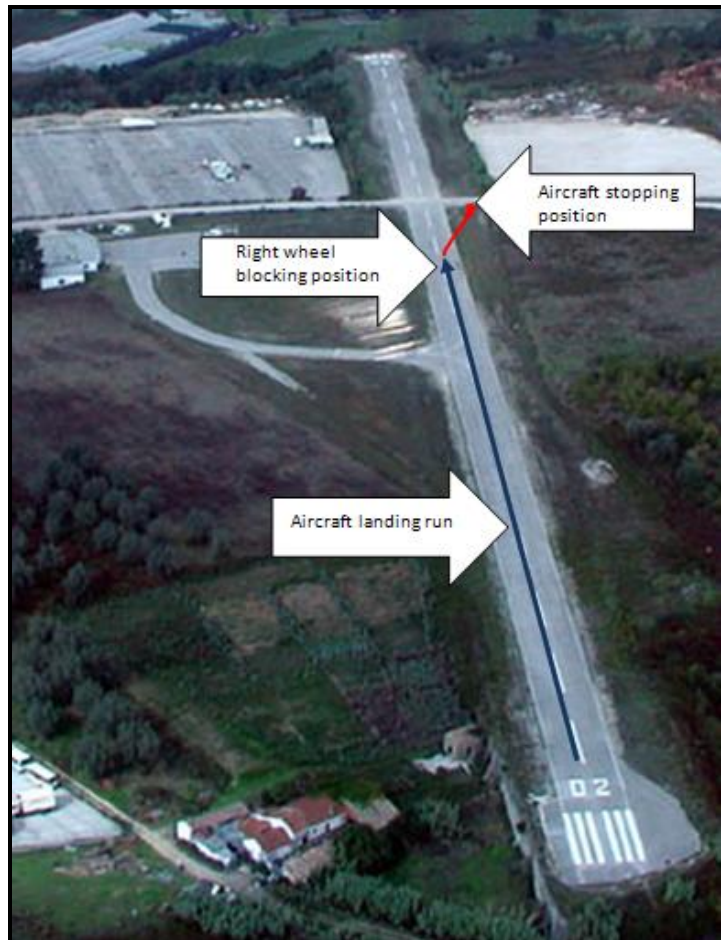
Picture Nº 1

At a certain time he felt that right wheel was blocked and the aircraft run out of runway, covered about 30m on the grass and came to a stop near the road that crosses the runway (picture nº 1 – pilot drawing).

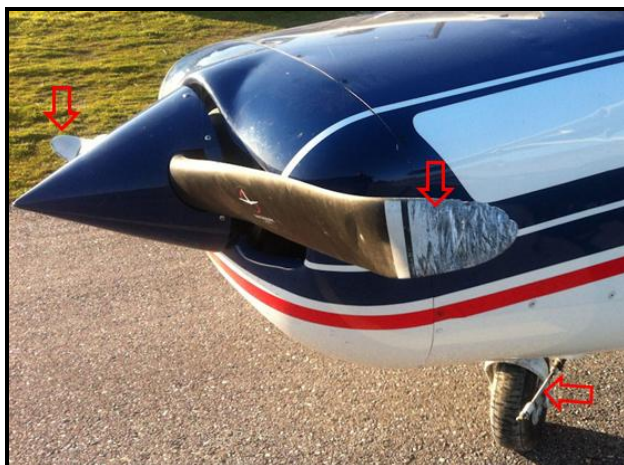
Picture Nº 2

The soil in runway edges was not compacted enough and the nose wheel dig a deep groove along its path, until coming to a halt in a terrain depression, causing nose wheel steering left command rod to break.

At same time, propeller to ground clearance was shortened and propeller blades contacted the ground causing blade tips to bent (picture nº 2).

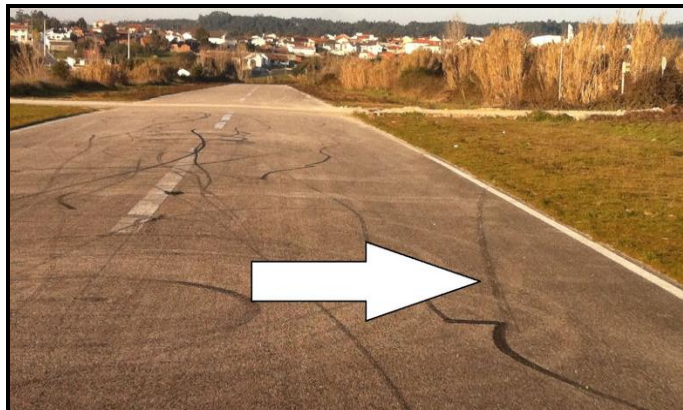
Picture N° 6

According pilot statement, the aircraft touched down on runway first 80m and rolled freely for more 200m, in order to dissipate speed. Only after speedometer stopped to indicate (<40kt), the pilot started to brake gently and the aircraft started veering to the right. Assumable right main wheel blockage occurred near runway right edge (*picture nº 6*), about 300m from runway threshold.

That is to say that runway mark extension and chroma (picture nº 6) as well as soil dug grooves' extension and deepness (picture nº 7) don't conciliate with an aircraft speed of less than 50-60kt.

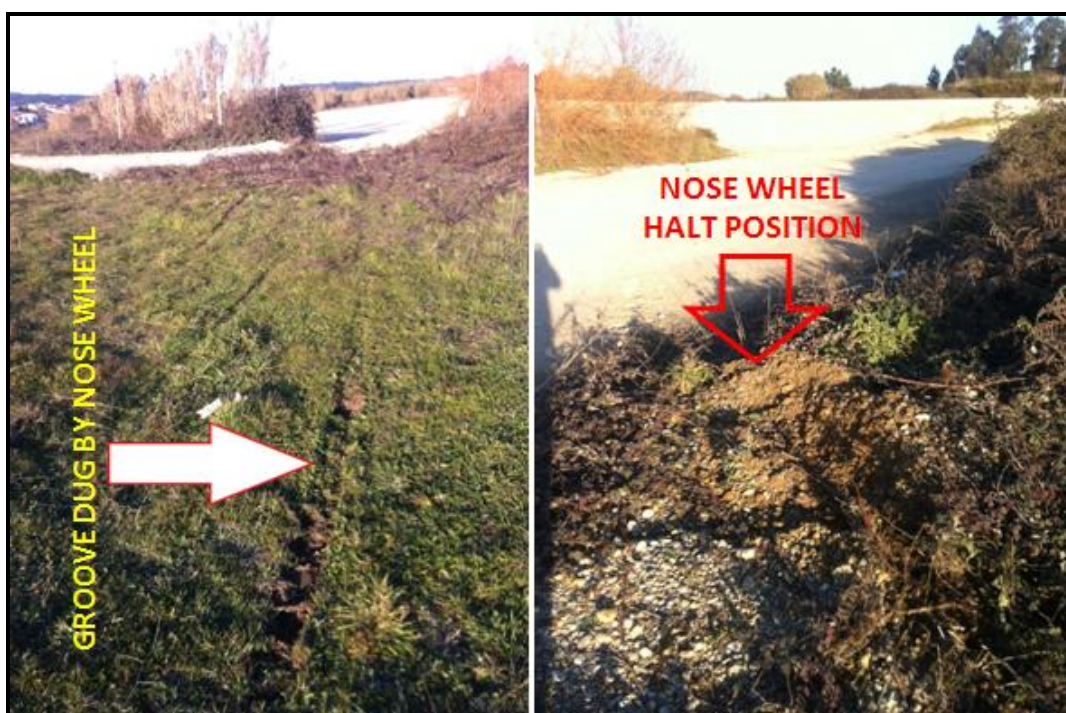
Picture N° 7

Tracing running distances and groove deepness, dug by aircraft wheels on runway and edge terrain, we must admit that aircraft speed was greater than expected speed, based on previous description.

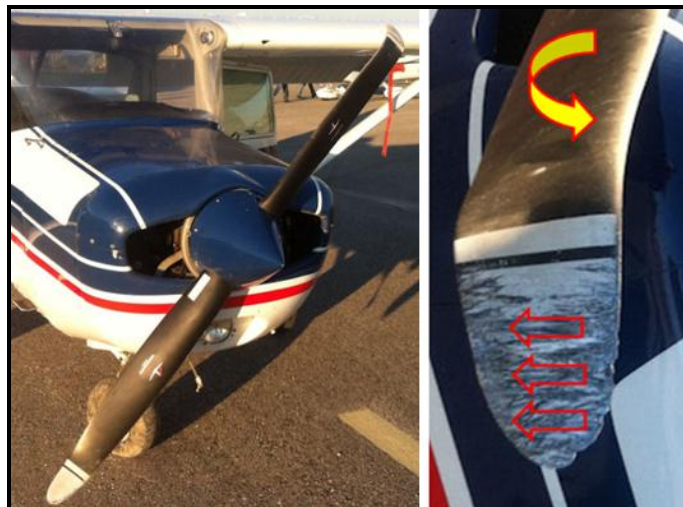
Picture N° 8

Coming to a halt near the road, with nose wheel buried in a relatively deep groove, the clearance between propeller tips and the ground was shortened and propeller blades, rotating at reduced speed, hit the soft soil and road tarmac, in sequence, causing the tips to bent forward and rearwards as shown on picture nº 8, where sliding effect is well visible.

Due soft terrain, the nose wheel dug a significant groove, before coming to a halt, close to the crossing road. Left nose wheel steering actuating rod, collided with the ground and broke out. Level difference between nose wheel dug grass hole and tarmac allowed propeller blades to contact the ground and bent their tips.
