**ACCIDENT**

| <b>Aircraft Type and Registration:</b> | AS350 B3e Ecureuil, G-MATH | |

**Synopsis**

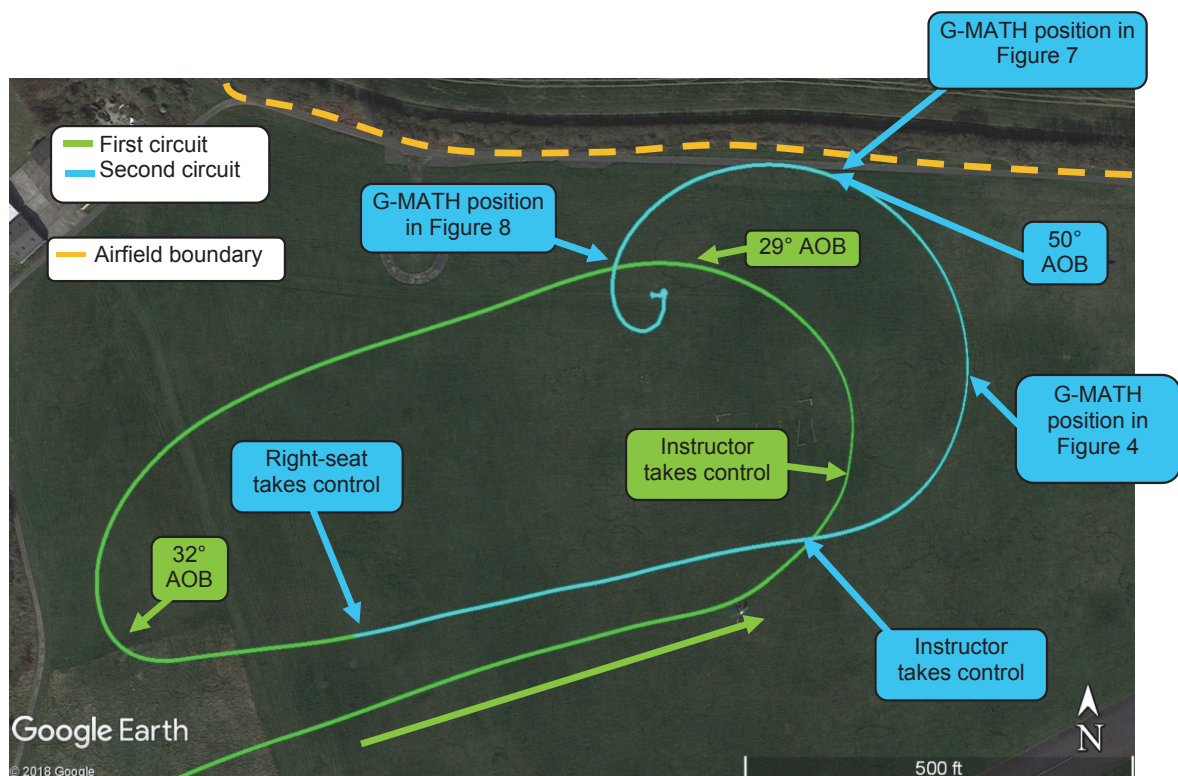
**Figure 3**  
Final 90 seconds of G-MATH flight data

When the instructor took control for the second go-around, the helicopter was at approximately 35 KIAS and approximately 20 ft agl. This occurred with the helicopter positioned slightly to the north-east of the first circuit. (Figure 3).

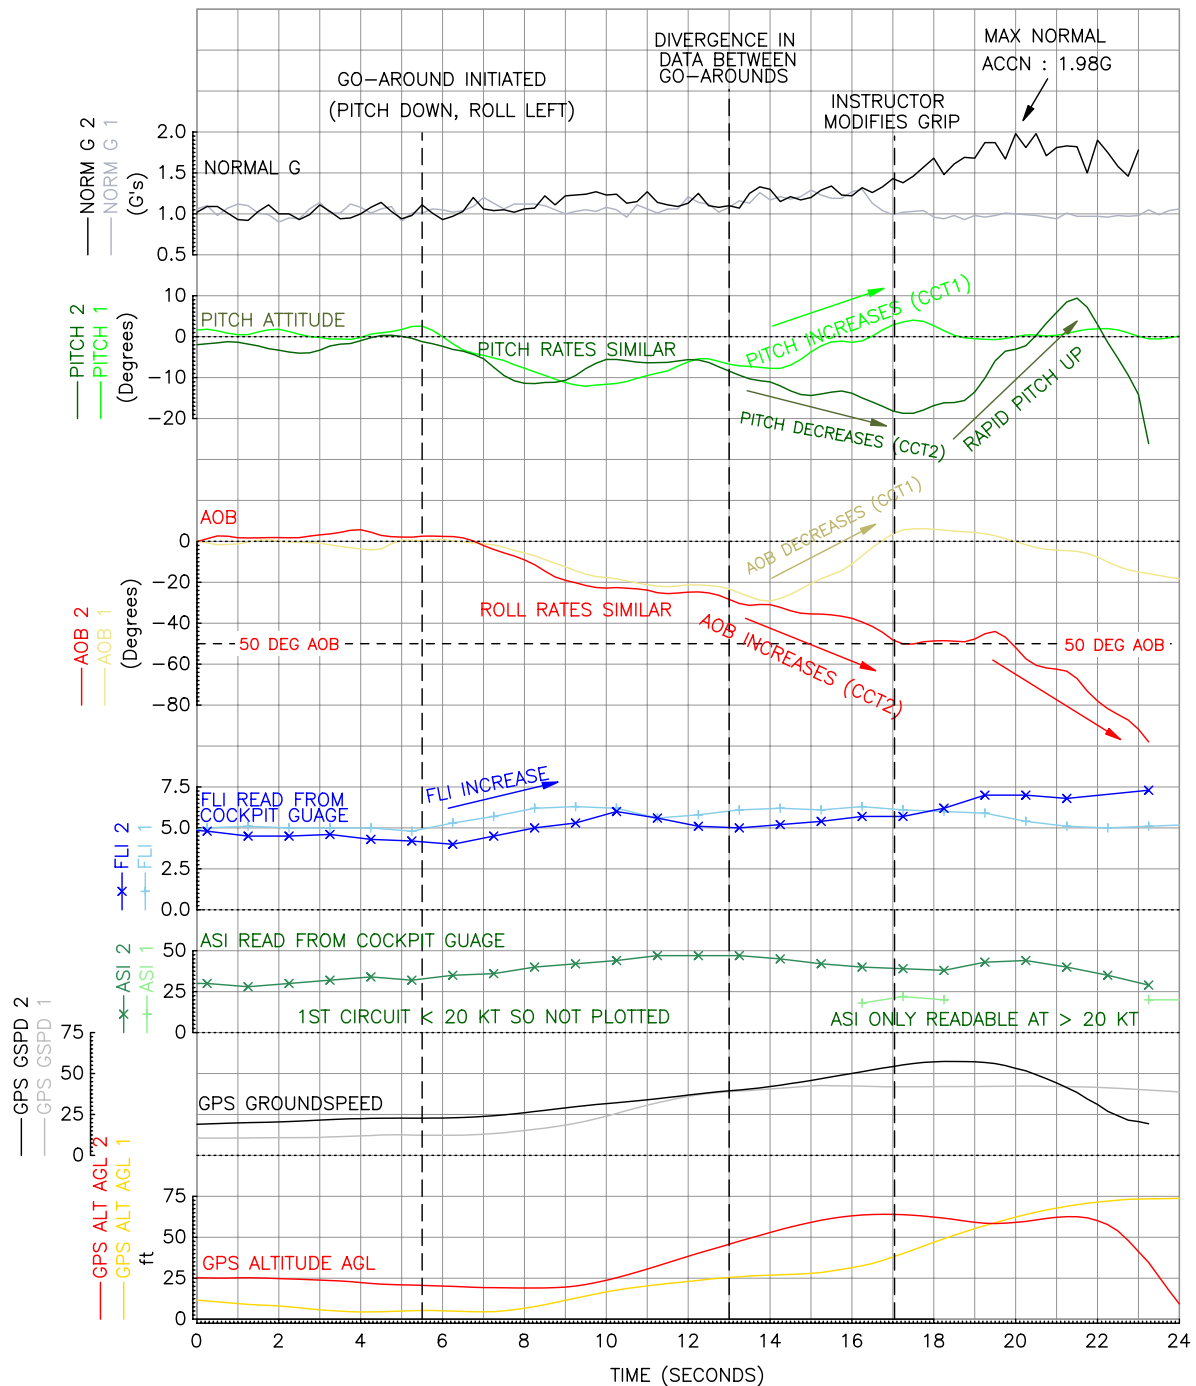
**Figure 5**

Figure 5 presents data from both go-arounds, aligned at the point when the helicopter began to pitch nose-down. This figure shows that the helicopter attitude during the initiation of the go-around was similar on both occasions. The helicopter pitched down and rolled to the left to approximately the same attitudes and at similar rates in the first 7.5 seconds of the turn. The rates of turn were  $-11.9^\circ/\text{sec}$  and  $-10.6^\circ/\text{sec}$  respectively.

The recorded data shows a divergence in parameters between the two go-arounds after the first 7.5 seconds. In the first go-around, the pitch and roll attitudes began to return to zero as the helicopter rolled out of the turn onto the downwind leg. In the second go-around, the roll and nose-down pitch continued to increase; this commenced at 0832:50 hrs.

G-MATH comparison of two go-around manoeuvres.

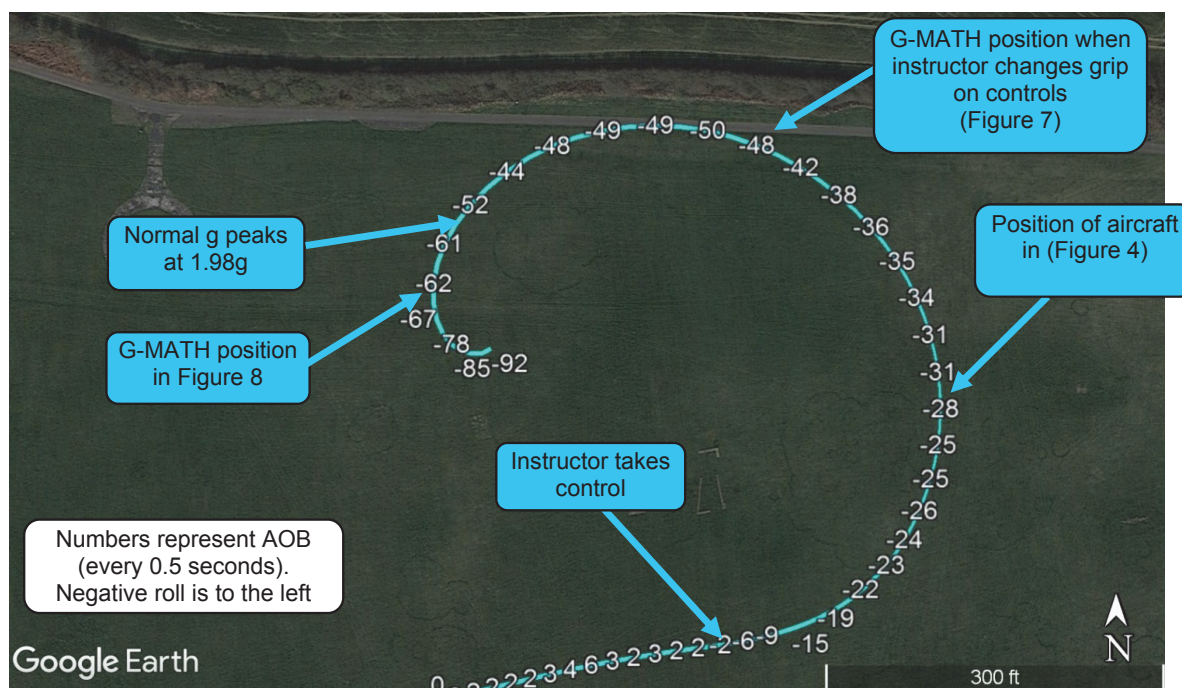
**Figure 6**

In the final stages of the second go-around (Figure 6) the AOB increased to 50° left and the helicopter pitched down to -19° over four seconds. (The view from the cockpit video and recorded position at this point showed the helicopter was just inside the airfield boundary hedge). The recorded height was 64 ft agl.

G-MATH final go-around manoeuvre showing AOB

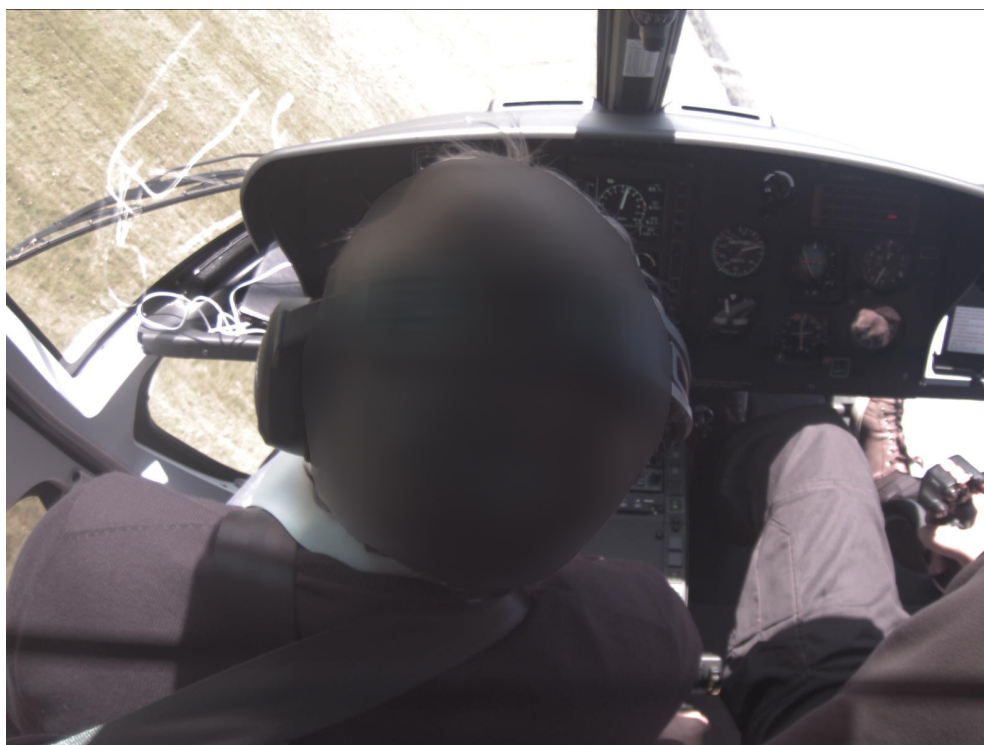
**Figure 8**

After the instructor's grip on the cyclic had changed, his body also leant to the right (Figure 8) and for the final 3 seconds prior to the accident, obscured the Vision 1000's view of the right collective lever and the position of the hydraulic cut-off switch on the end of the right collective. The view of the CWP was not obscured and the red HYDR light remained illuminated until the end of the recording.

G-MATH at 0832:58 hrs during second go-around showing instructor's right lean (62° AOB). (instructor's head has been blurred)

It is possible that an unexpected control force reversal, the sudden steep AOB, and the proximity of the ground caused the instructor to become startled. The instructor's right lean, away from the approaching ground, could be interpreted as an 'aversive movement', as would be expected in a startle response. It may have been theoretically possible for the instructor to exert sufficient control force to recover, but the possible startle may have resulted in a psychomotor impairment that prevented him from doing so. The amount of time available to the pilot to recover from the high AOB was less than five seconds and this is consistent with the period where impairment may be expected.
