Accident Investigation Board Denmark

# **BULLETIN**

**LANCAIR IV P**

**SE-XRU**

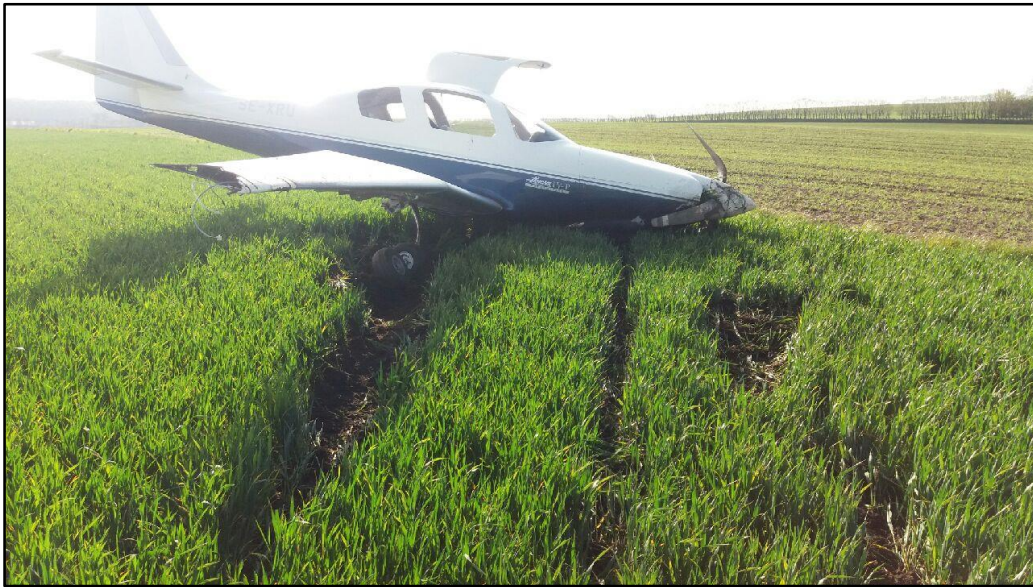
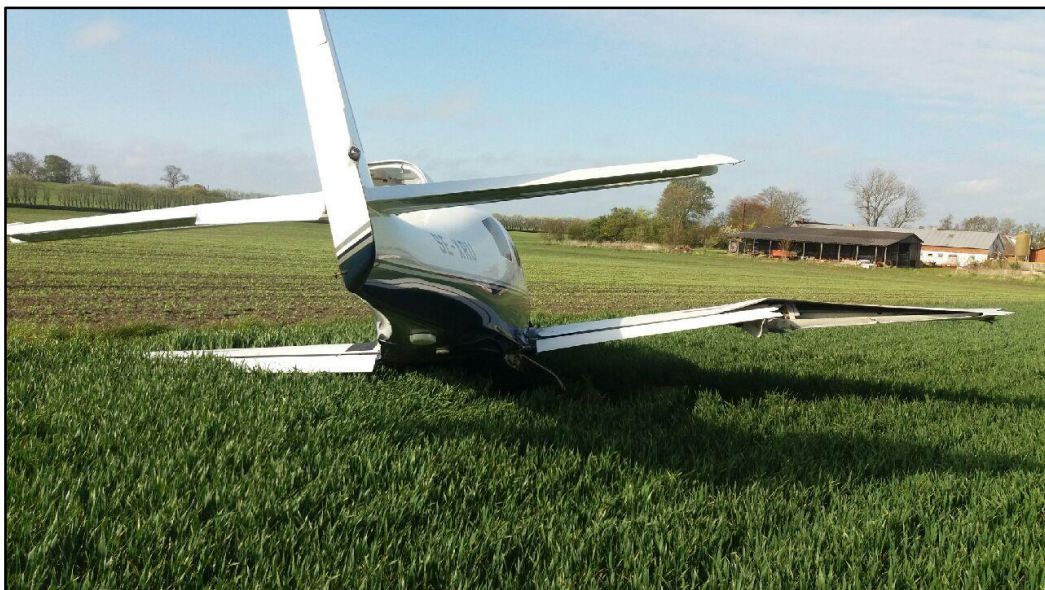
The crops had a length of approximately 40 to 50 cm.

There was no traces of engine oil on the ground below the aircraft.

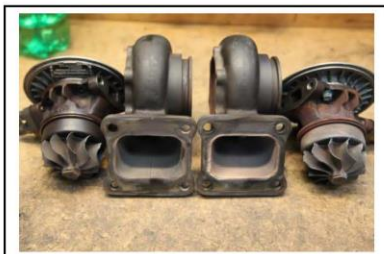
Turbo and transition exhaust port.

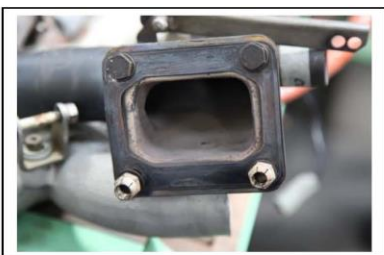
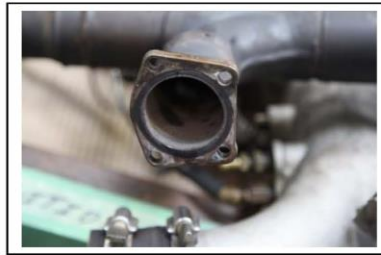
Exhaust pipe

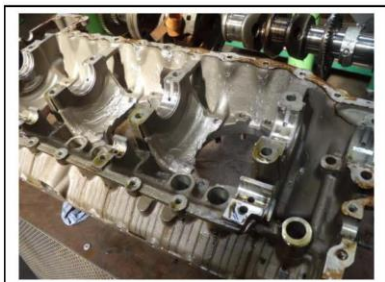
Camshaft bearing bridge

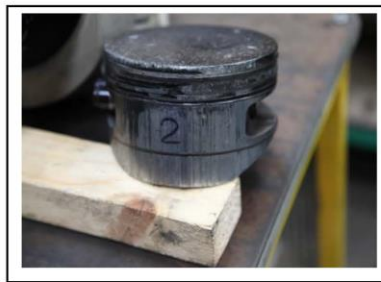
Piston cyl.#2

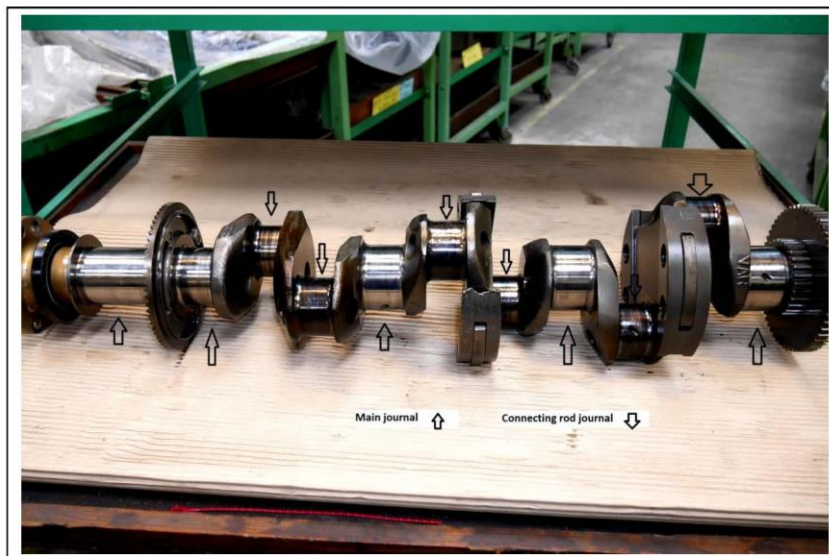
Main and connecting rod journal

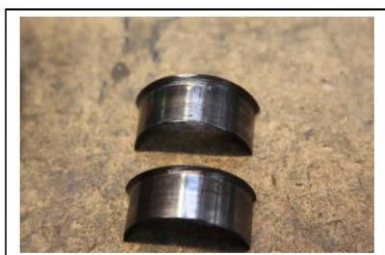
Connecting rod bearing

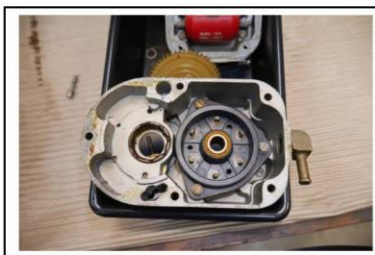
Magneto

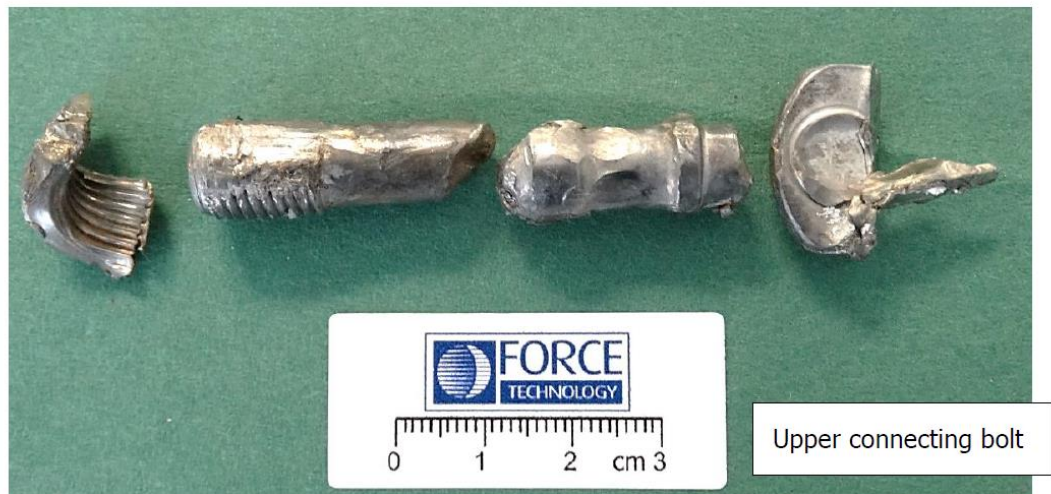
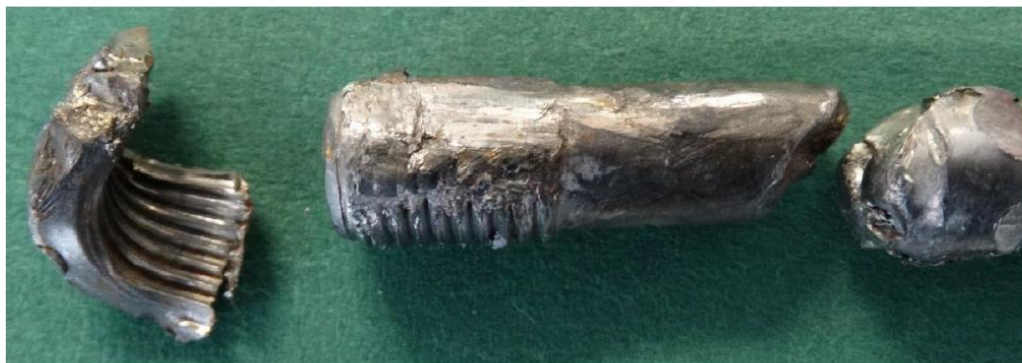
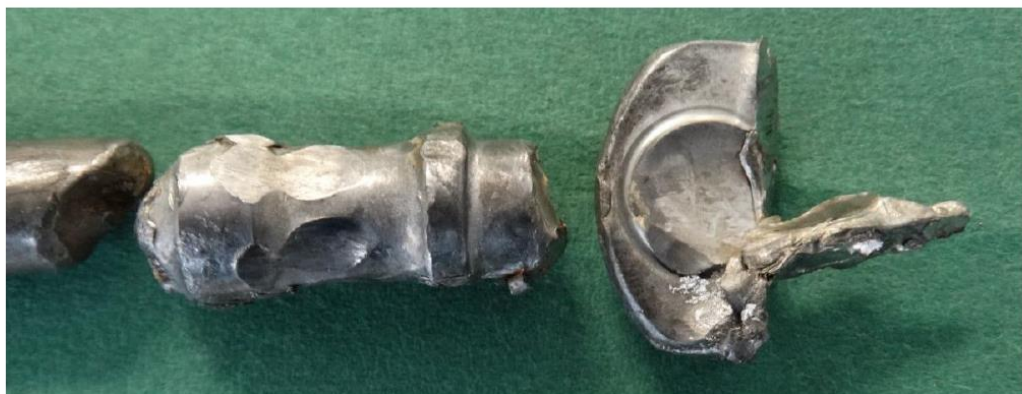
The bolts were broken in several places, and bolt heads and nuts were heavily battered from contact with surrounding bodies and surfaces, c.f. Figures 1-6 in Appendix 1.

Examination of the fractures revealed failure modes by overload due to axial, shear and bending loads. There are no signs of bolts being loose prior to failure. Likewise, there are no signs of pre-existing material defects being responsible or contributory to the fracturing. The overall appearance indicates bolt failures caused by collateral damage rather than being involved in the cause and origin of the engine problems that prompted the emergency landing.

The fracture mode is overload imposed in the course of escalating engine problems.  
The fracture in the bolts is due to consequential damages.

Figure 1 Parts from the upper connecting rod bolt and matching spiral lock nut after cleaning.

Figure 2 Close-up of part from Figure 1.

Figure 3 Close-up of part from Figure 1.

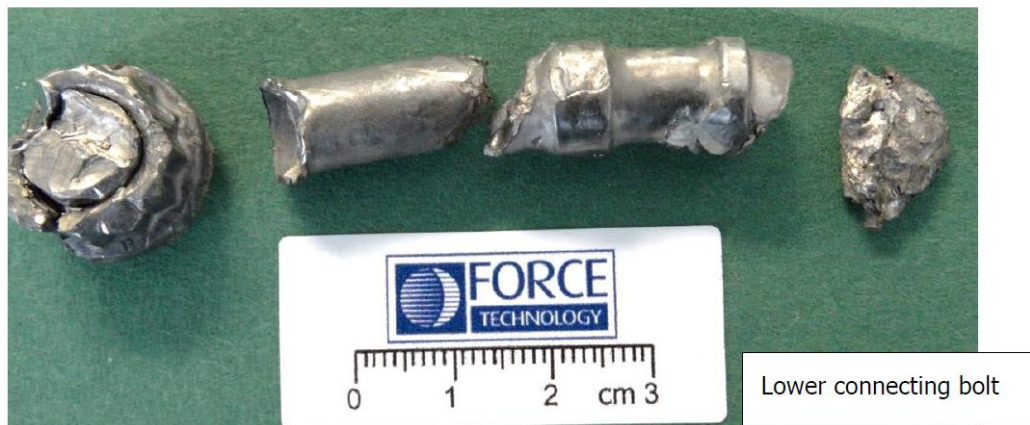
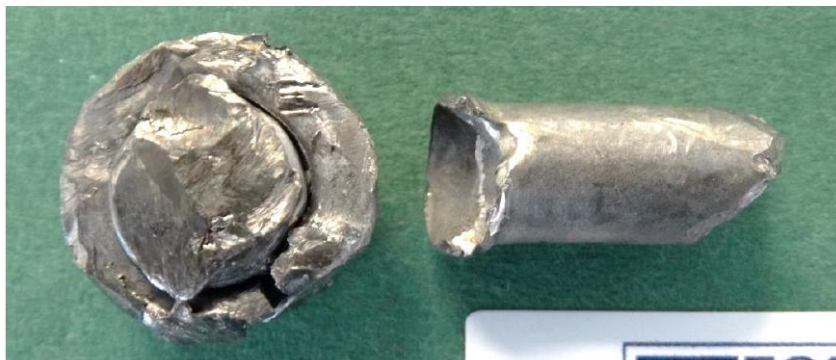
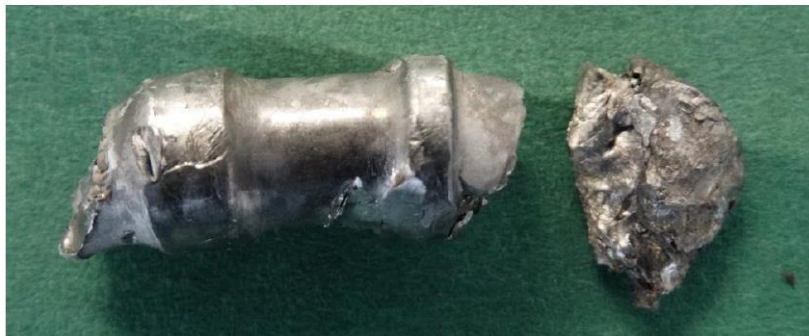
Figure 4 Parts from the lower connecting rod bolt and matching spiral lock nut after cleaning.

Figure 5 Close-up of part from Figure 4.

Figure 6 Close-up of part from Figure 4.
