Statens haverikommission
Swedish Accident Investigation Board

Report RL 2010:09e

**Accident to aircraft SE-GEE at
Gryttjom airfield, Uppsala county,
Sweden on 3 June 2009**

Case L-07/09

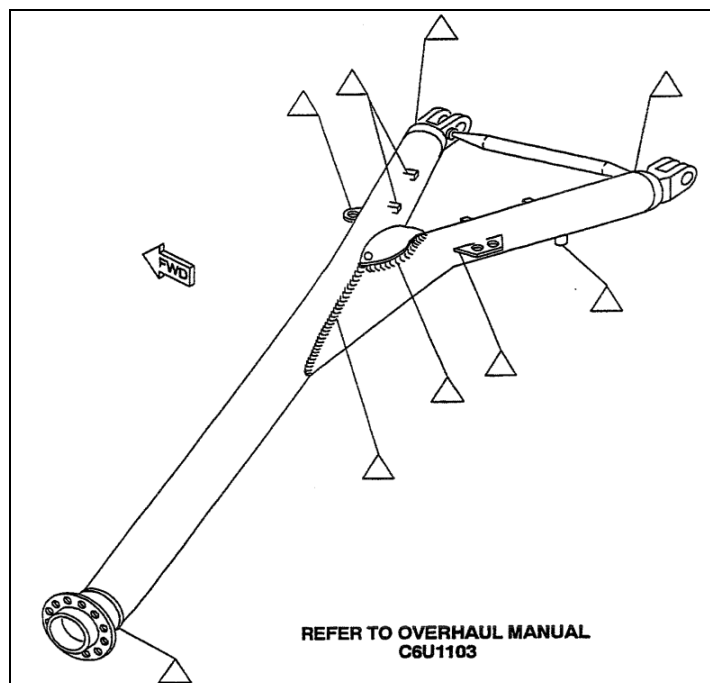
Figure 3. Inspection points according to PSM 1-6-7 Part 3

In addition, visual inspection, in accordance with PSM 1-6-7, which is to be performed on the landing gear legs with the fairings removed and at intervals of 2,400 flying hours, seems to be inadequate in this respect. Also these inspections do not focus particularly on the critical areas where cracks could occur as specified above.

There are therefore reasons for the supervisory authority, in conjunction with the manufacturer, to consider the need for supplementing the present maintenance system in respect of crack formation in the landing gear.

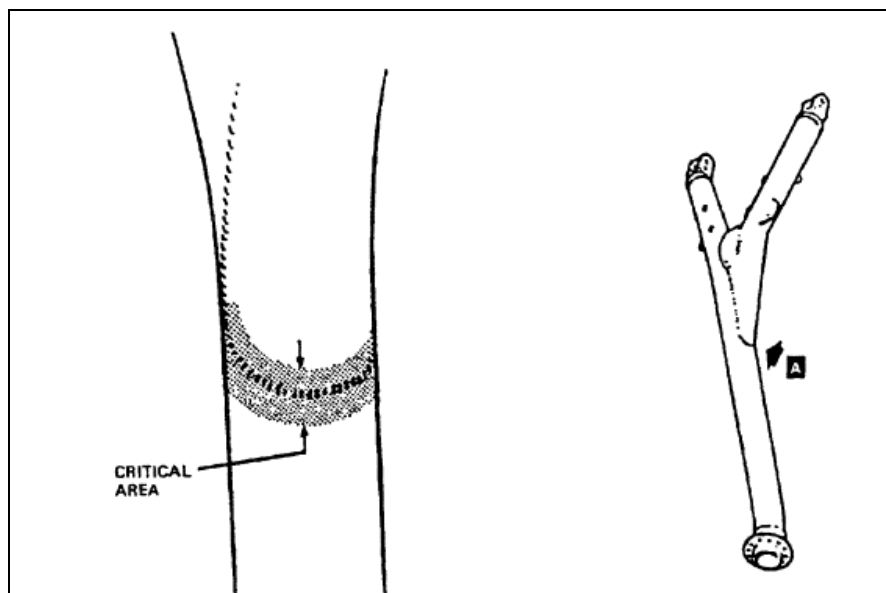
On 20 December of the same year the manufacturer also issued a mandatory Service Bulletin (SB) No. 6/380. This SB contained the information that cracks could occur as the result of corrosion in the inner “pocket” associated with the oval hole in one of the welded landing gear pipe joints.

Figure 4. Critical area in accordance with SB No. 6/360.

Initiation of this particular fatigue cracking took place in the area that according to SB No. 6/380 is critical to fatigue. The actual fracture did not however begin from any internal attack of corrosion at the welded joint, which had previously been the case. Instead, crack initiation began along a welded joint on the outside of the landing gear pipe section, something that the manufacturer had not experienced before.

The affected welded joints and material adjacent to them would therefore have to be inspected for cracks. Initially this would take place in accordance with two alternative programmes; “Schedule 1” or “Schedule 2”. Subsequently further inspections would take place in the form of a recurring crack check, called “Check D”.

After the first time that a “Check D” has been carried out, this check must be repeated at intervals of 12,000 flying hours or five years, whichever comes first.

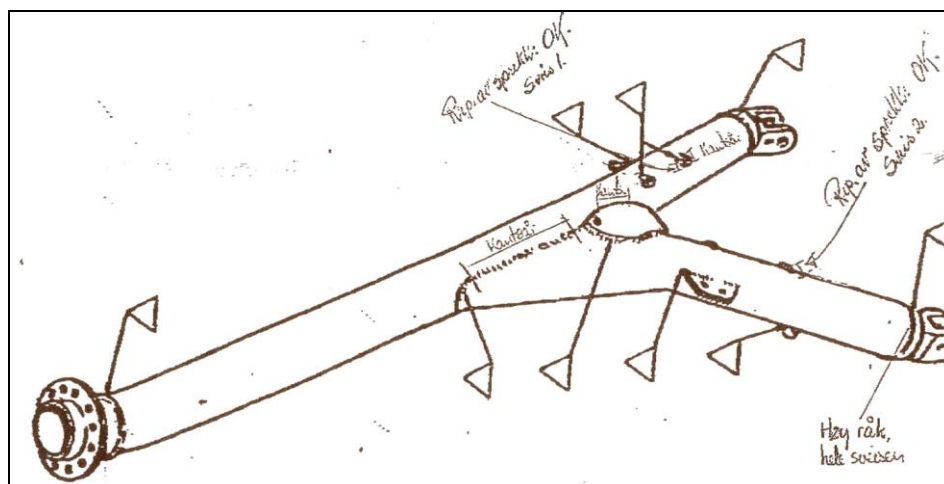
During the second periodic inspection, in 1995, cracks were found in some of the welded joints of the landing gear, as shown in the sketch below and these were repaired by re-welding. In the metallurgical investigation of the landing gear leg that is described in Section 1.16.1, it was not possible to define with certainty the precise extent of this welding repair in relation to the critical area according to SB No. 6/380, where the original welding was also located.

Figure 5. Sketch showing earlier cracks and repairs.

In its investigation, SHK has not been able to find any definitive explanation for why the fatigue cracking was initiated on this particular landing gear leg. However it is apparent from the landing gear technical documentation that weld repairs had been made on cracks in the welded joints that are directly associated with the weld joint where the cracks began.

These weld repairs have to some extent overlapped the original welding in the critical area. Metallurgical defects had probably arisen in the area, in the form, for example, of internal stress, localised hardening or microscopic contamination of the material. It is well known that such defects promote the initiation of fatigue cracks.

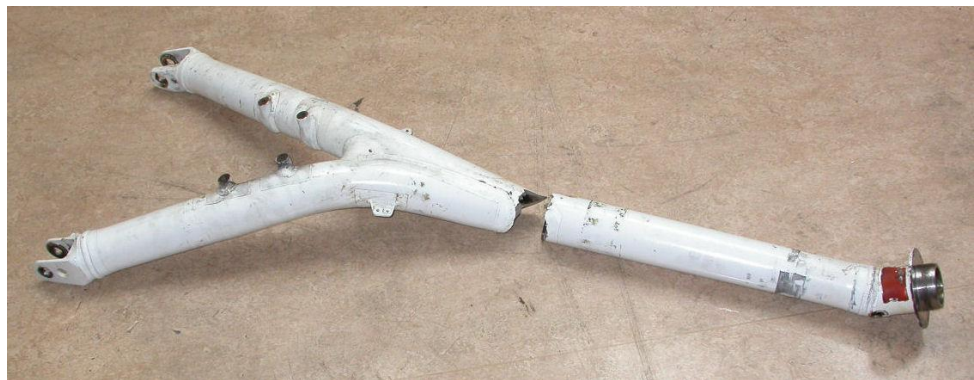
Figure 6. Right landing gear leg

The examination showed that the fracture was due to metal fatigue that at its beginning followed the edge of a weld. In the area of the starting point, which is at the outside of the pipe section, four fatigue cracks grew almost straight into the centre of the pipe. From these cracks the fracture then grew around the outside diameter, reaching just beyond halfway. The distance from the starting point to the oval hole mentioned in SB No. 6/380 was 16-22 mm. The entire fracture was in the longer pipe section and had no connection with the edge of the hole.

The four cracked surfaces were not in the same plane; each crack plane was at a slight angle relative to the others. This kind of appearance usually indicates that torsional stress had occurred in the loading that caused the crack initiation and growth. The remainder of the fatigue fracture surface was more planar, which is probably due to purely bending stress becoming predominant.

Initially the fracture followed the outer edge of the weld, and is always present in the basic material of the pipe section. The pipe has the same wall material thickness around the entire fracture, approximately 9.6 mm.

It was clear from the technical examination that the landing gear leg had several fatigue cracks initiating from the edge of the outer welded joint. The landing gear had been regularly subjected to large and oscillating loads, and the fatigue cracks had successively grown to join and form a common crack that penetrated the whole thickness of the material. The location of the cracking, inside the landing gear fairing, meant that the crack growth could progress for a long time without being discovered.

The landing gear fracture occurred in connection with taxiing before take-off at almost maximum take-off weight from an uneven grass surface. All the indications are that the landing gear was then subjected to such a high load that, weakened by the fatigue cracks, the landing gear leg pipe was no longer able to sustain the loads that were imposed on it, so that a momentary overload fracture took place.

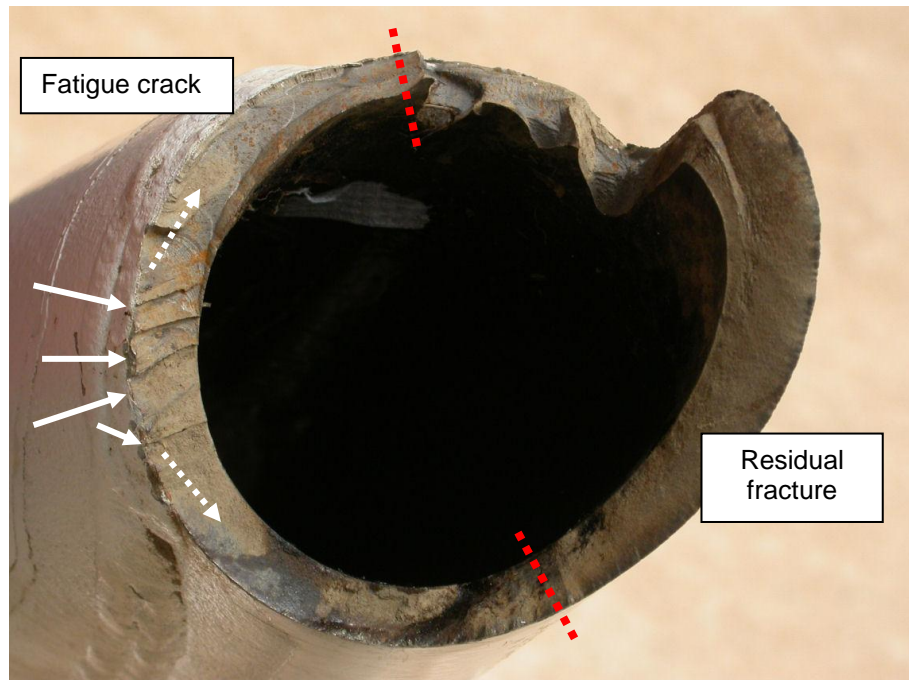
Figure 7. The fracture surface, seen in the direction facing the aircraft fuselage

The arrows in the illustration above show the fatigue fracture starting points and growth. The demarcation between the fatigue and the residual fracture has been marked by red dashed lines.

In the initial area, where the cracking is discoloured by corrosion, there are several hundred beach lines. In the remaining area up to the final fracture the fatigue surface consist of shorter areas showing fatigue, interspersed with areas where the crack has momentarily jumped several millimetres. Before the crack began to grow unstable with momentary jumps, it was about 75 mm long at the outer surface.

The total age of the fatigue cracking is difficult to judge, but probably more than a year for this particular type of flight operation.

There is no sign that corrosion had occurred in the initial area. The discoloration caused by corrosion that can be seen was formed on the fracture surface of the crack.

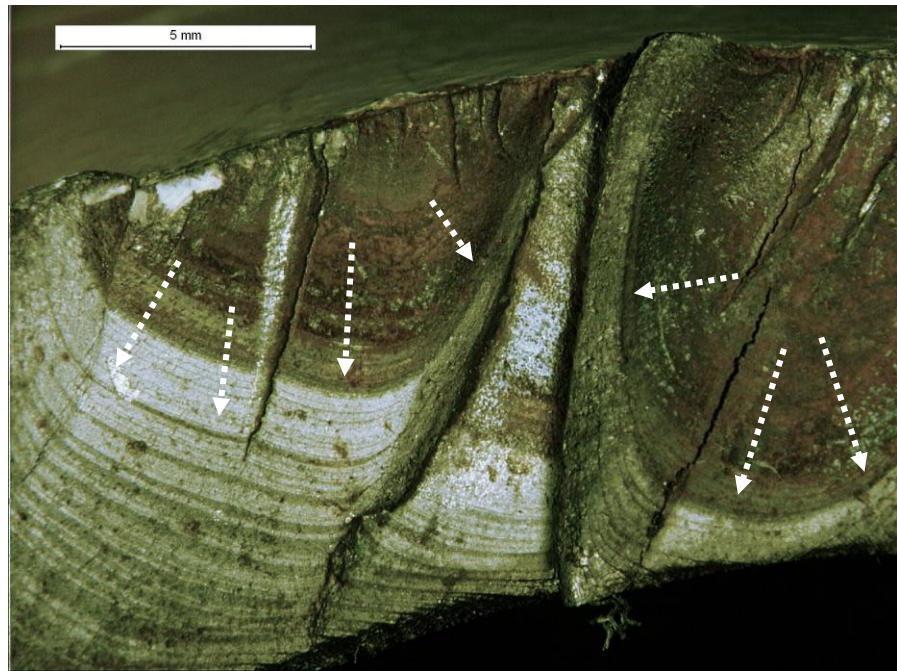
Figure 8. Beach lines on the fracture surface near to the starting point. The local direction of crack growth is marked.
