***Final report RL 2013:01e***

**Incident involving the helicopter SE-JNE  
in Gällstad, Västra Götaland County,  
on 6 February 2012**

Ref no L-12/12  
2013-01-11

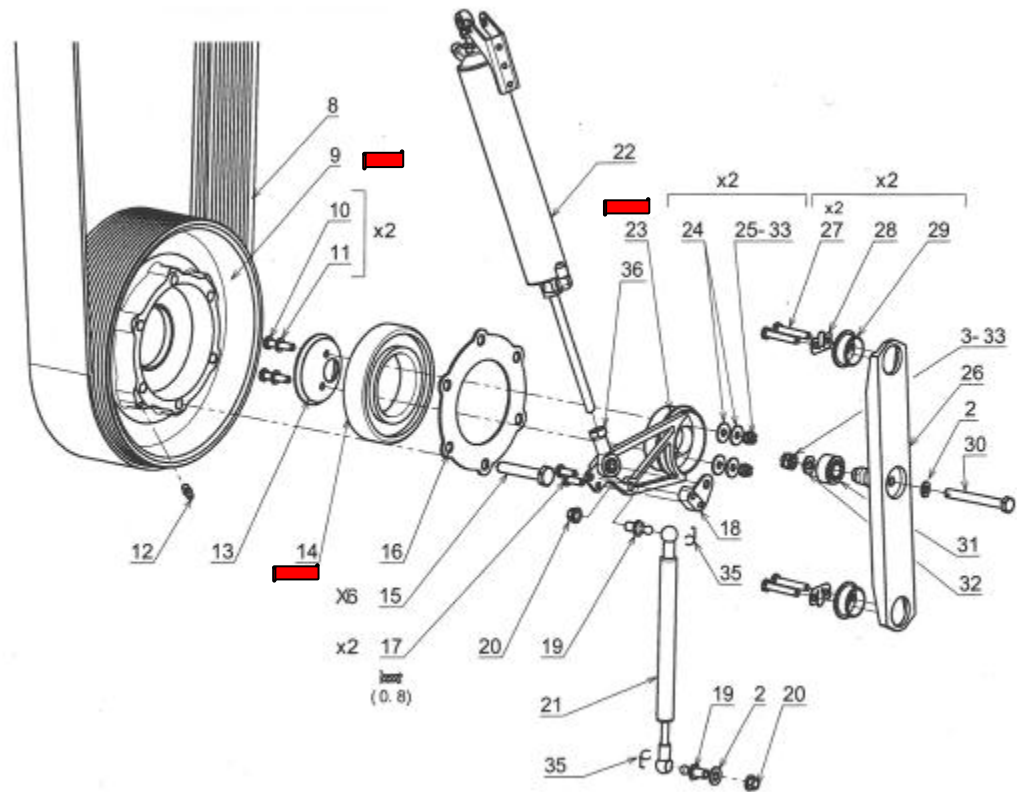
The three parts that SHK has investigated; the lower pulley, bearing and coupling arm (eccentric), are all listed as critical details; in Figure 3 these are marked in red. In the certification process, a number of tests are carried out to

An independent laboratory (Exova) has investigated the pulley pos. 9, ball bearing pos. 14 and eccentric pos. 23, the references to each part relating to Figure 3. The purpose of the examination was to determine, if possible, the origin of the damage. Initially, it was suspected that the ball bearing had been subjected to axial forces of a magnitude that had not been taken into account in the design of the belt tensioning mechanism. The examination did not prove this theory.

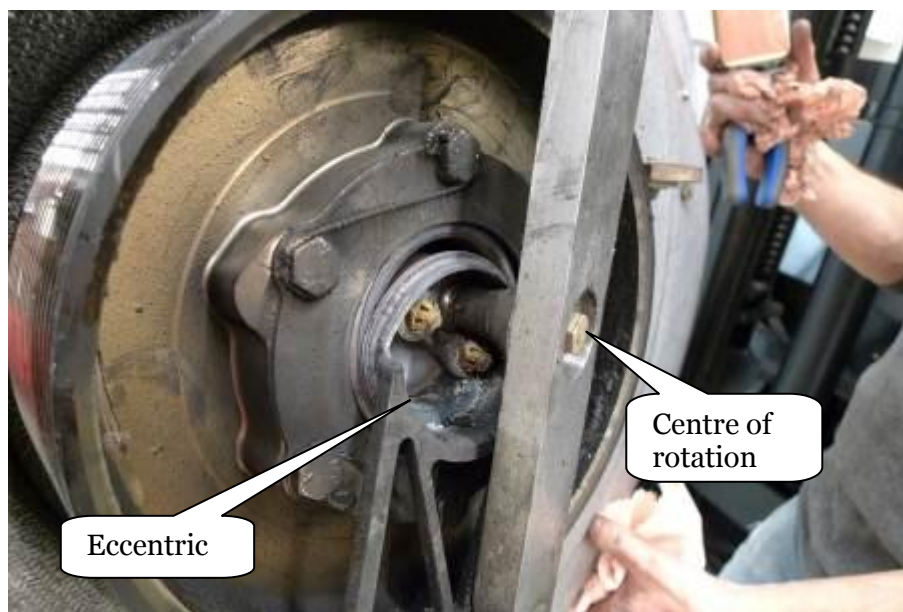
A more detailed examination of the helicopter's drive line demonstrated that the avant-garde front engine mount point had serious damage. The single row deep groove ball bearing that constitutes the engine's front mount had failed. The ball race had been compressed, see Figure 6.

**Figure 4** - The engine pulley with front engine mount and eccentric for the fitting of the drive belt. The vertical bar is fixed in the structure; when the belt is fitted, the entire engine rotates around a point in line with the hexagonal bolt head.

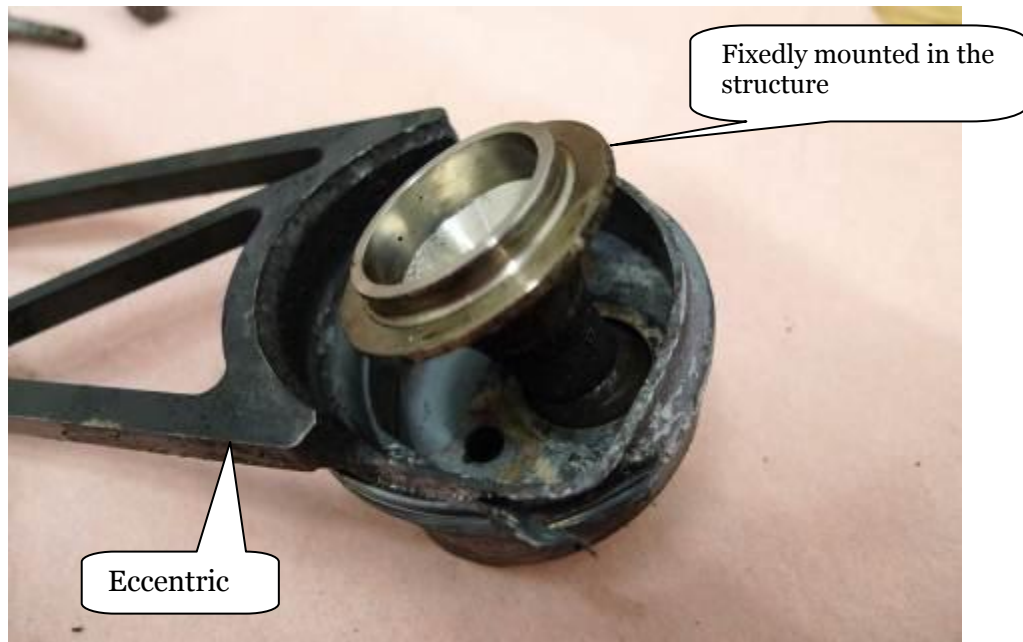
When the bearing had failed, the outer bearing race began rotating in the bottom (engine) pulley. At the same time, the eccentric's support in the inner bearing race began to rotate. The force increased and reached a level so great that the hydraulic cylinder failed to keep the drive belt in tensioned position. The drive belt loosened and started to slip on the drive wheels.

**Figure 5** - Severely heat-affected eccentric; the material has reached the yield point. The black lower part should be circular and lie flush with the ball bearing's inner bearing race.

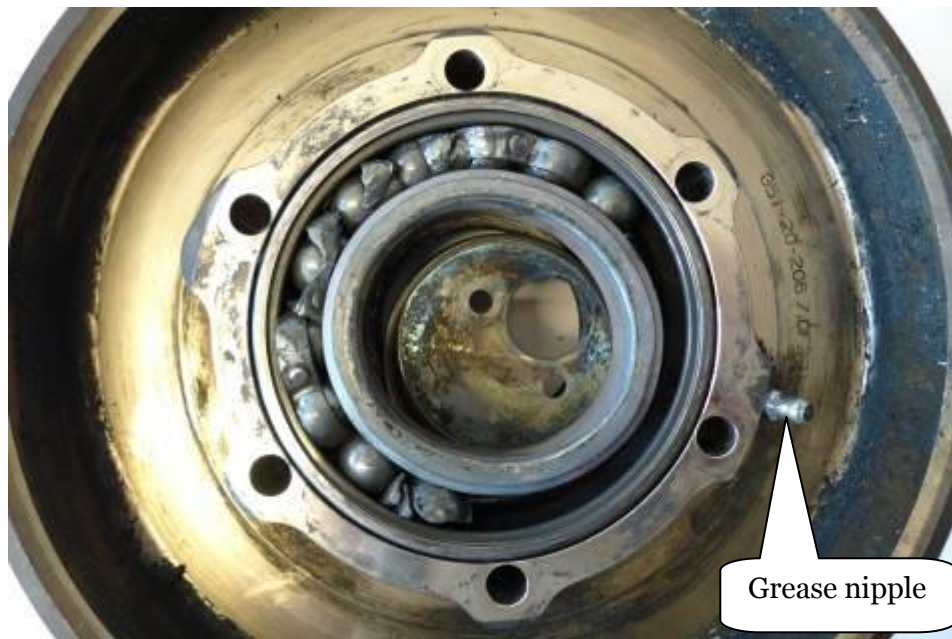
**Figure 6** - The pulley mounted on the engine; note that the ball bearing's inner bearing race is elliptic. The bearing's ten balls have been compressed in a part of the bearing. The ball cage has been damaged, allowing the balls to move so that the distance between the balls is not evenly distributed.

The ball bearing had ceased to function as a bearing. The temperature rise was severe due to the considerably increased friction and the stability of the front engine suspension being breached. According to CS 27X602<sup>6</sup>, the integrity of the engine and the belt drive is, in an extension of the incident, to be classed as hazardous. For this class of critical parts, a “Critical parts plan” is produced.

EASA is recommended to ensure that Hélicoptères Guimbal amends the procedure for the lubrication of bearings with part number HG61-0790 so that at inspections it is possible with certainty to determine that a sufficient quantity of grease has been injected into the ball bearing and at the correct position.

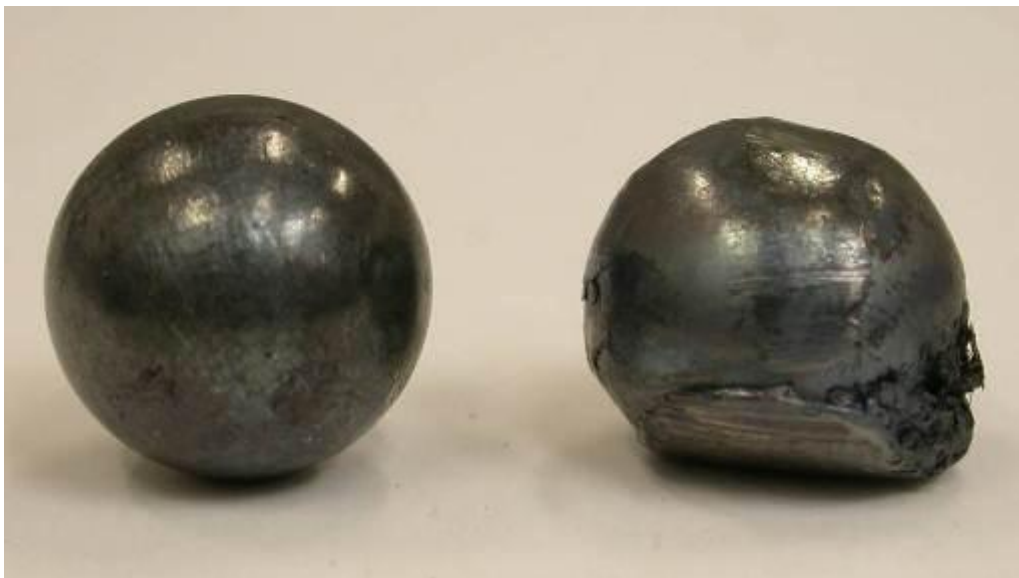
The bearing's inner bearing race has begun to slide towards the centre of the eccentric. The frictional heat has yielded a temperature of over 800 °C, and the microstructure of the material has disintegrated and phase transformation has taken place. The material had been so soft that it had been plastically deformed and pressed radially, outwards over the balls. The temperature has also reduced the hardness of the inner bearing race from about 700 HV to 320 – 370 HV<sup>7</sup>.

**Figure 7** - Reference ball and ball with friction damage (Photo: Exova)

A complete bearing should contain ten balls. All these remained, but one ball exhibited more extensive damage, see Figure 7. This ball has become jammed between the inner and outer bearing races and begun to slide towards the outer race (normally the balls roll). With increasing friction, this ball has gradually ground down the ball cage, allowing the balls to gather in one cluster along a little more than half the circumference of the bearing.

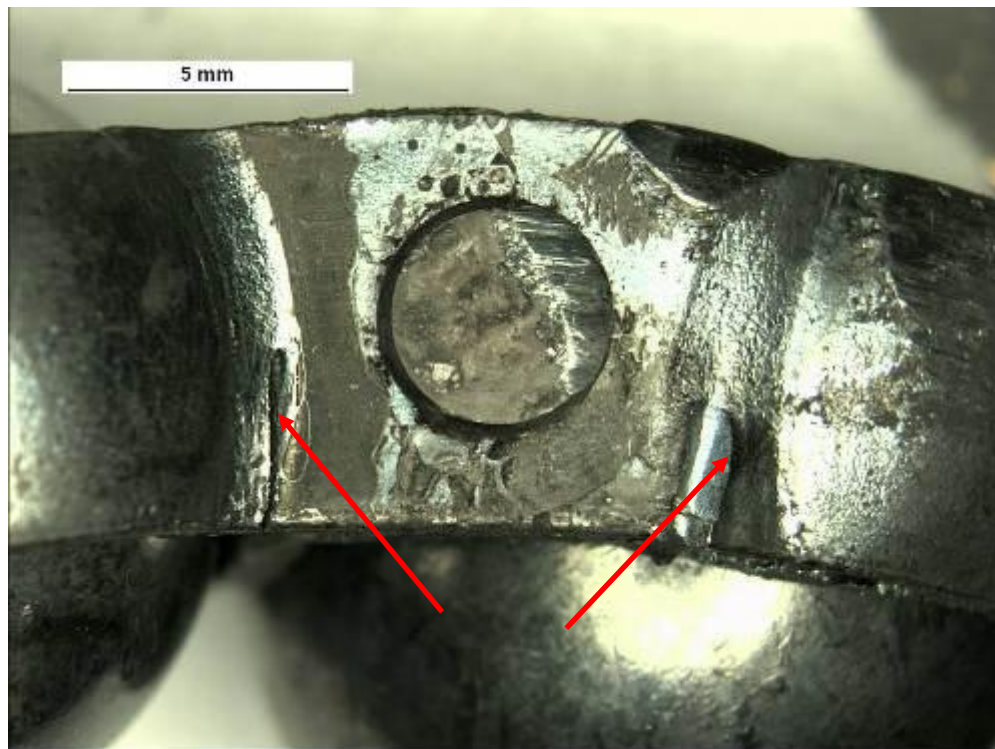
**Figure 8** - Cracks in the ball cage on the back of the rivet (red arrows); the damage is secondary. Note that there were primary fatigue cracks in parts of the ball cage (Photo: Exova).

The jammed ball has also caused the outer bearing race to rotate in the pulley. However, the damage to the outer bearing race is less pronounced than that to the inner race, and the hardness and microstructure of the bearing race have not been affected to the same extent as those of the inner race. Besides the damage mentioned, there are only fatigue cracks/fractures on the ball cage, see Figure 8. Neither typical bearing damage, such as “spalling<sup>8</sup>” in the bearing races, nor axial load, could be substantiated.

- the bearing had overheated due to insufficient lubrication
- the ball cage had failed due to fatigue fractures caused by vibrations
- the bearing had overheated due to excessive play between the bearing's inner race and the coupling arm's eccentric that caused the bearing race to slip and generate heat, the latter sequence, however, being less likely
