**Statens haverikommission**  
Swedish Accident Investigation Board

***Report RL 2009:17e***

**Accident to aircraft D-EBKB at Veberöd,  
Skåne County, on 6 June 2008**

Case L-11/08

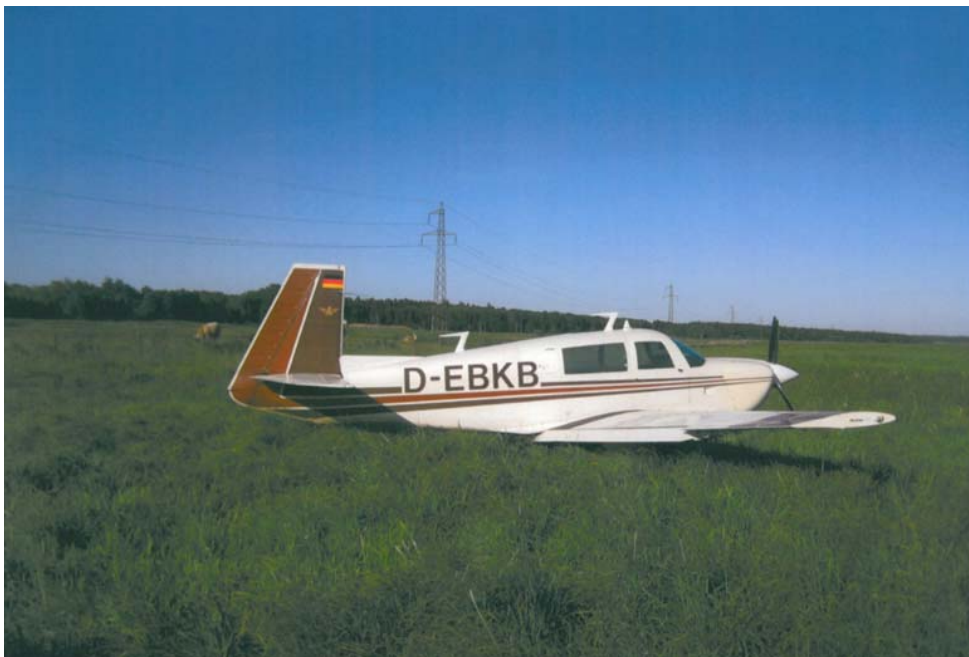
Fig.2. The aircraft after the emergency landing.

The aircraft suffered the following damage in the emergency landing:

- Skin damage to the left wing
- Skin damage to the right tailplane
- Damaged landing gear doors
- Tips of propellers broken off
- Structural damage to the fuselage

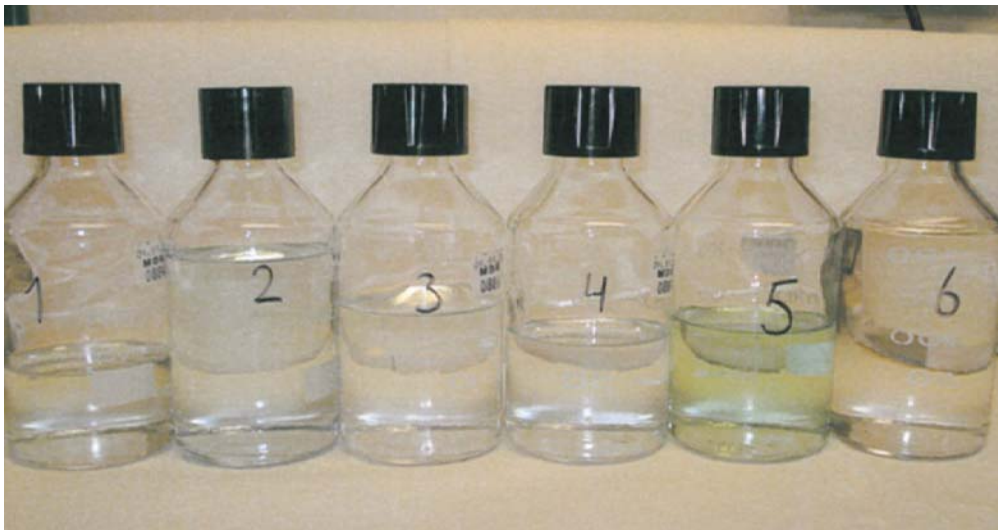
Fig.3. Fuel samples.

While collecting the fuel samples, according to the technician at the site, a fluid layer could be discerned in the sample taken from the injector. The method of taking this sample was to disconnect the fuel line from the servo to the injector and then start the electric pump. The sample contained a clearly visible amount of fluid with a higher density than could be seen at the bottom of the sample bottle.

Due to the variations in the amounts of fuel, the samples were analysed to different extents. Samples 2 and 5 were of a different colour to the other samples, which were all colourless. The analysis of sample 2 (light blue colour) showed that it included leaded petrol, probably 100LL. Sample 3 (blue-green colour) also probably included leaded petrol but the amount of the sample was too small for the lead content to permit analysis.

The analyses showed no abnormal contaminants in any of the samples. Examination of the chemical structure (by means of Gas Chromatography) indicated however some heavier fractions, which could imply a mixture of about 10% road vehicle petrol. The water amounts in all the fuel samples were normal (<50 mg/kg), apart from the sample taken from the injector, where the amount of water was 70 mg/kg.

Taken together, the results of the examination showed that the fuel in the accident aircraft probably consisted of a mixture of three different types of petrol, 91-96 UL, 100 LL and road vehicle petrol.

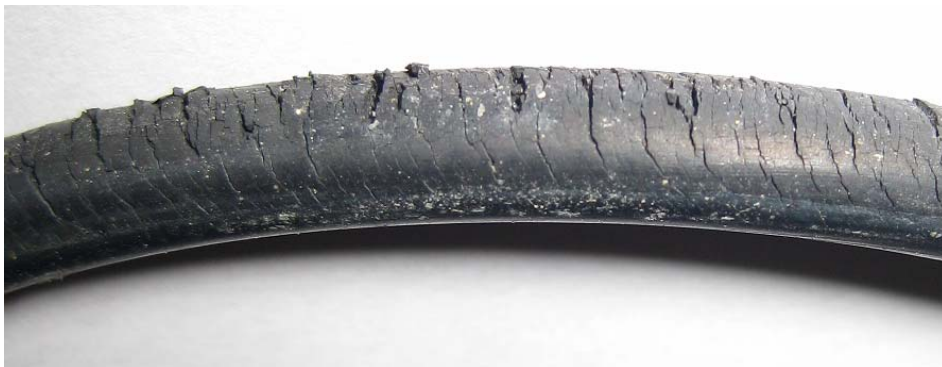
Fig. 4. Right tank filler cap O-ring.

The fit and sealing capability of the filler caps were tested. The left filler cap fit well and water placed in the recess around the cap did not pass through the seal. The right filler cap did not fit so well in its opening and water placed in the recess around the cap made its way quite quickly through the seal and down into the fuel tank.

On checking the condition of the O-ring it was found that it had large drying out cracks and wear. According to the inspection report from the technical maintenance organisation that was responsible for the aircraft, the O-rings had been checked in accordance with AD 85-24-03.

On examination of the aircraft fuel tanks it was found that the filler cap of the right wing tank did not provide sufficient sealing. Water that was placed in the recess made its way in a relatively short time through the seal and down into the tank. Considering the condition of the O-ring, SHK believes that it is unlikely that the measures prescribed by AD 85-24-03 were actually carried out.

The accident was probably caused by deficient maintenance, resulting in an unsealed right wing tank filler cap, which meant that water could have leaked into the aircraft's wing tank.

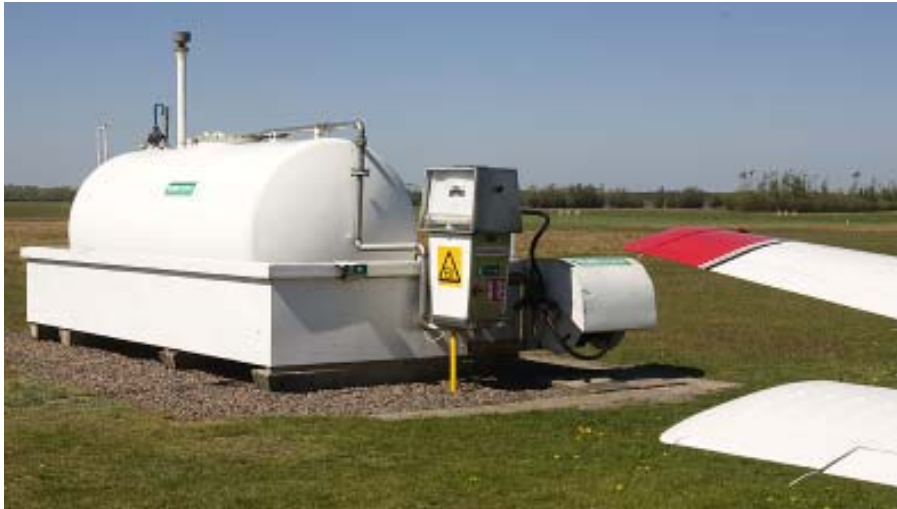
Fig.5. Storage tank installation at Sjöbo/Sövde airfield.

The local flying club at Sjöbo/Sövde airfield is responsible for the operation and maintenance of the storage tank installation at the airfield. The tank is drained once per week and the fuel filter is drained before the first refuelling each day. When fuel is sold, it is the pilot concerned who manages the refuelling him/herself and decides how much fuel to take. It is clearly stated on the installation that the fuel type is 91-96 UL.

The tank is installed sloping down towards the bottom drain, which is located at the lowest point at the rear of the tank. Extraction of fuel - i.e. when aircraft are being refuelled - takes place through a float inside the tank.

From the flying club refuelling and draining diary for that particular day it can be read that the filter had been drained that morning and that other aircraft had refuelled before and after the accident aircraft was refuelled.
