Statens haverikommission
Swedish Accident Investigation Board

Report RL 2009:18e

**Incident to Aircraft LN-RPA at Luleå/Kallax
airport, Norrbotten county Sweden, on
27 February 2007**

Case L-02/07

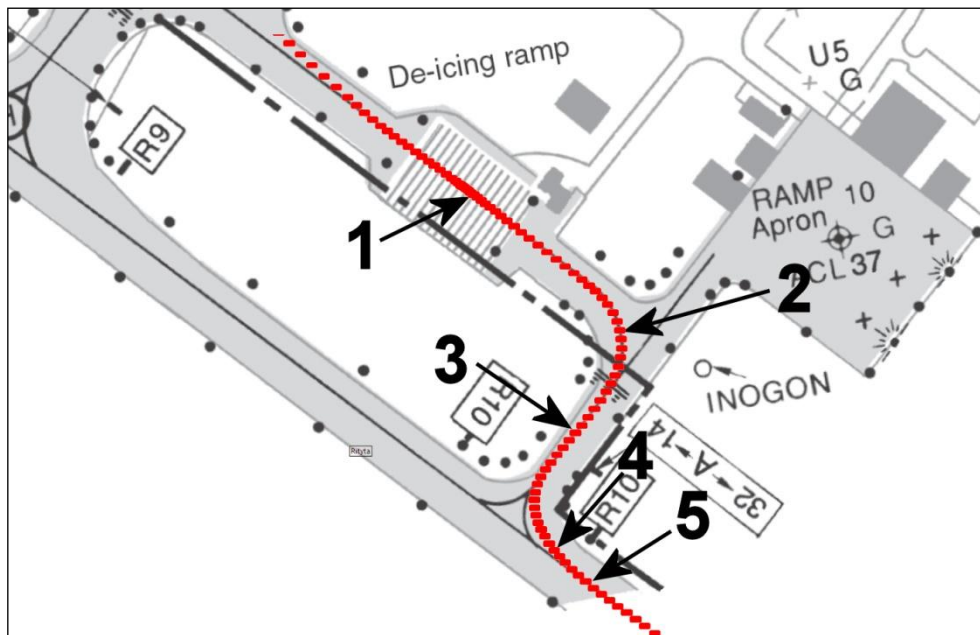
Figure 4. Taxi route according to the QAR, and locations while communicating

The numbers in the above illustration correspond to selected parts of the radio communications in accordance with the table below. The arrow heads indicate when transmission was started:

Another fact that indicates there was a certain amount of stress was the speed of taxiing from the de-icing ramp to the take-off point. On the straight part of taxiway A the average speed was 17.5 knots. On a non-slippery surface this would be a normal speed, but in the prevailing conditions that were present, this speed could be considered rather high. During the initial part of the 180 degrees turn towards the runway the speed was still relatively high, decreasing while in the turn to 7.5 knots. This speed must also be regarded as high for a turn in slippery conditions. Taxiing was not halted when the aircraft entered the runway, but continued to a rolling start. In addition to this procedure, suggesting a degree of urgency, it also reduced the possibilities to perform the procedures that according to the company should be made before take-off.

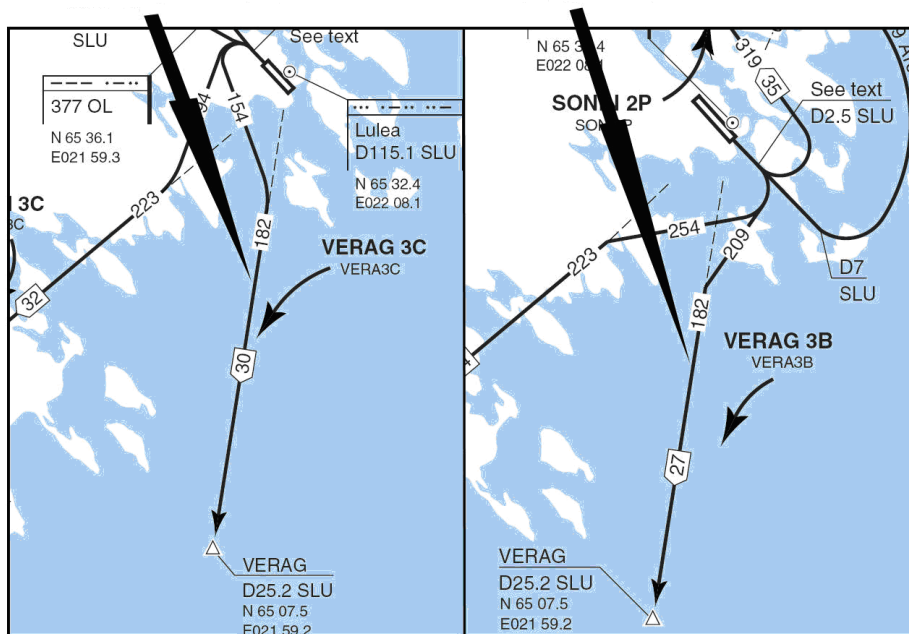
Figure 5. Departure routes (SID) to the south when taking off from runway 32 (left), and from runway 14 (right)

The SID SK001 flew along
take-off from runway 32

The SID SK001 was cleared to
fly along with runway 14

1. Check of clearance. The barrier was broken as the clearance did not correspond with the planned route. A contributing factor to that was probably the difference between the names of the two SID's only consisted of single letter.

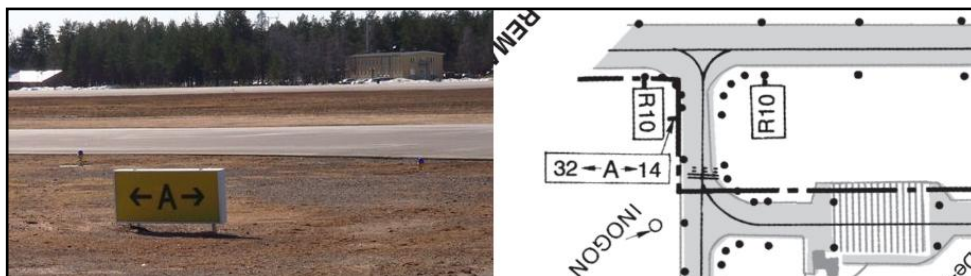
Figure 6. Sign at taxiway R10

Figure 6 below at the left shows what the actual sign looked like placed by taxiway R10, at its left side, just before taxiing out on to taxiway A. SK001 passed this sign immediately after de-icing was completed, and at about the same time as the co-pilot was receiving the clearance to Stockholm/Arlanda. , The illustration to the right is from the AIP.

The description of the sign in the AIP does not correspond with the sign's actual layout.

AIP has been revised with regards to signage at Luleå /Kallax Airport, documentation is now in accordance with actual conditions.

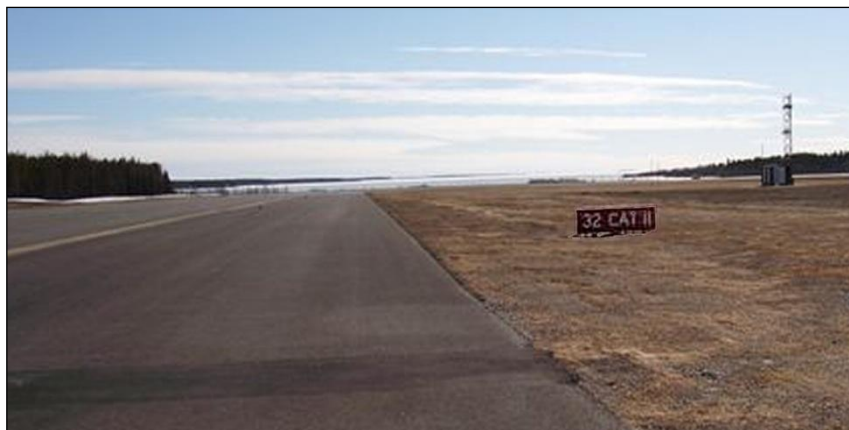
Figure 7. Holding position for runway 32 in CATII conditions below shows the sign that is located by taxiway A close to intersection A7 (at the full length of runway 32). When CATII²⁰ is in force, this is the "holding position" for runway 32.

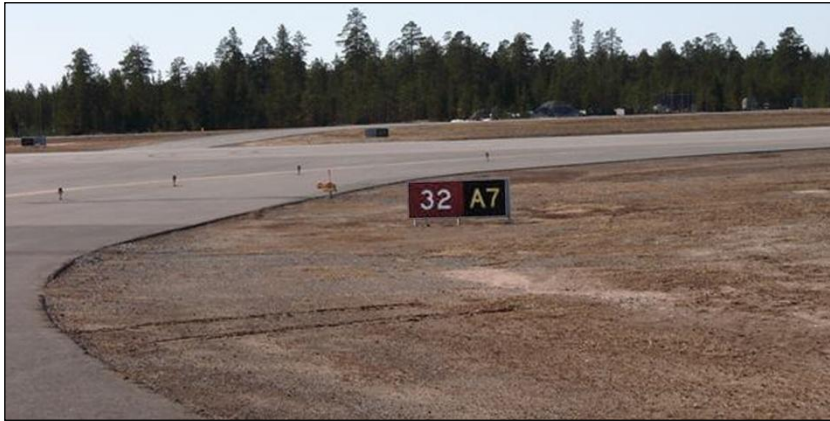
Figure 8. Sign at runway 32, full length
below shows the sign just before entering runway 32, full length.

There are no stop bars at any entry point to the runway. A stop bar is a row of red lamps submerged into the taxiway that can be lit or extinguished from the control tower. A row of lit red lamps may not normally be passed by an aircraft, until they have been turned off from the control tower.
