Report RL 2001:31e

***Accident involving helicopter SE-JCA
at Vidsel airport, BD county, Sweden,
on the 7th of May 2001***

Case L-020/01

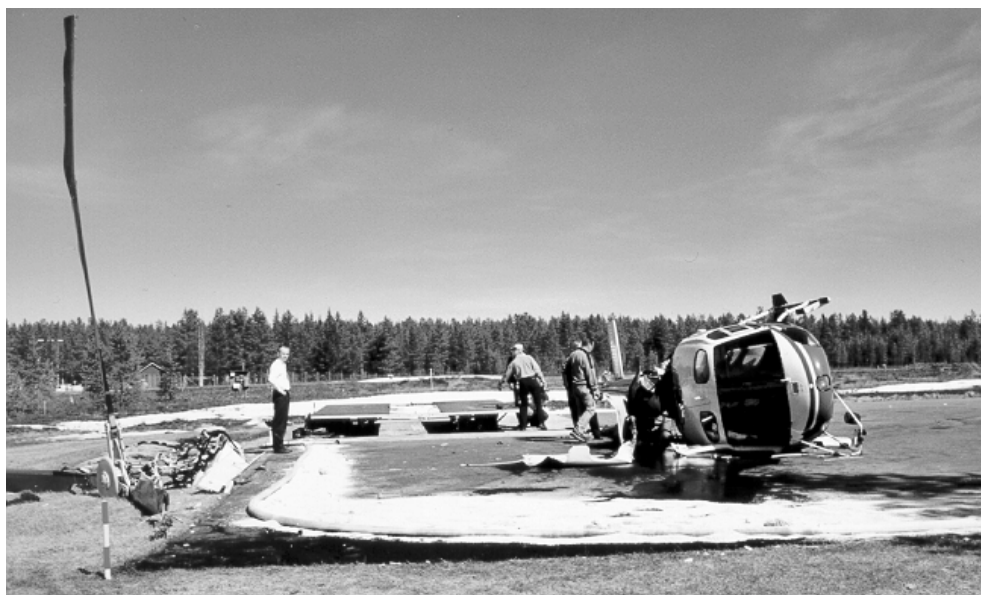
After the accident the helicopter was lying on its right side and facing in a direction of approximately 240°. The tail boom of the helicopter was about one and one-half meters from the left side of the forward edge of the landing trailer. The engine mounting was battered. The transmission and the main rotor had separated from the helicopter and came to rest approximately six meters north of the aircraft. The tail rotor had separated from the tail boom and came to rest about one meter from the right rear edge of the helicopter-landing trailer. Helicopter parts of diverse sizes were lying spread around the helicopter within a circle with a radius of approximately 20 meters.

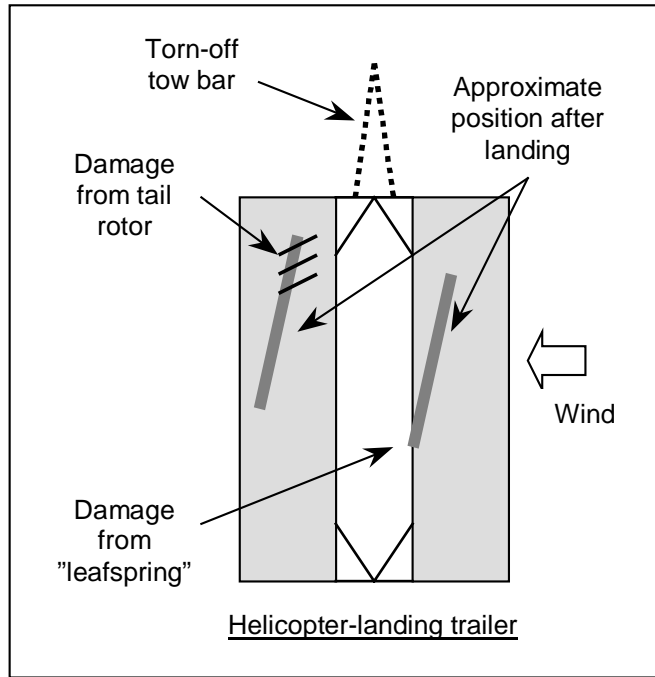
The trailer's tow bar was torn-off and was found approximately 25 meters from the trailer. Damage to the landing bed of the trailer was indicated by impact marks from the tail rotor and abrasion marks from the helicopter's landing gear flexible steel strip, as depicted in the sketch below.

Based on testimony from the pilot and the indicative damage on the trailer, the approximate position of the helicopter on the trailer after the initial landing has also been included in the sketch. The wind direction was variable, but primarily contacted the trailer from the right side.

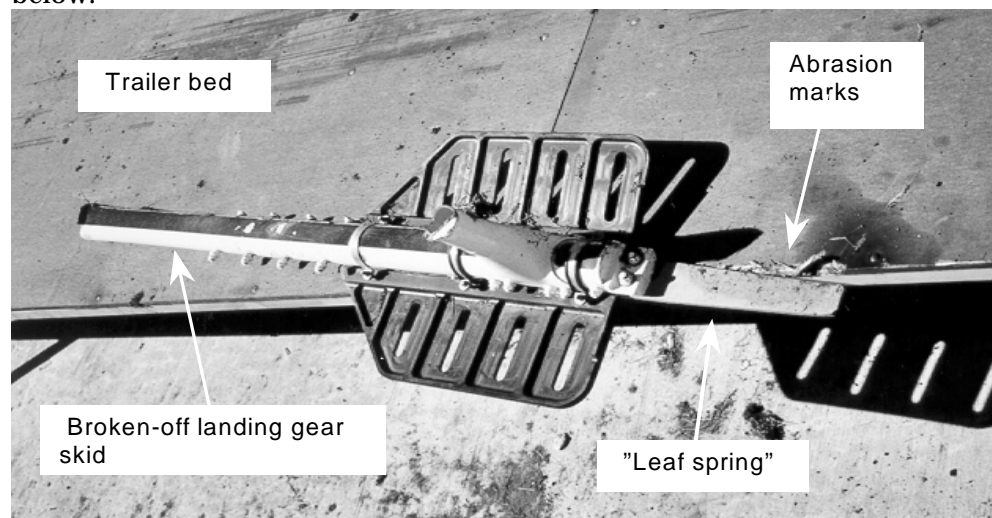
The landing gear of the helicopter was equipped with so-called Flexible Steel Strips. These consist of approximately 30 cm long "leaf springs" which are mounted on the aft edge of the landing skids. With no load on the landing gear these leaf springs extend somewhat downward in relation to the skids. The purpose of the springs is to reduce the risk of spontaneous turning in connection with landing on a rigid surface. Damage to the bed on the helicopter-landing trailer indicates that the leaf spring on the right-hand landing skid caught on the bed, which is depicted in the picture below.

The pilot's intention was to correct the parking position of the helicopter on the trailer by hovering upwards, yawing somewhat to the left, and then setting the helicopter down on the trailer again. During the ascending hover the downward pointing flexible steel strip on the right-hand landing skid caught on the edge of the landing bed. Upon landing, the flexible steel strip happened to end-up outside of the landing bed surface. Its becoming caught was probably due to the fact that the pilot was already applying left rudder during the ascending hover in order to adjust the parking position. It cannot be ruled out that he, in addition to this, reflexively applied additional left rudder to compensate for the rotor torque during the ascending hover, which is the normal procedure for helicopters with counter clockwise rotating main rotors, i.e. the type helicopter he was most used to flying. As a result, during the ascending hover, the flexible steel strip was partially affected by a lateral force that counteracted the yaw to the left and partially by a friction coefficient that held the landing skid down.

Therefore, when the flexible steel strip freed itself from the edge, the helicopter suddenly began to yaw rapidly to the left. The pilot was taken unawares by the sudden yaw and everything points to the fact that at this point, he did not apply right rudder rapidly enough and with sufficient deflection in order to arrest it.

Landing a helicopter on a helicopter-landing trailer is a demanding precision maneuver, especially if the landing bed is small in proportion to the helicopter. In the case at hand the total surface area of the bed was certainly large, but it was divided-up into two smaller surfaces with an approximately 0.9 meter wide empty space between them, a fact that must be considered unsuitable from the standpoint of flight safety. In this case the empty space resulted in the ability of the downward pointing flexible steel strip to become fastened on the edge of the bed. Generally speaking, a helicopter-landing trailer, besides being sufficiently large and stable for the actual helicopter type, should have a landing bed surface that is entirely covered and designed so that minimal risk of entanglement exists.

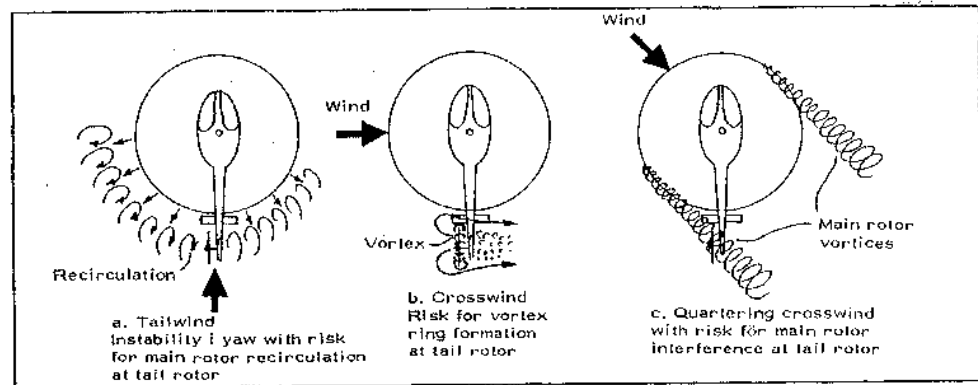
With a quartering crosswind from the front, tip vortices from the main rotor blades are driven rearwards to the tail rotor and cause so-called vortex interference, which diminishes the tail rotor's effectiveness. On helicopters whose main rotors rotate counter clockwise the risk of this

originates principally from a quartering crosswind from the left. On helicopters whose main rotors rotate clockwise a similar risk applies with a quartering crosswind from the right.

Contributory to this could have been, that initially during maneuvering the helicopter was in a right-quartering crosswind situation and as such was in a flight situation, that according to section 1.18.1 involves the risk of aerodynamic disturbance of the tail rotor function, with temporary diminished yaw control as a result. As is evident from this section, helicopters with clockwise rotation of the main rotor— as in the case of the helicopter in question— can be sensitive to right-quartering crosswind. The situation could also have been worsened when the helicopter entered a tailwind situation after 90 degrees of turn.
