**Statens haverikommission**  
Swedish Accident Investigation Board

## ***Report RL 2007:15e***

### **Accident with helicopter LY-HCS at Heby, U county, on 21 June 2005**

Case L-18/05

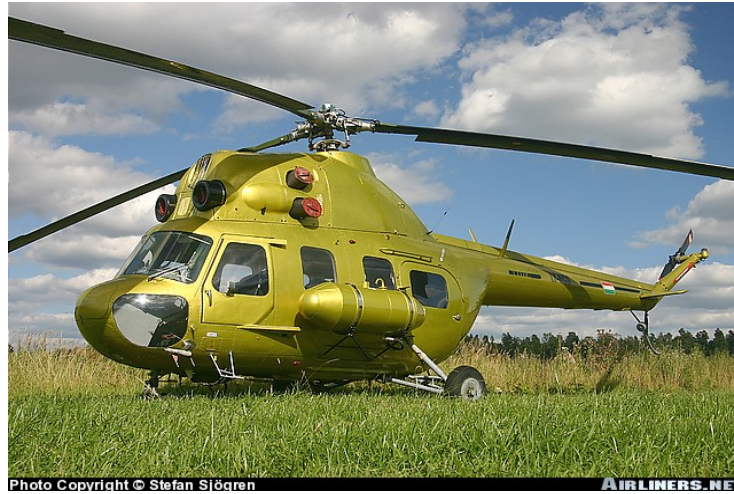
*Photograph 1. The helicopter concerned*

The helicopter was equipped with extra fuel tanks, one on either side, outside the body. Photograph 1. It was also equipped with dual controls.

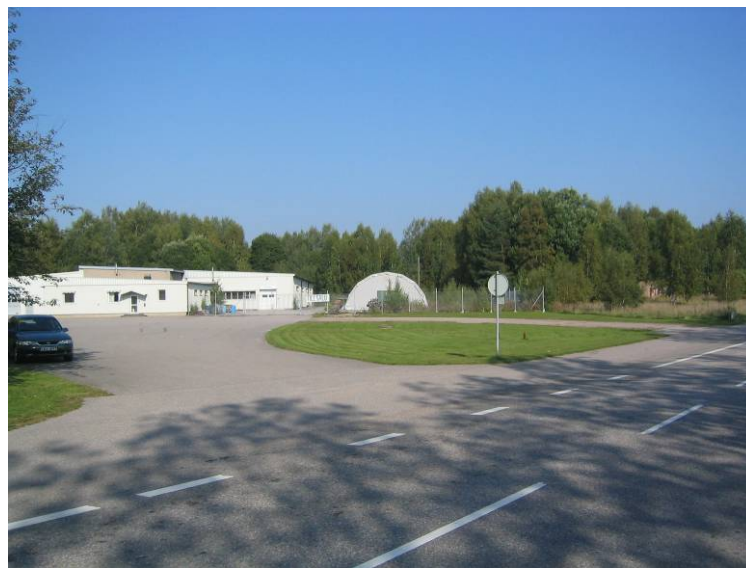
*Photograph 2. The take off area, taken against the direction of travel*

The site consists of an take off area, intermediate terrain and accident site. The take of area was an asphalted area outside a vacant factory building, photographs 2 and 3. The accident site was on an asphalted road surface in the Heby community and an adjacent grassed area, photograph 4. The intermediate terrain is the same road with street lighting poles and street trees, photographs 3 and 4. A nursing home, the vacant factory and private houses are nearby. SHK has taken measurements at the take off area, these being given in photograph 5<sup>9</sup>.

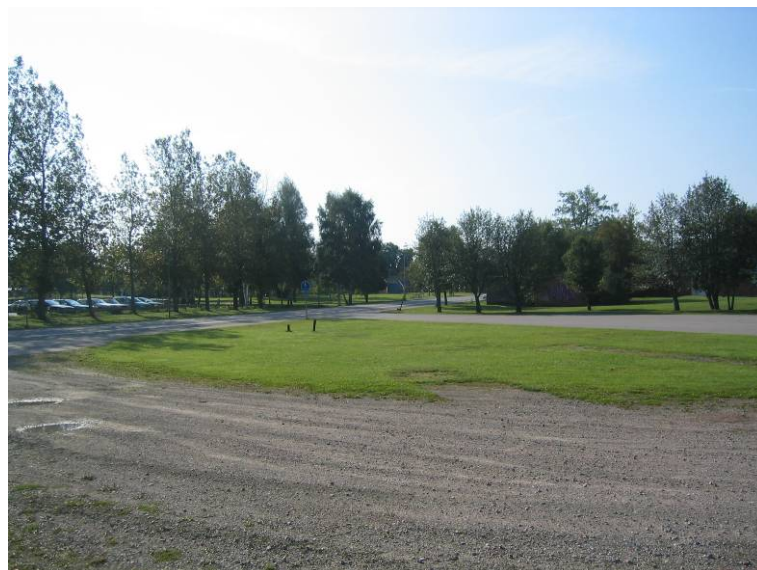
*Photograph 3. The take off area, taken in the direction of travel*

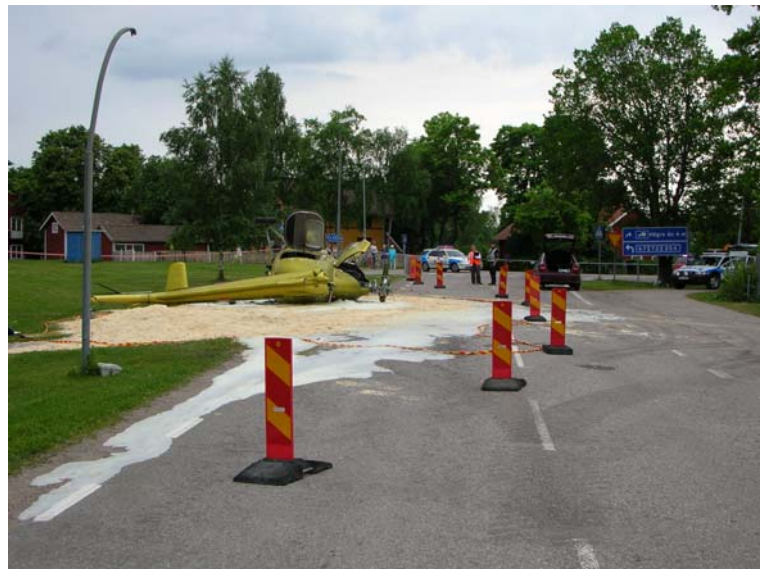
*Photograph 4. The final position of the helicopter*

After the accident, the helicopter came to rest on its right side. Fuel escaped and was ignited. See 1.14 below. The main rotor was completely wrecked and its pieces scattered. The tailboom was considerably damaged.

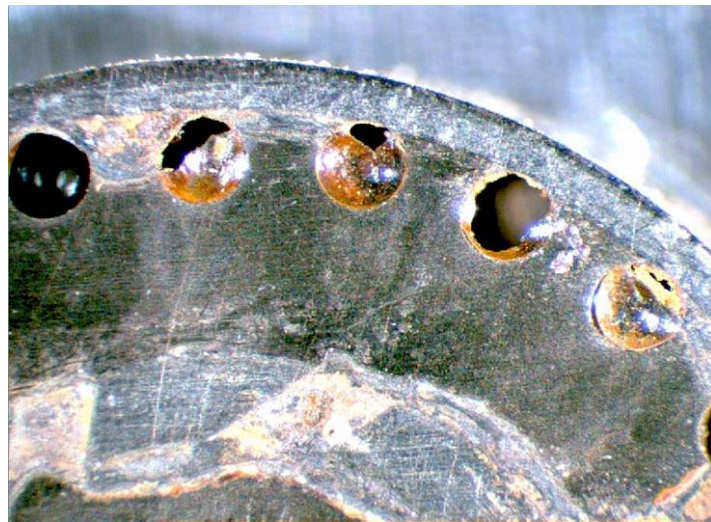
SP Sveriges Tekniska Forskningsinstitut AB<sup>11</sup> have investigated the fuel injection system in the engines and discovered foreign material in the channels in the injection nozzle of engine no 2. This had partly obstructed the nozzle, photograph 6. It consisted mainly of corrosion products which adhered firmly to the insides of the channels.

*Photograph 6. Part of the injection nozzle showing foreign material*

The entire fuel injection system has been tested by the engine manufacturer PZL-Rzeszow. They estimate that the maximum possible fuel flow in one of the engines was reduced by approximately 50 % by the deposits of foreign material.

The reduction in the available power from one of the engines must have had a decisive effect on the capacity of the helicopter to accelerate and climb. The loss of power had its cause in the part-obstruction of the fuel injection nozzle. This had its origins in corrosion in the channels of the nozzle. SHK considers that these could not have been obstructed suddenly and in connection with the accident but must have reasonably become clogged gradually as corrosion developed.
