Factual Report

Type of Occurrence:	Serious incident
Date:	30 September 2005
Location:	East of Frankfurt/Main
Aircraft:	Airplane
Manufacturer / Model:	Boeing / B 737-300
Injuries to Persons:	None
Damage:	None
Other Damage:	None
Information Source:	Investigation by BFU
State File Number:	BFU 5X018-05

During approach to Frankfurt/Main Airport the airplane was subject to rolling motions; initially 23° to the right and then 62° to the left.

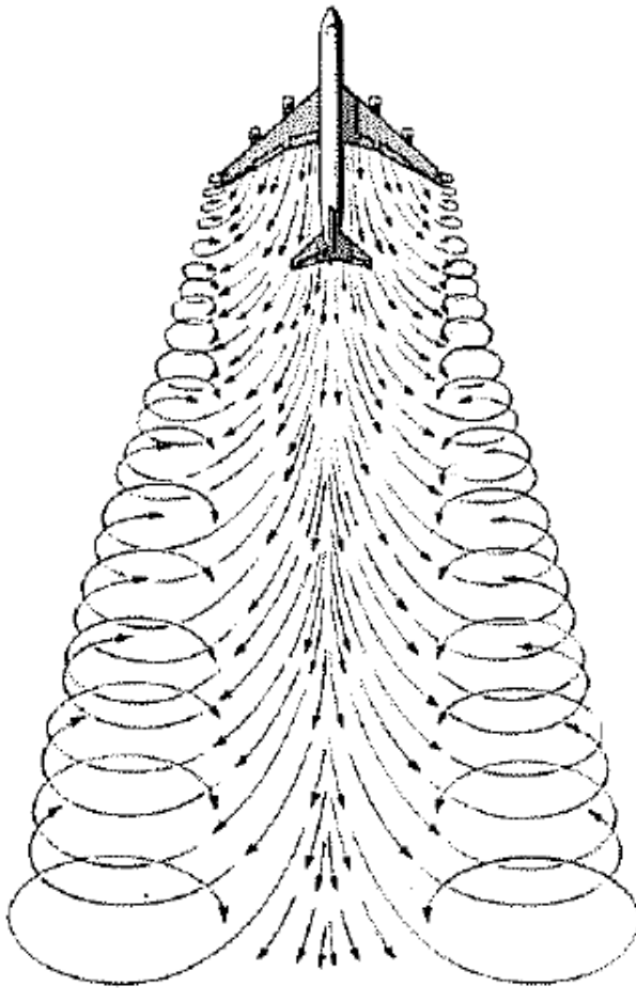
Der Aufrollvorgang

The lift is generated by creation of a pressure differential over the wing surfaces. The lowest pressure occurs over the upper wing surface. On the upper wing surface the air flows inward from the wing tip toward the fuselage. The highest pressure therefore occurs in the middle of the wing lower surface. There the air flows outwards from the fuselage toward the wing tip. The resulting circulation and the downwash effect above the wing cause air turbulence at the wing trailing edge which rolls up in a spiral pattern at the wing tip. After the rolling-up is complete the wake turbulence of an airplane consists of two vortexes rotating against each other.

Any airplane causes wake turbulences during the flight. They consist of a pair of wake turbulences originating at the wing tips, rotating against each other. The lift is responsible for the generation of the turbulence and the resulting wake turbulence.

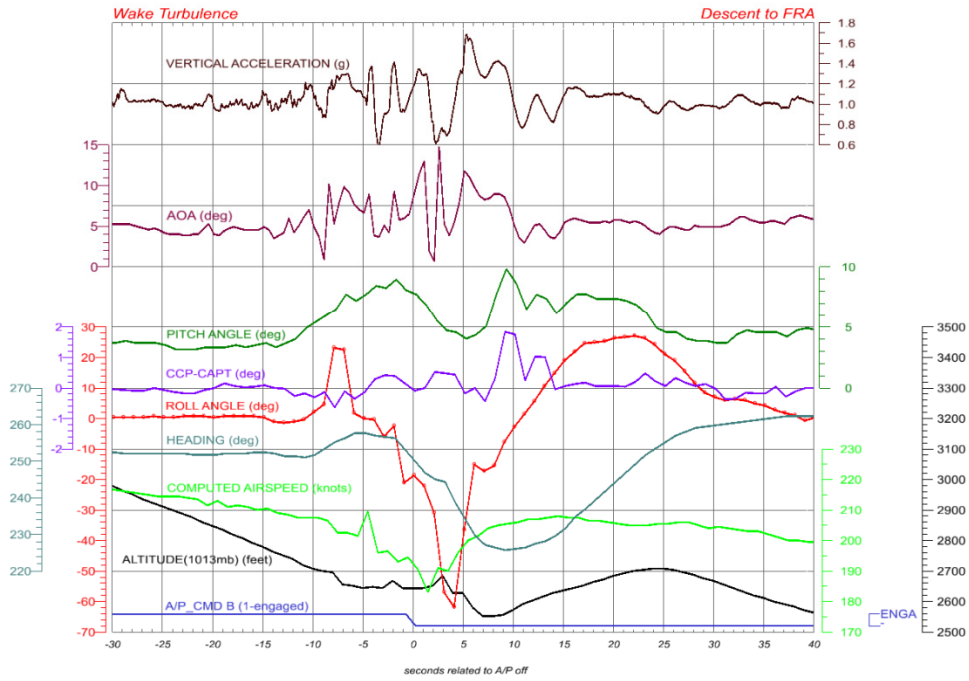
Image 1: FDR-Data B737

Based on the FDR data, Image 1 (Appendices) depicts the situation prior to and after the disengagement of the B737 autopilot. Initially the airplane rolled 23° to the right and then within 11 seconds 62° to the left.

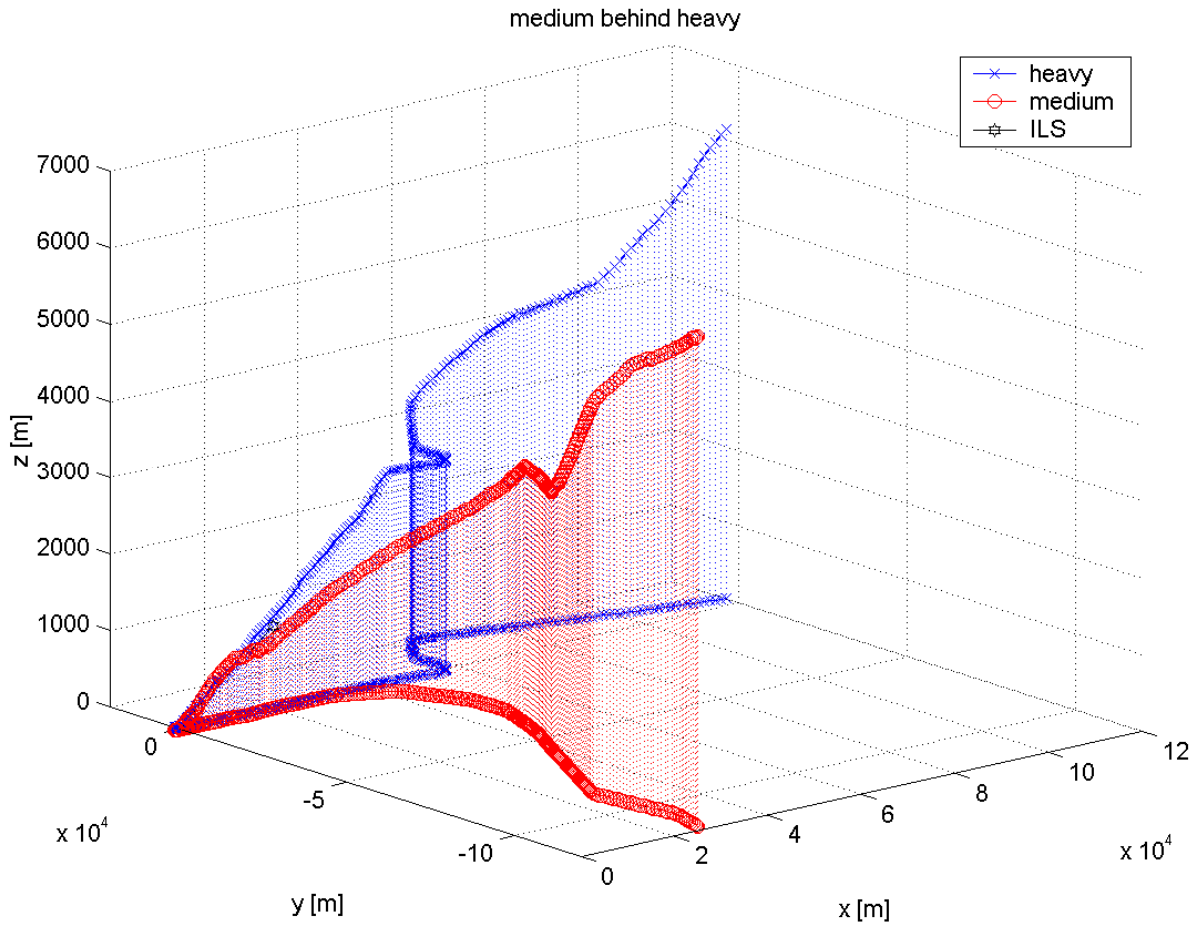
Image 2: 3D Flight path overview, B737 (red o) following B747 (blue x)

The Images 2 and 3 (Appendices) depict the 3D images of the approach sequence and the flight path above ground. The last 11 NM of the ILS flight path are depicted in black. The significant flight path deviation of the B737 at the beginning of the final approach characterises the place where the serious incident occurred.

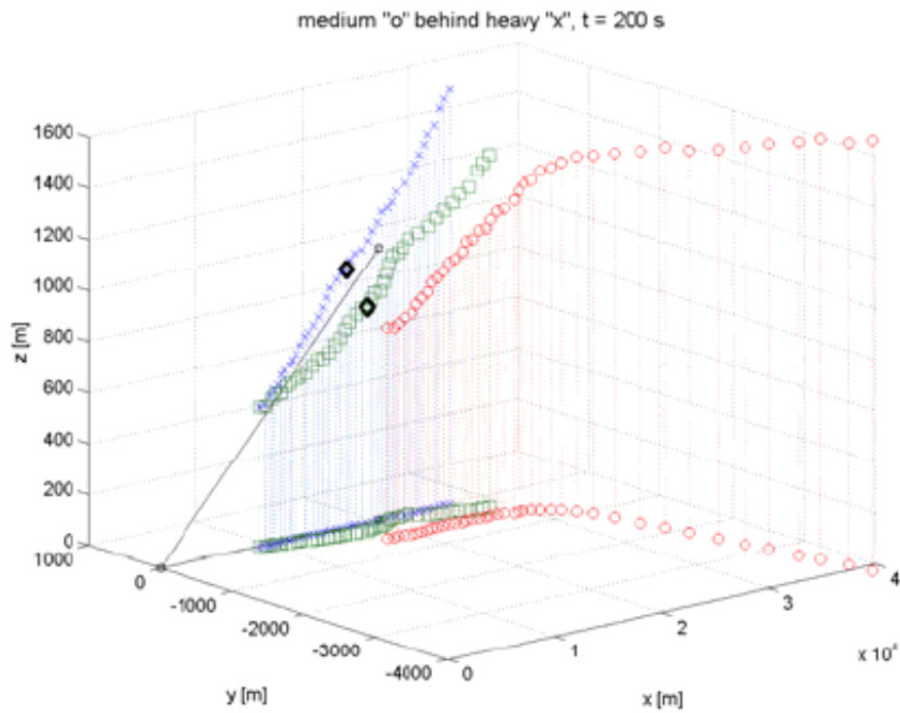
Image 4: 3D View of the flight paths and the wake turbulence position

Image 4 (Appendices) depicts the 3D image of the flight paths of the two airplanes at the moment the autopilot of the B737 had been disengaged. The wake turbulence of the preceding B747 is marked green. Images 5 and 6 (Appendices) depict the side view and the flight path above ground. The variance of the wind data caused the bumpy course of the wake turbulence graph. A "black diamond" indicates the area of the wake turbulence closest to the succeeding airplane at the time the autopilot was disengaged. The area where the wake turbulence was generated is also marked on the flight path of the preceding B747.

Due to the wind conditions the wake turbulence drifted to the flight path of the B737 approaching the parallel runway. Due to the higher altitude of the B747 (above the ILS) the wake turbulence descended toward the B737 approaching the glideslope below the ILS. Based on the simulation the distance between the wake turbulence and the B737 was estimated as 48 m vertically and 273 m laterally. The resulting circulation of the wake turbulence at an age of 99 s was then 380 m²/s. For a category Medium airplane this is strong wake turbulence which can cause this particular reaction if encountered in relevant distance. Based on the layout of the runways, the prevailing wind direction, the estimated distances, and the inaccuracy of the prevailing wind data, it can be assumed that the succeeding airplane had come close to strong wake turbulence or had encountered it.
