# Aircraft proximity event – Piper PA-34, VH-PWQ and Cessna R182, VH-JYG

Avalon airport, Victoria, 22 May 2012

**ATSB Transport Safety Report**  
Aviation Occurrence Investigation  
AO-2012-071  
Final

**Report No.** AO-2012-071

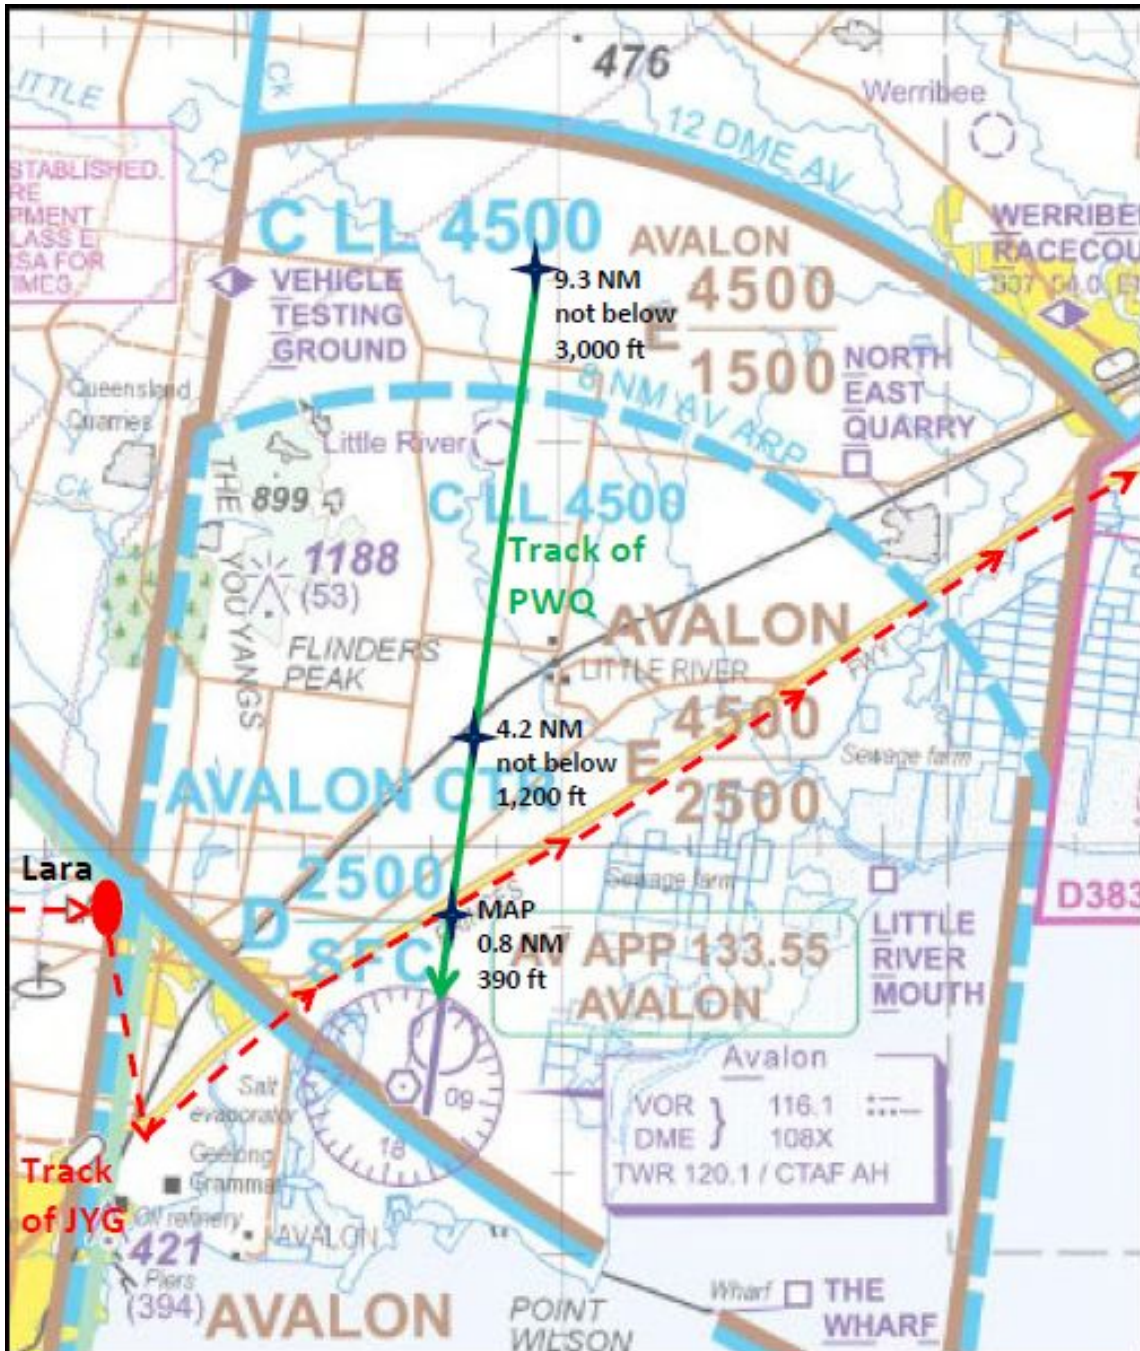
At 1607, the pilot of JYG reported sighting PWQ and, believing that a collision risk existed, transmitted he would '... climb to get out of the way.' The airprox<sup>7</sup> occurred at 1608 when the aircraft passed within 0.1 NM and 100 ft of each other.

Figure 1: Track of JYG (broken red) and PWQ (solid green) with ILS distances and heights (black text)

Traffic information must be concise, but it needs to include enough relevant reference information to enable the pilot to determine if action is required to avoid conflict. The recent amendments to MATS provided more detail on the provision of safety alerts in all classes of airspace and on when to issue avoiding action within surveillance coverage.
