Interim Report

| Date: | 15 February 2013 |
| Manufacturer / Model: | Embraer / EMB-500 |
| State File Number: | BFU CX001-13 |

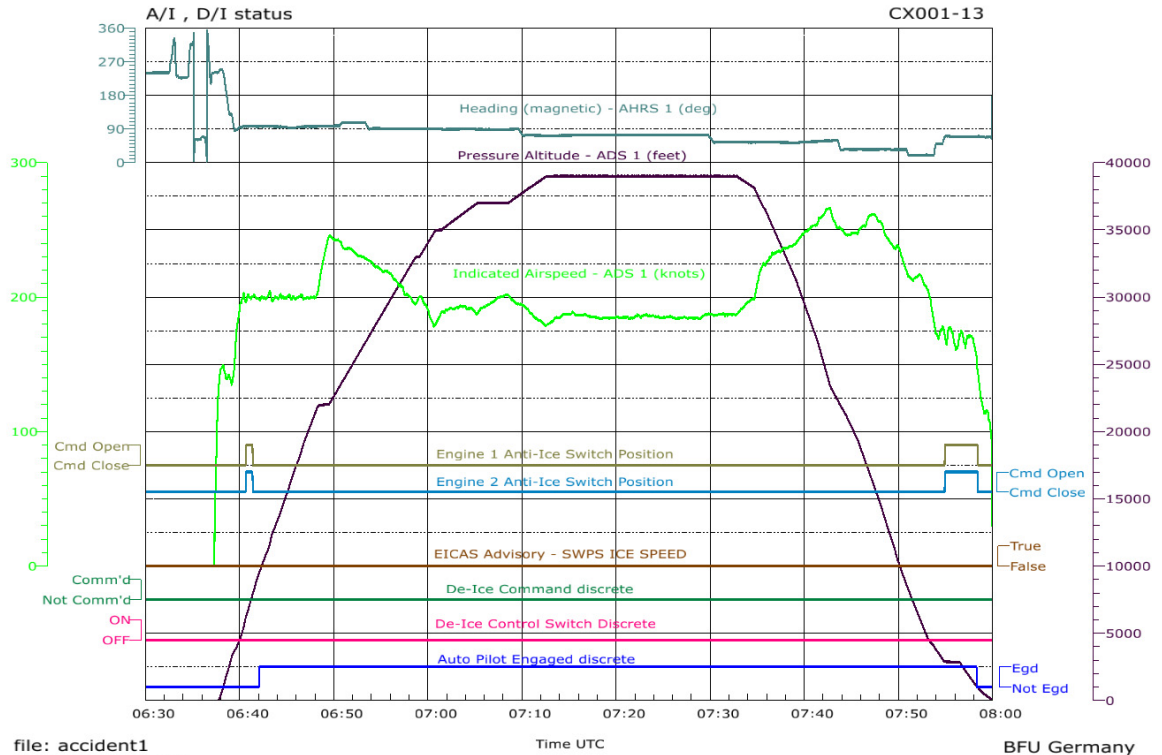
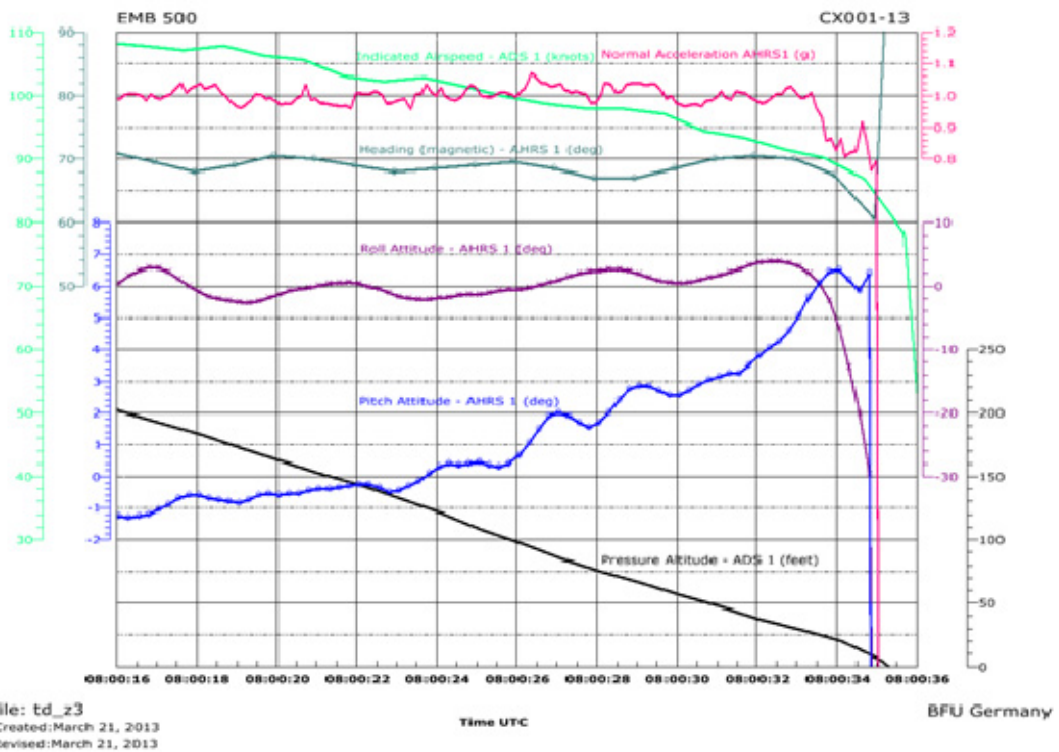
Excerpt flight data recorder data

According to the flight data recordings, at 0742 hrs while the airplane was in Flight Level (FL) 70 in climb the engine anti-ice systems of both engines were activated for 46 seconds. Forty seconds later the autopilot was activated. At about 0813 hrs the airplane reached FL390. Twenty minutes later the aircraft began to descend.
