Final Report

CX002-0/01
Mai 2003

Type of Occurrence: Accident
Date: 08. February 2001
Location: Nürnberg / Germany
Aircraft: Airplane
Manufacturer, Model: Learjet LR35A
Injuries to Persons: Fatal
Damage: destroyed
Other Damage: minor

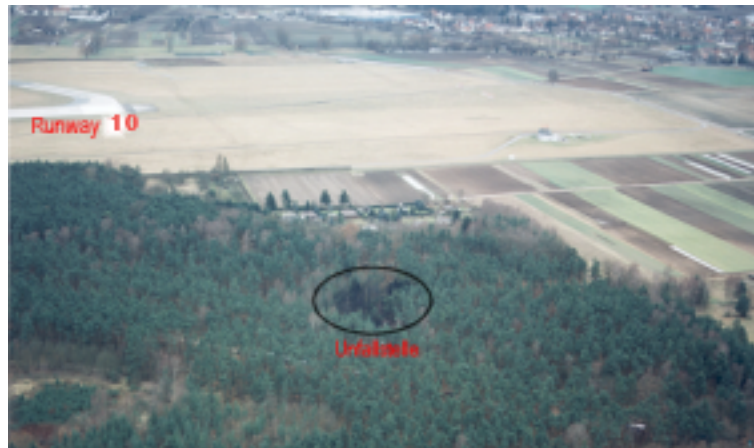
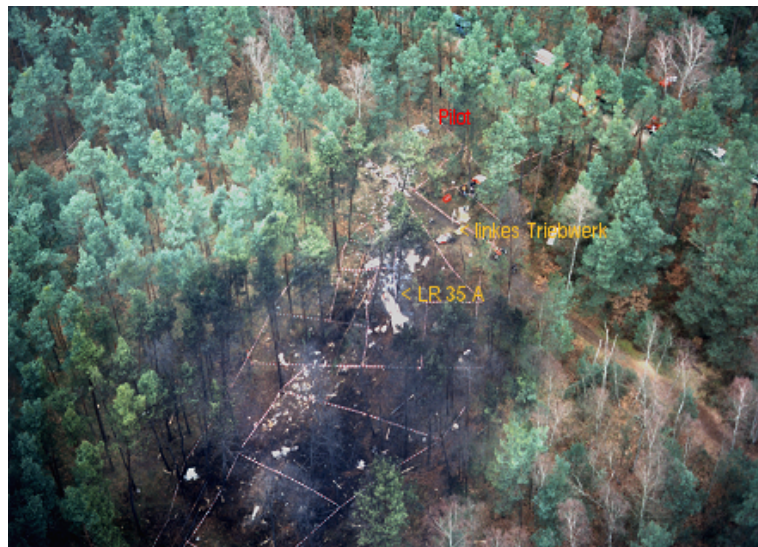
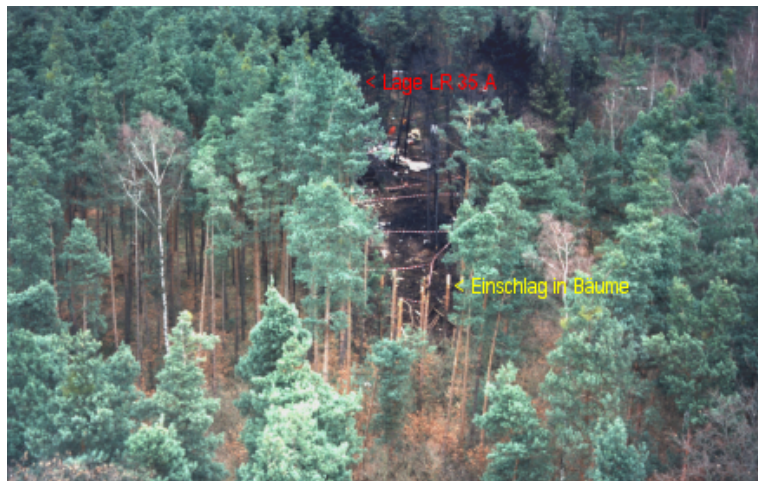
The fuselage of the airplane had been destroyed by the ground impact and the subsequent fire. The tail section was heavily damaged. The horizontal tail had been torn off and was found under the left-hand wing. These parts, however, were not damaged by the fire. For the most part the rudder and trim positions could be determined. The rudder trim was observed to be in a centered position. The flaps were in a position between sixteen and twenty degrees. The flap lever in the cockpit was set to 20 degrees.

The left main landing gear was down and locked. The right main landing gear and nose wheel assembly were torn off their attachment points. The gear lever was in the down position.

The left-hand engine was found at a distance of several meters from the main wreckage. The right engine was lying on the wreckage. The left wing had separated from the fuselage. The fan blades of the left-hand engine did not show any traces of rotation. The right jet engine had obviously been rotating with high power. The indications of the engine instruments, which were discovered later on, were in conformity with the traces found on the engines. Caused by the impact, both thrust levers were in the neutral position.

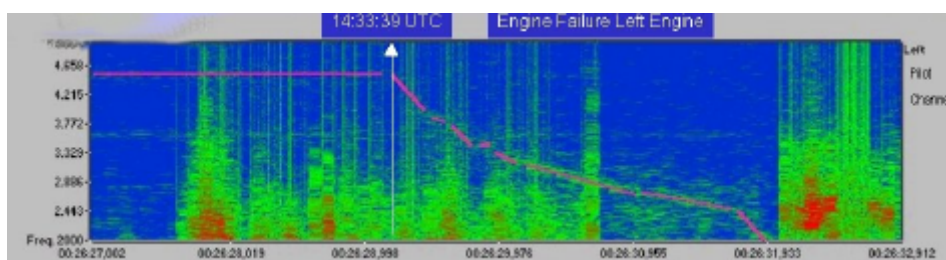
Spectrum Analyses CVR - Engine Failure - (Pilots' Channel only)

A little less than 3 minutes after the take-off at an altitude of appr. 5900 ft and an airspeed of 250 kt the failure of one of the power plants is clearly to be heard on the cockpit voice recorder. The second pilot informed Nürnberg tower that they had an emergency because of the failure of the left power plant and that they intended to initiate a descent for landing. The tower controller confirmed receipt of the message and requested the crew to contact radar on the frequency 118.97 as they were responsible for the airspace concerned.

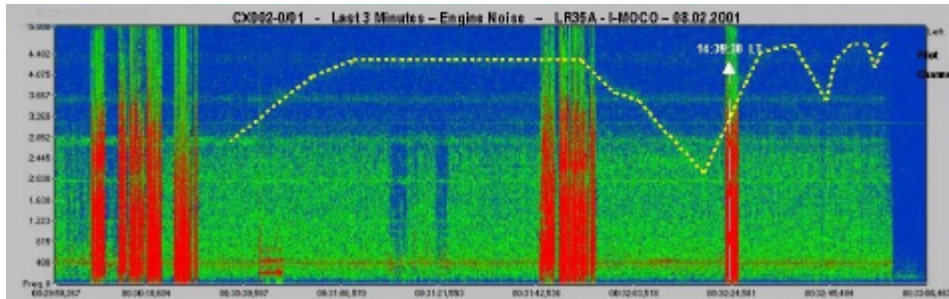
Engine Noise last 3 Minutes - (CVR - Pilots' Channel only)

The Learjet descended below the 3° glide path for an instrument approach. The sudden speeding up of the right engine occurred almost simultaneously with the reduction of the descent rate. The airplane started to deviate from the extended center line to the left. Approximately 10 seconds later the pilot commanded "Flaps 20" in Italian language, the engine power was slightly reduced for a short time. The instruction to reduce the flap setting was confirmed by the second pilot with "Flaps 20", but obviously was not carried out immediately. The short command "Do it" was following. The descent rate was reduced to almost level flight. Simultaneously the engine was speeded up again to take-off power. The height increased to approximately 30 to 50 meters above ground, the engine power was slightly reduced for a short time and thereafter increased again. The flight behavior of the Learjet showed that after the retraction of the flaps to 20° the airspeed was permanently quite close to stall speed. In addition to the low airspeed and the flight configuration changes the asymmetric fuelling of the tip tanks had presumably contributed to the flight behavior observed during the last 30 seconds before the crash.

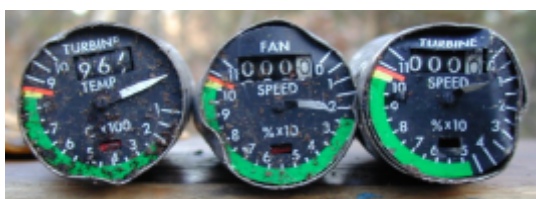
Right engine had been running at high speed

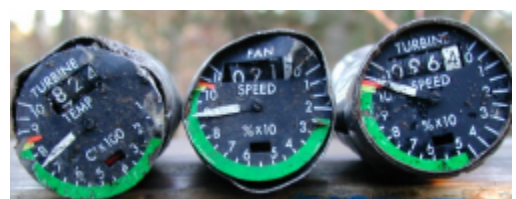
Engine - Engine Instruments

left engine	right engine
fan speed (%N1)	00.0	91.4
turbine speed (%N2)	00.0	96.4
ITT (C°)	967	824

Right Engine ↑
