Aircraft Accident Report

CX003-0/01
March 2002

Occurrence: accident
Date of the occurrence: 08. March 2001
Location: Hamburg
Aircraft: aeroplane
Manufacturer/type: Cessna / C 525 Citation Jet
Injuries to persons: none
Damage to the aircraft: Aircraft severely damaged
Other damage: one runway edge light destroyed

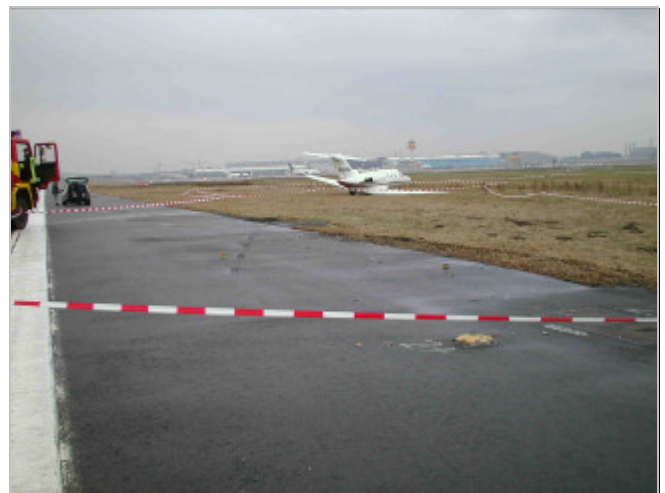
At appr. 21:20 hrs Central European Time, the Citation Jet was on final approach to runway 15. According to the statement of the pilot, the aeroplane touched down normally with the right-hand landing gear yielding immediately. By counteracting the aeroplane movement, the pilot managed in delaying ground contact of the right-hand wing and afterwards holding the Citation Jet over a distance of 1000 m on the runway. Finally the aeroplane stopped 30 m to the right beside runway 15 und appr. 300 m in front of the intersection with runway 23.
