Factual Report

CX008-0/07
September 2007

Type of Occurrence: Accident
Date: 16 June 2007
Location: Seedorf airfield
Aircraft: Aeroplane
Manufacturer / Model: Avions Pierre Robin / DR 400-160
Injuries to Persons: Pilot and two passengers fatally injured
Damage: Aircraft destroyed
Other Damage: Forest damage
Source of Information: Investigation by BFU

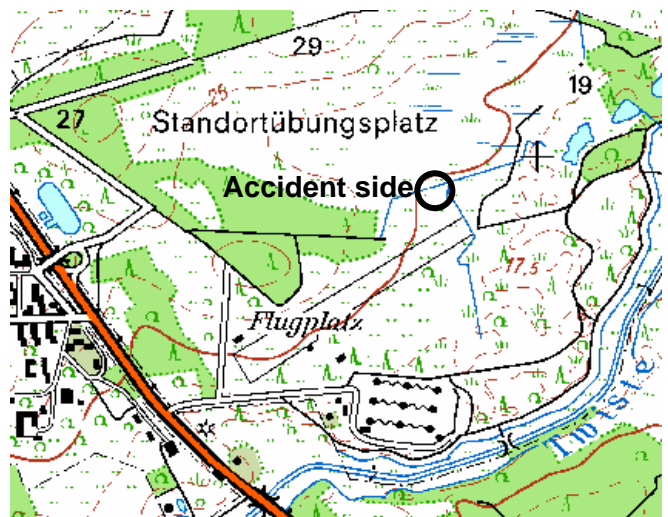
At about 13:10 hrs, a witness noticed a cloud of smoke near Seedorf special airfield. At about 16:30 hrs, the police found the burnt-out aircraft at the north-eastern end of the airfield, approx. 150 m to the left of the end of grass strip 06 in a forest.

The three occupants could only be recovered dead
