# Investigation Report

Type of Occurrence:	Accident
Date:	14 September 2009
Location:	Near Jena-Schöngleina Airfield
Aircraft:	Airplane
Manufacturer / Model:	G. J. Vicherek, Czech Republic / Europa XS
Injuries to Persons:	Two persons fatally injured
Damage:	Aircraft destroyed
Other Damage:	Minor damage to forest
Information Source:	Investigation by BFU external experts for field investigation
State File Number:	BFU CX014-09

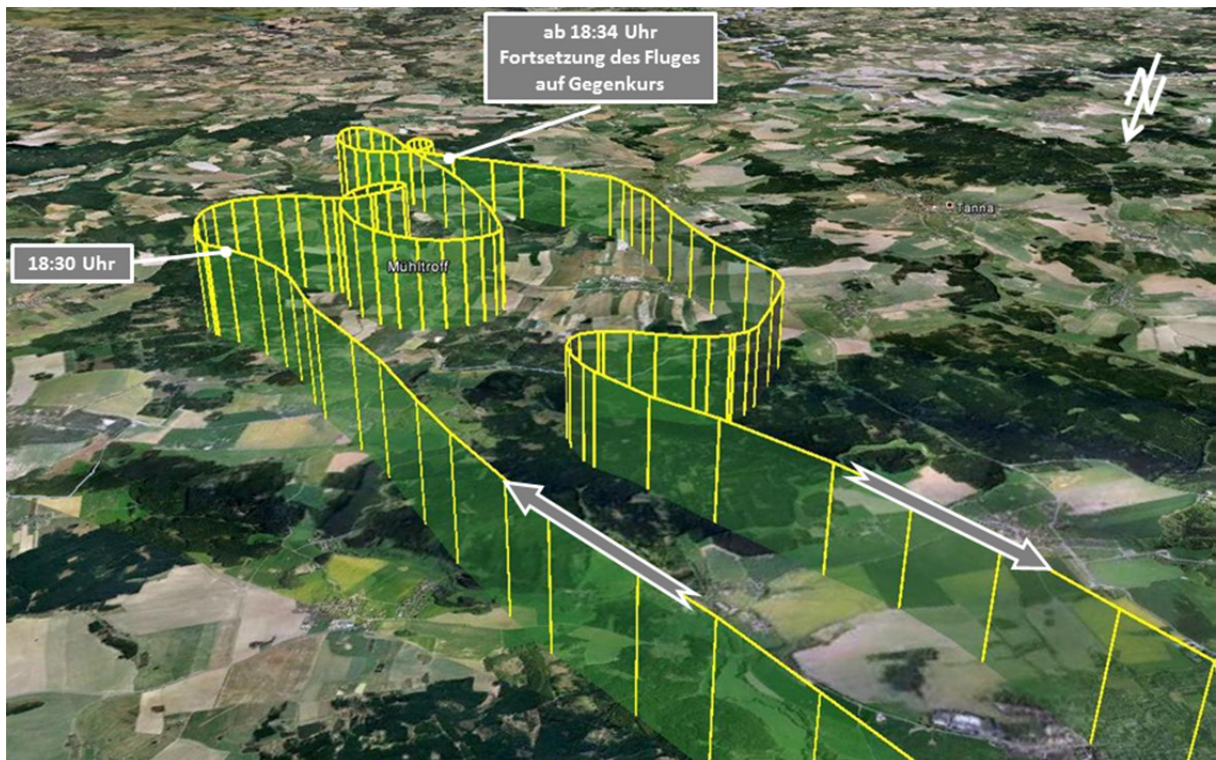
Flight path between 1824 hrs and 1843 hrs

According to the GPS recording, until 1830 hrs the airplane flew with almost constant south-east heading and constant altitude toward the destination airport.

After several changes in heading, at 18:34 hrs it was on opposite course, i.e. on a north-west track.

Until 1830 hrs, the airplane's south-east track and flight altitude remained almost constant. At that time the distance to the destination was still about 115 NM. The subsequent heading change and the decision made at 1834 hrs show that the pilot estimated that the visual meteorological conditions might not be sufficient to continue the flight.

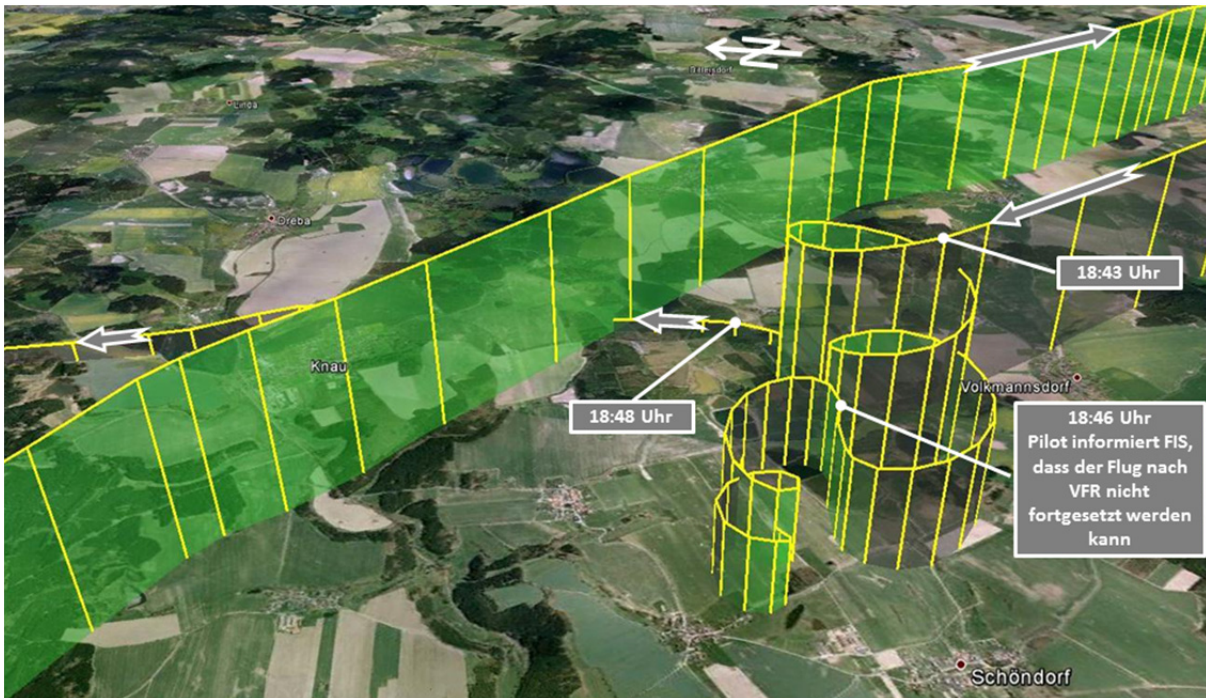
Flight path between 1843 hrs and 1851 hrs

At 18:43 hrs the airplane left the cruising altitude, according to the radar recording it was at about 3,600 ft AMSL, and continued the flight in approximately 1,600 ft AMSL on a north-west track.

At 1846 hrs the pilot informed FIS that he could not continue the VFR flight: *"[...] I don't think we can continue further VFR so we'll try go back and take a landing at an airport nearby, can you give us the current weather at Hof please."*

The subsequent descent to approximately 1,600 ft AMSL and the information to FIS at 1846 hrs that the VFR flight could no longer be maintained show that the weather conditions in the area had worsened rapidly. It is to be assumed that due to weather conditions the return flight to Erfurt Airport, 36 NM away, was impossible as well.

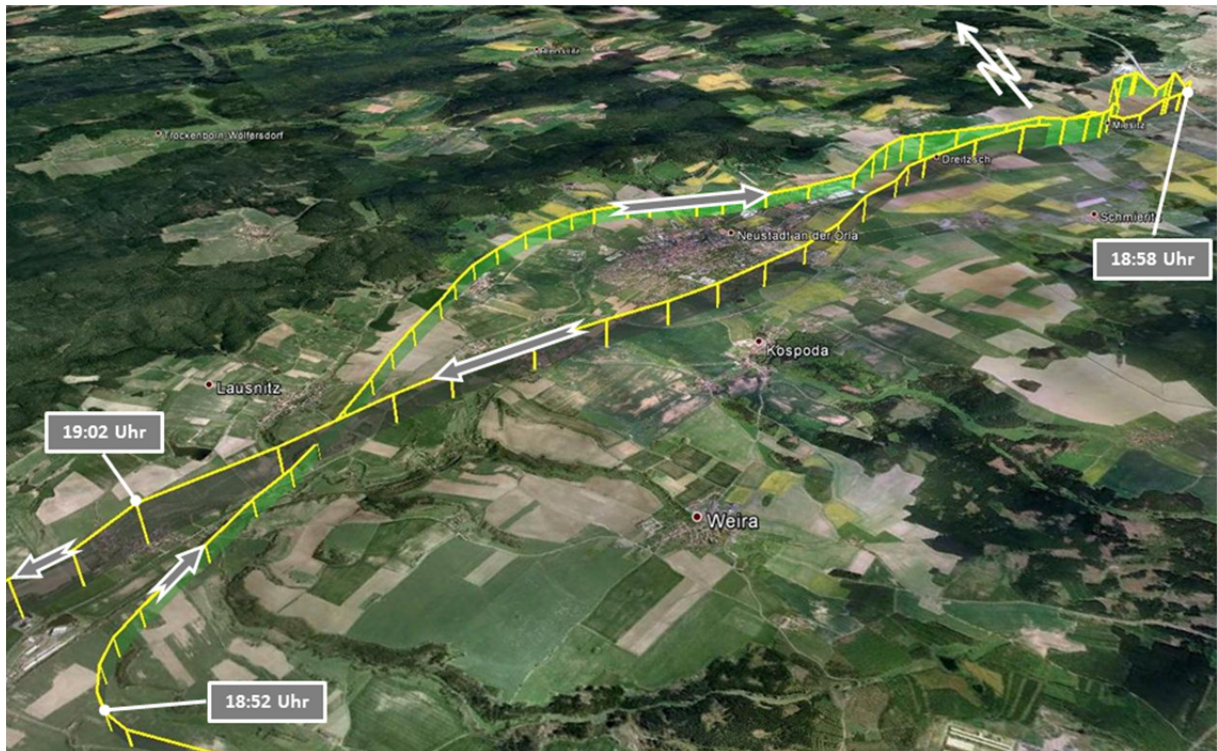
Flight path between 1852 hrs and 1902 hrs

At 1852 hrs the airplane was on an eastern track and had entered a wide valley located between the towns Neustadt an der Orla and Triptis. At 1858 hrs shortly before reaching Triptis it changed course again to a western track. The flight altitude recorded by radar was between 1,600 ft AMSL and 1,500 ft AMSL.

After 1852 hrs FIS tried to contact the airplane by radio a total of seven times. Radio contact could not be established again.

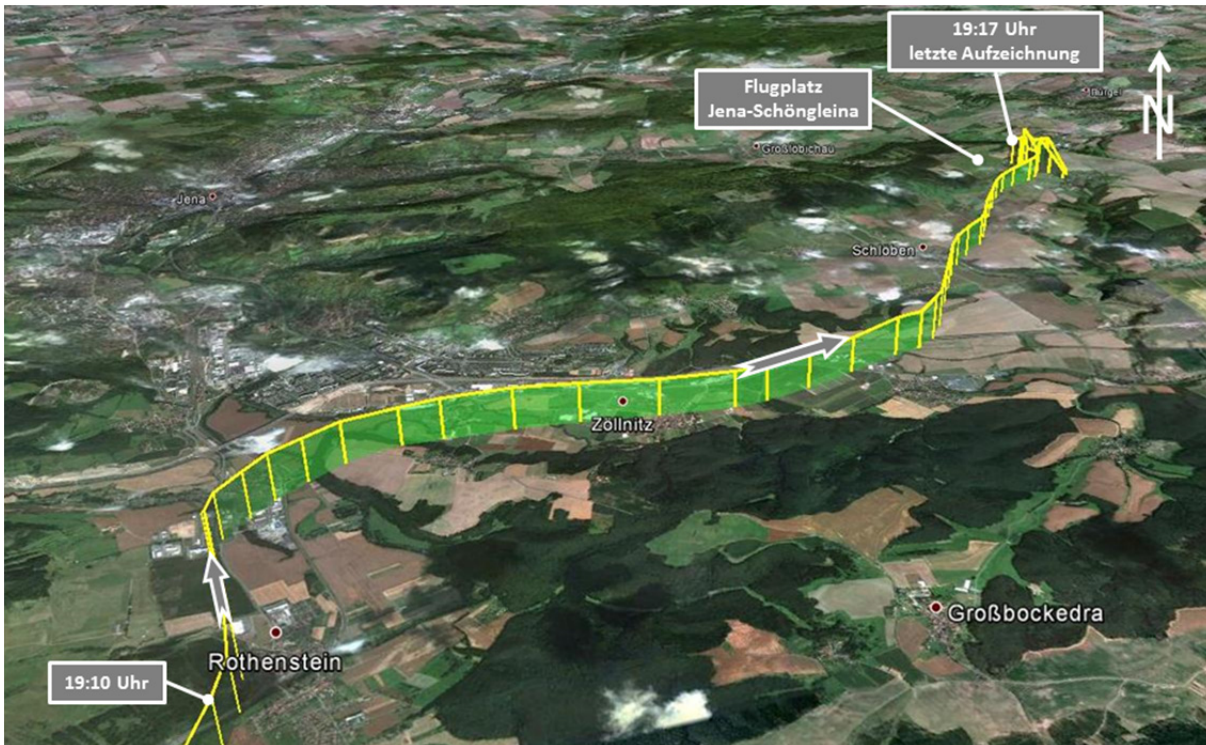
Flight path between 1910 hrs and 1917 hrs

The GPS recording shows that the airplane had followed two valleys north and at 1910 hrs it reached the town of Rothenstein, 1.5 NM south of Jena. Afterwards the flight ran parallel to the motorway A4 on an eastern and north-eastern track.
