Investigation Report

Type of occurrence:	Accident
Date:	18 November 2009
Location:	Emden
Aircraft:	Civil Air Transport
Manufacturer / Model:	Dassault / Falcon 900EX
Injuries to persons:	None
Damage:	Aircraft seriously damaged
Other damage:	Slight crop damage
Source of Information:	Investigation by BFU
State File Number:	BFU CX015-09

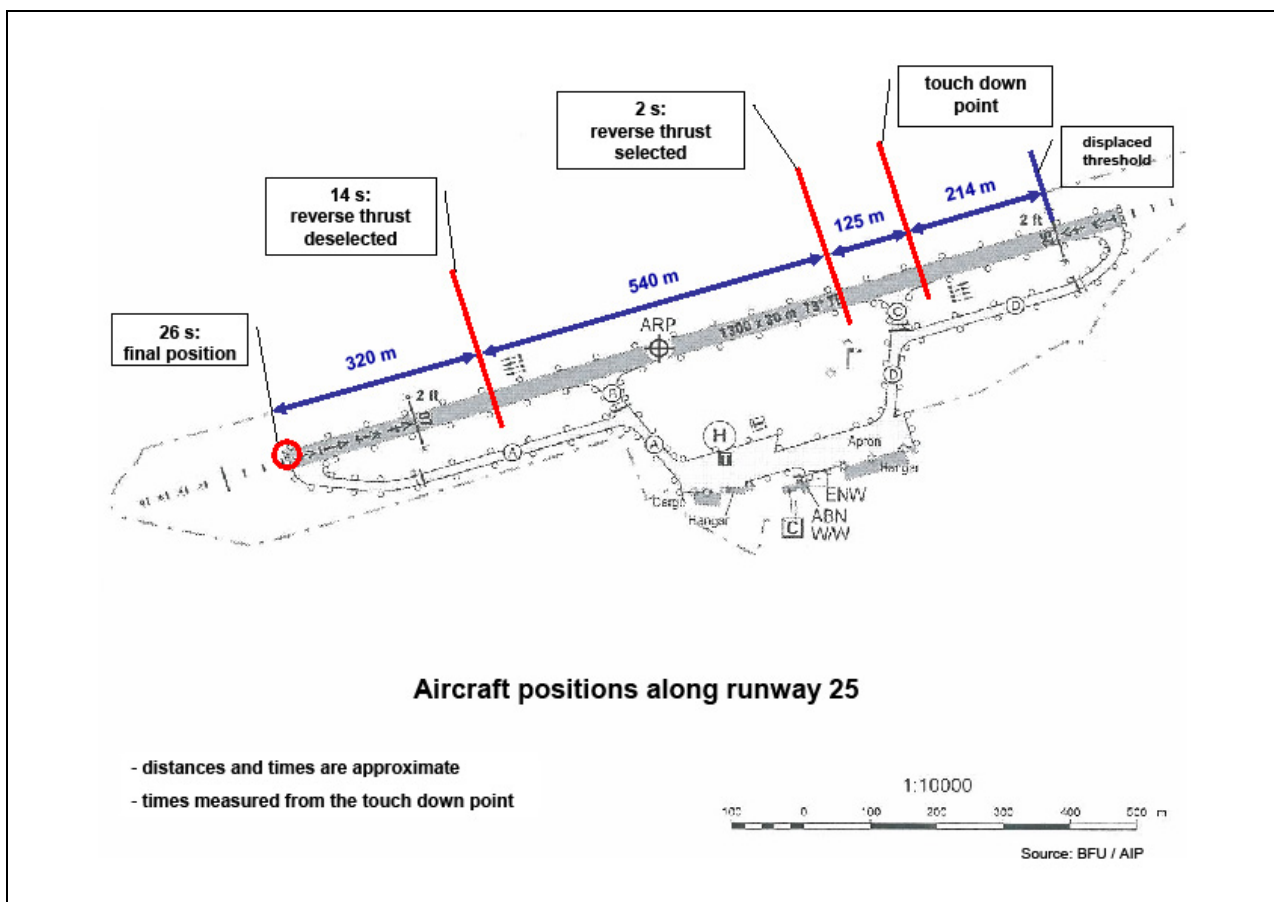
said it was their intention to avoid a collision with the runway lights located on the grass just after the hard runway. At this point, the DFDR recording shows the speed as about 62 kt CAS (49 kt ground speed). The aircraft rolled off the end of the hard runway at a ground speed of about 15 kt; 2.40 m from the runway edge it collided with a concrete plinth for Runway 07/25 approach lighting. The nose gear broke off, and the aircraft came to a stop one metre further on.
