# Investigation Report

Type of Occurrence:	Accident
Date:	12 September 2010
Location:	Abbesbüttel
Aircraft:	Hot Air Balloon
Manufacturer / Model:	Lindstrand Hot Air Balloons Ltd. / LBL 330A
Injuries to Persons:	Eight people with severe and five people with minor injuries
Damage:	Aircraft severely damaged
Other Damage:	Damages to buildings, cars and fences
Information Source:	Investigation by BFU
State File Number:	BFU 3X134-10

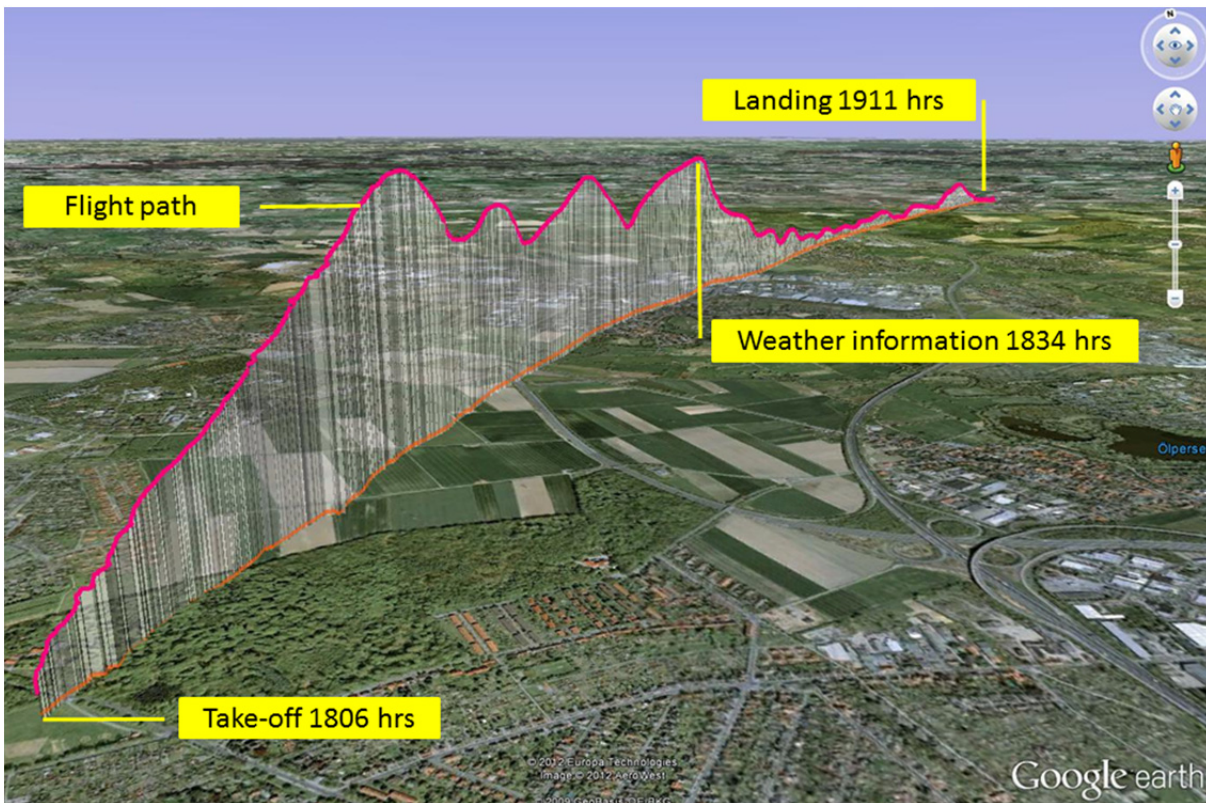
Flight path reconstruction

At 1907 hrs the balloon began to descent and touched down on a stubble field at 1911 hrs at a wind speed of about 3 kt.

The GPS data read-out showed that after touch-down the balloon stood at the landing site for about 1.0 to 1.5 minutes. During this time, the pilot had begun to vent the burner hoses and to extinguish the pilot lights while he waited for the ground crew. Suddenly, wind had arisen and the balloon had moved. He had then instructed the passengers to hold on like they did during the landing and began to open the envelope. The wind made a sail in the form a spinnaker of the larger part of the envelope and the basket was dragged along the ground.

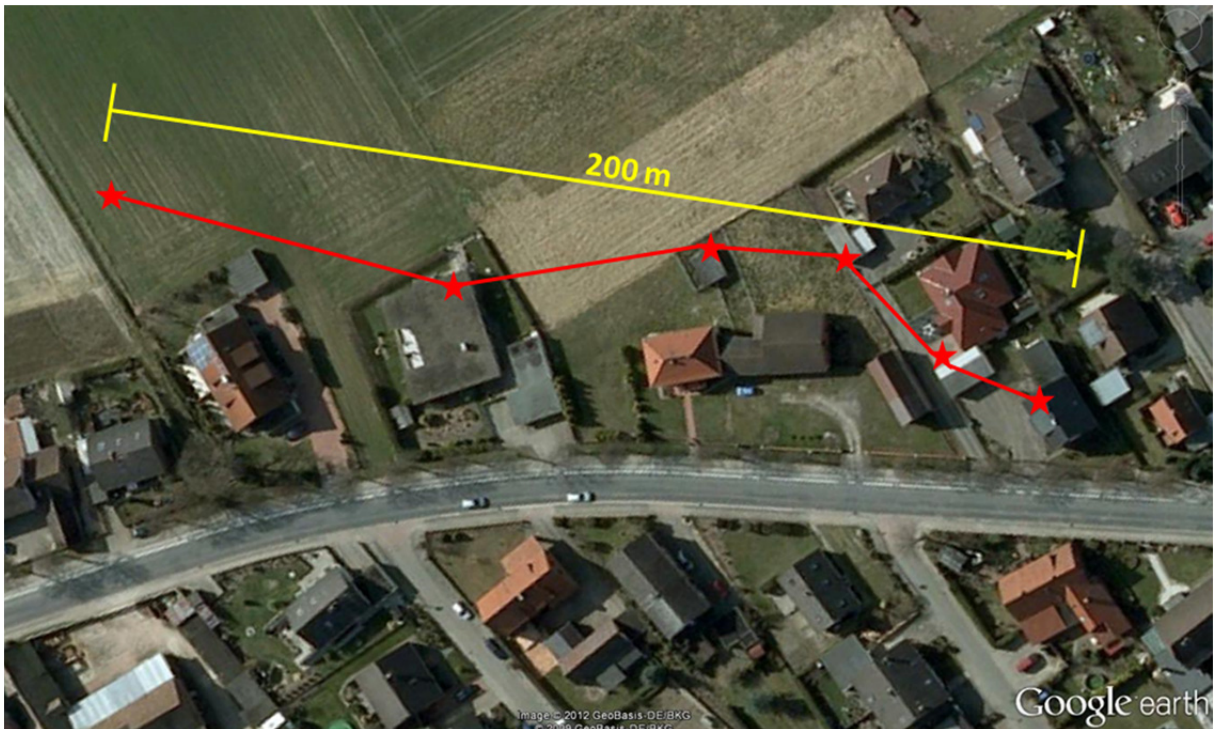
Accident site

The accident site was located at the north-western part of the town Abbesbüttel on several private properties.
