# Investigation Report

Type of Occurrence:	Accident
Date:	18 February 2012
Location:	Lahr Special Airfield
Aircraft:	Helicopter
Manufacturer / Model:	Amateur-built aircraft / Safari
Injuries to Persons:	Pilot fatally injured
Damage:	Aircraft destroyed
Other Damage:	None
Information Source:	Investigation by BFU external experts for field investigation
State File Number:	BFU 3X006-12

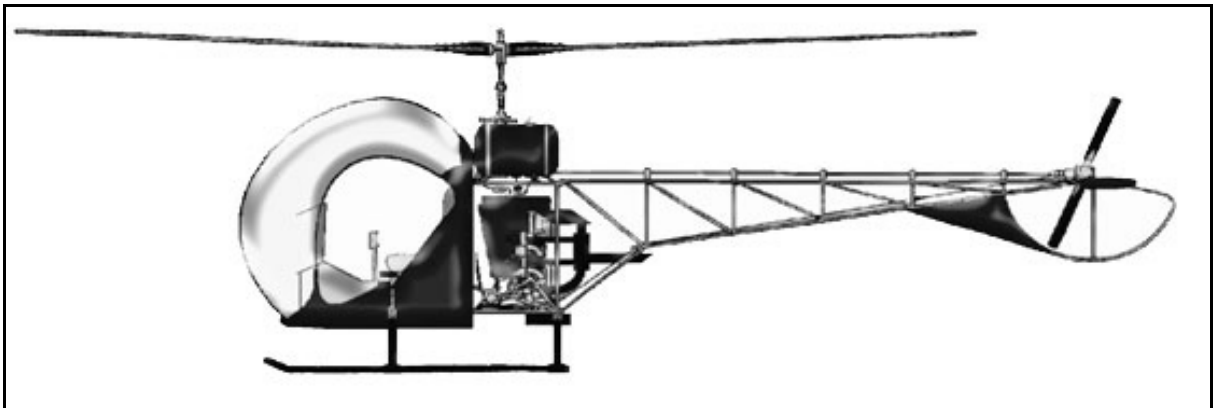
Side view

The helicopter Safari of the current kit producer Safari Helicopter is a two-seat helicopter for self-construction. Visually it is based on the Bell 47. The helicopter has skids, a two-blade main rotor rotating clockwise and a tail rotor for anti-torque. Maximum take-off mass is 700 kg. The helicopter is supposed to be equipped with a Lycoming 360 engine. Components such as main rotor head and tail rotor are delivered to the customer fully assembled.
