Investigation Report

Type of Occurrence:	Accident
Date:	21 March 2013
Location:	Berlin
Type of aircraft:	Helicopter
Manufacturer / Model:	1. Eurocopter / EC155 B 2. Eurocopter / AS 332 L1
Injuries to Persons:	One person fatally, four people severely injured and five people with minor injuries
Damage:	Both aircraft seriously damaged
Other Damage:	Damages to fields and vehicles
Information Source:	Investigation by BFU
State File Number:	BFU 3X010-13

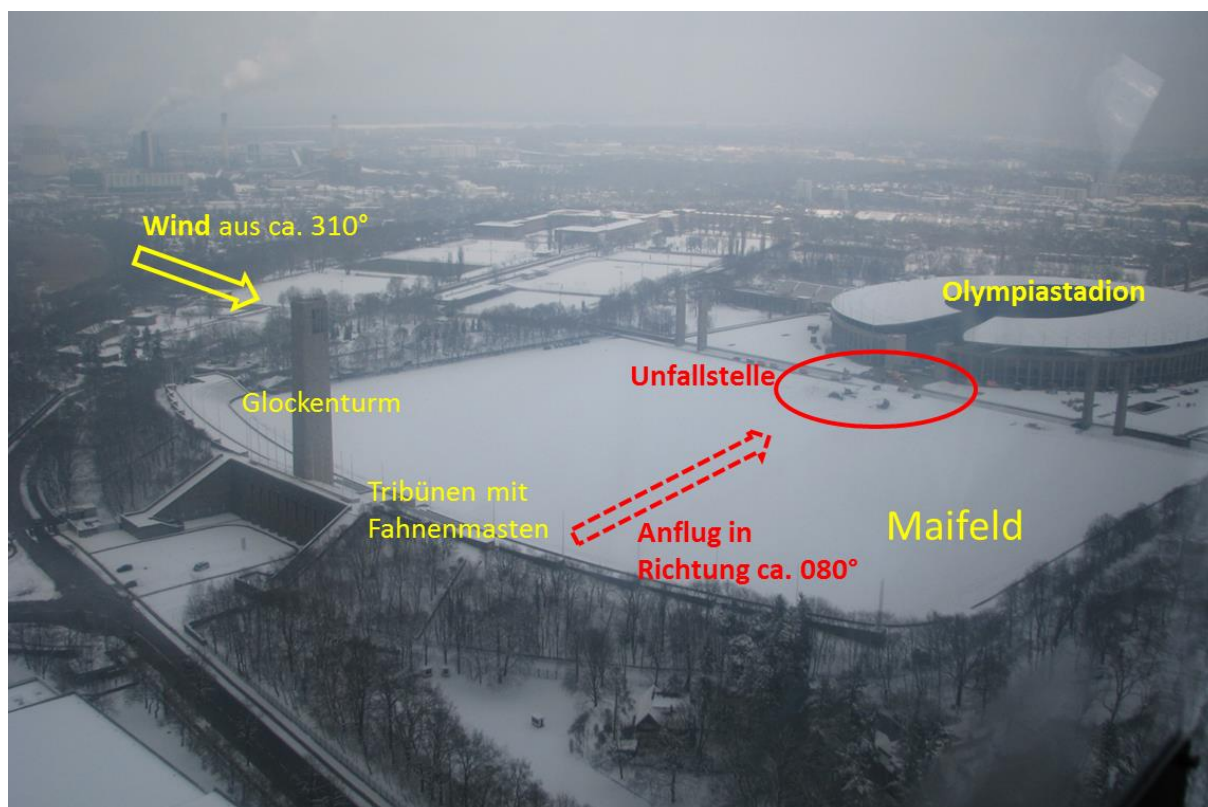
Overview Maifeld, Olympia Stadium and accident site

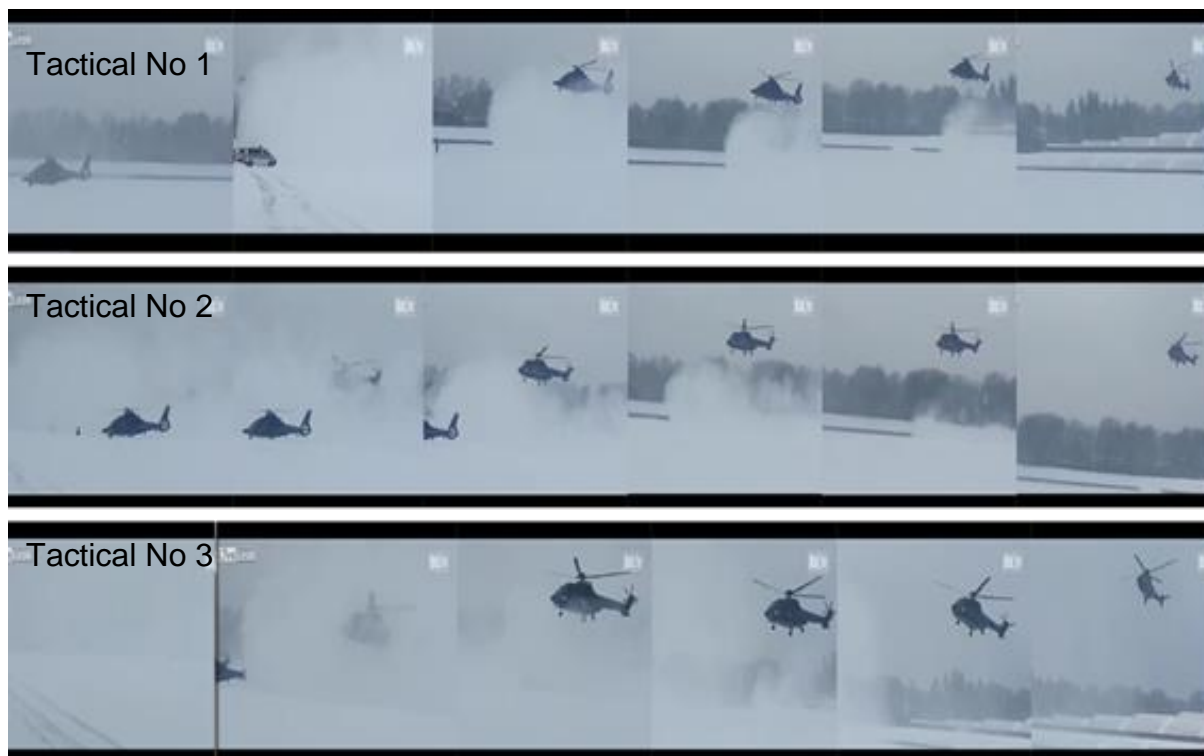
The second helicopter to land was Tactical No 2, an AS 332 L1, occupied by one pilot, one flight engineer and fourteen tactical forces. Tactical No 2 approached right of Tactical No 1 which was contradictory to the landing position agreed on prior to take-off. The crew stated the decision had been made because of the observed re-circulating snow and the drift of it. Because Tactical No 2 had changed their landing position, Tactical No 3 enquired and received the instruction to land left of Tactical No 1. The video recordings show that the approach of Tactical No 2 was rather steep with slow forward speed. Already during the descent the helicopter caused snow to recirculate and was engulfed by it. The crew stated that they had had visual contact with the marshaller or Tactical No 1 at all times. Prior to the final touch-down the helicopter hovered for about 30 seconds forward and backward and caused snow to re-circulate the entire time. The pilot stated that hovering was prolonged a little in order to achieve better positioning and alignment with Tactical No 1. The re-circulating snow engulfed Tactical No 1. The pilot of Tactical No 1 observed the slow touch-down of Tactical No 2 and commented: "Er hat zu früh die Fahrt herausgenommen (he decelerated too soon). Na ja, ihr seht jetzt was das für ein Problem ist, man hat keine Referenz mehr" (Now you can see what problem this is, one has no reference point any more). And: "Er geht jetzt nach hinten mit der Maschine (He now goes backward with the machine). Das ist sehr gefährlich" (This is very dangerous).

At that time Tactical No 3, also an AS 332 L1, was on approach already. It was occupied with one pilot, one flight engineer and thirteen tactical forces. According to the agreed change the helicopter approached left of Tactical No 1. During the approach the re-circulating snow around Tactical No 1 was observed and described as moderate. After passing the stand the helicopter curved left and while decelerating it was slightly left of the corresponding marshaller (viewed from the approach direction). The flight engineer confirmed that the landing gear had been extended, asked the pilot if he could see the marshaller and turned off the heating. The pilot acknowledged this information either with "Ja" (Yes) or "Okay". The video recordings show that the helicopter hovered with reduced forward speed slowly to the right during the descent. It also caused re-circulating snow which engulfed the marshaller and the two helicopters already on the ground. During touch-down the flight engineer reported "Ja null Fuß, oh" (Yes zero feet, oh) before the CVR recording stopped. The Pilot stated that until the flare and the complete deceleration about 2 m in front of the marshaller he had had visual contact with the marshaller at all times. The increased

re-circulating snow had made the image of the marshaller somewhat diffuse and then he suddenly disappeared entirely.

Approaches of the three helicopters

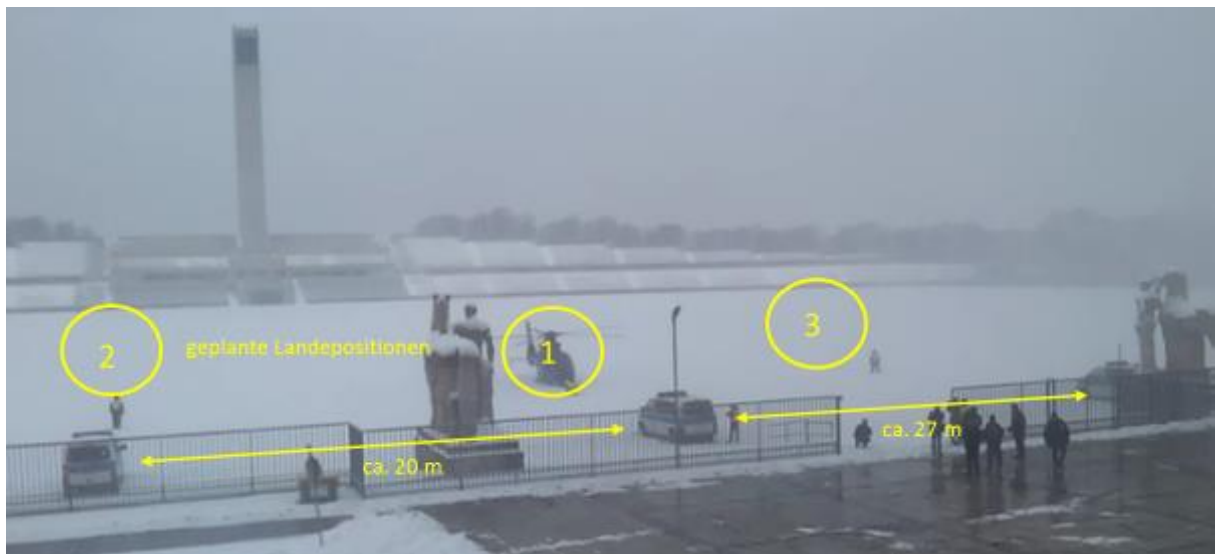
Buses were parked at the eastern end of the Maifeld as landing markers for the helicopters. The distance between the buses was approximately 20 m and 27 m, respectively. About 15 m in front of each of them stood one marshallsers.

Overview landing site Maifeld

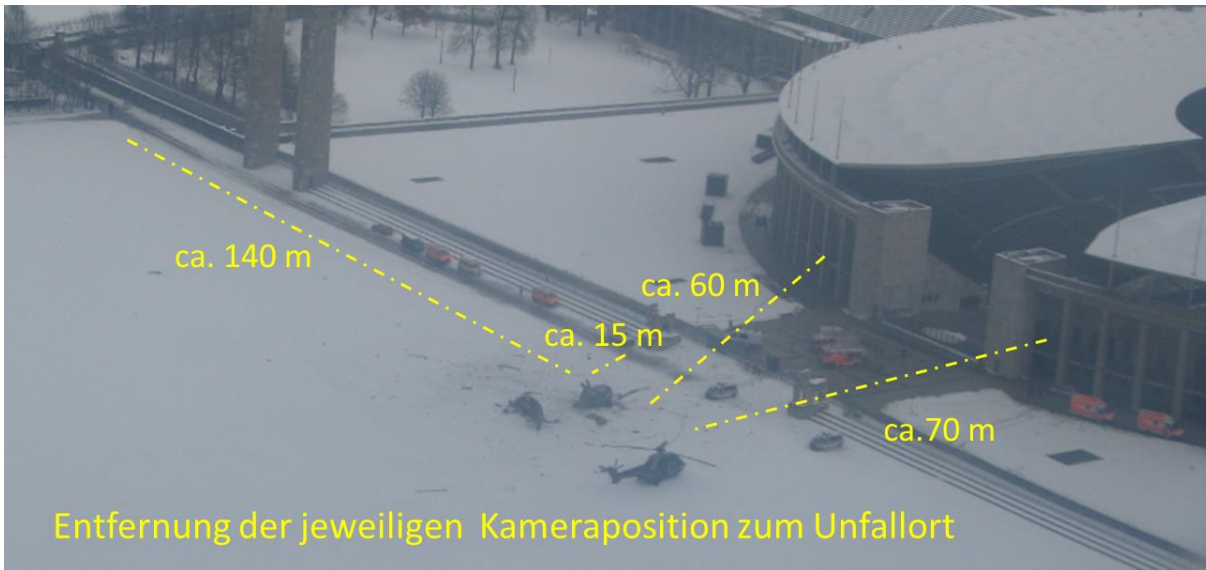
The BFU has four video recordings from different positions on the ground of the approaches of the three helicopters, the re-settling of the re-circulating snow after the accident and the evacuation of the occupants.

Camera positions, camera angle and distance to the accident site

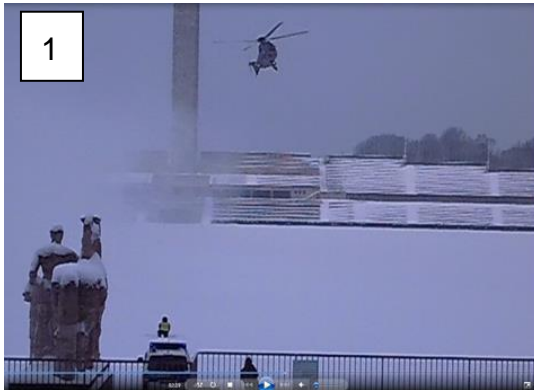
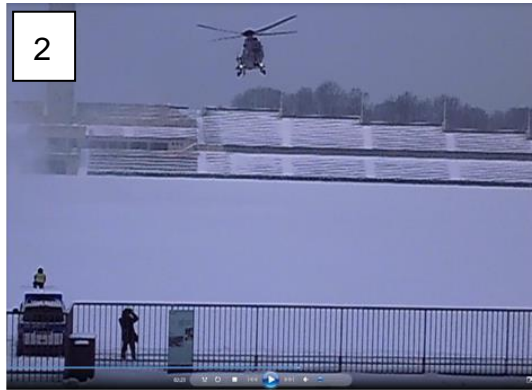
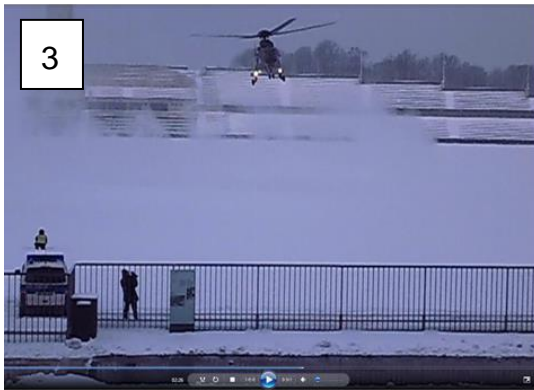
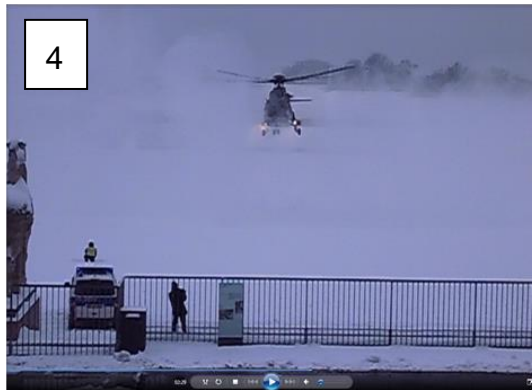
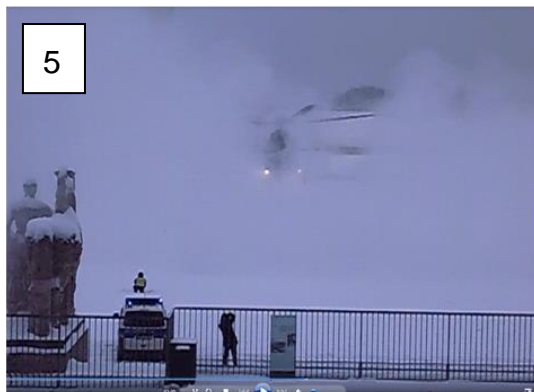
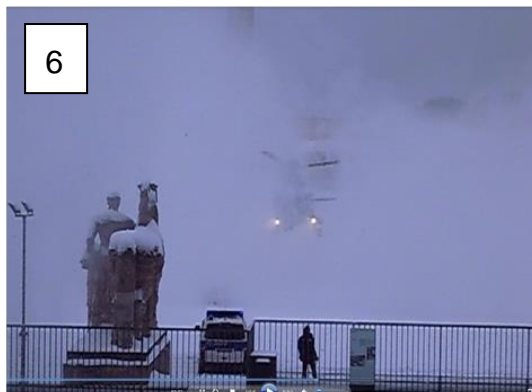
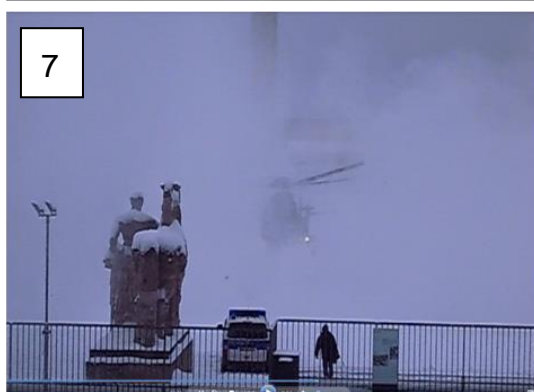
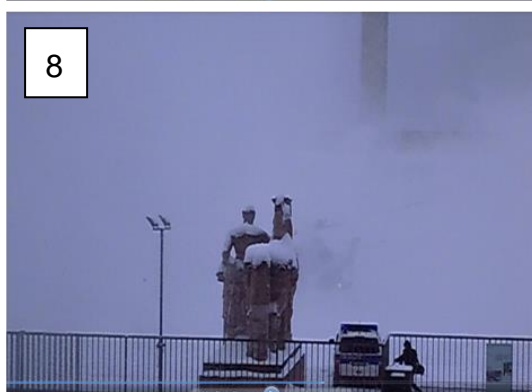
Sequence of photos of the approach of Tactical No 3
