INCIDENT INVESTIGATION REPORT

**QANTAS AIRWAYS LTD.
BOEING 707-338C AIRCRAFT VH-EAD
AT FIUMICINO AIRPORT, ROME
ON 30th APRIL 1970.**

Prepared by:
Air Safety Investigation Branch Melbourne
November 1970.

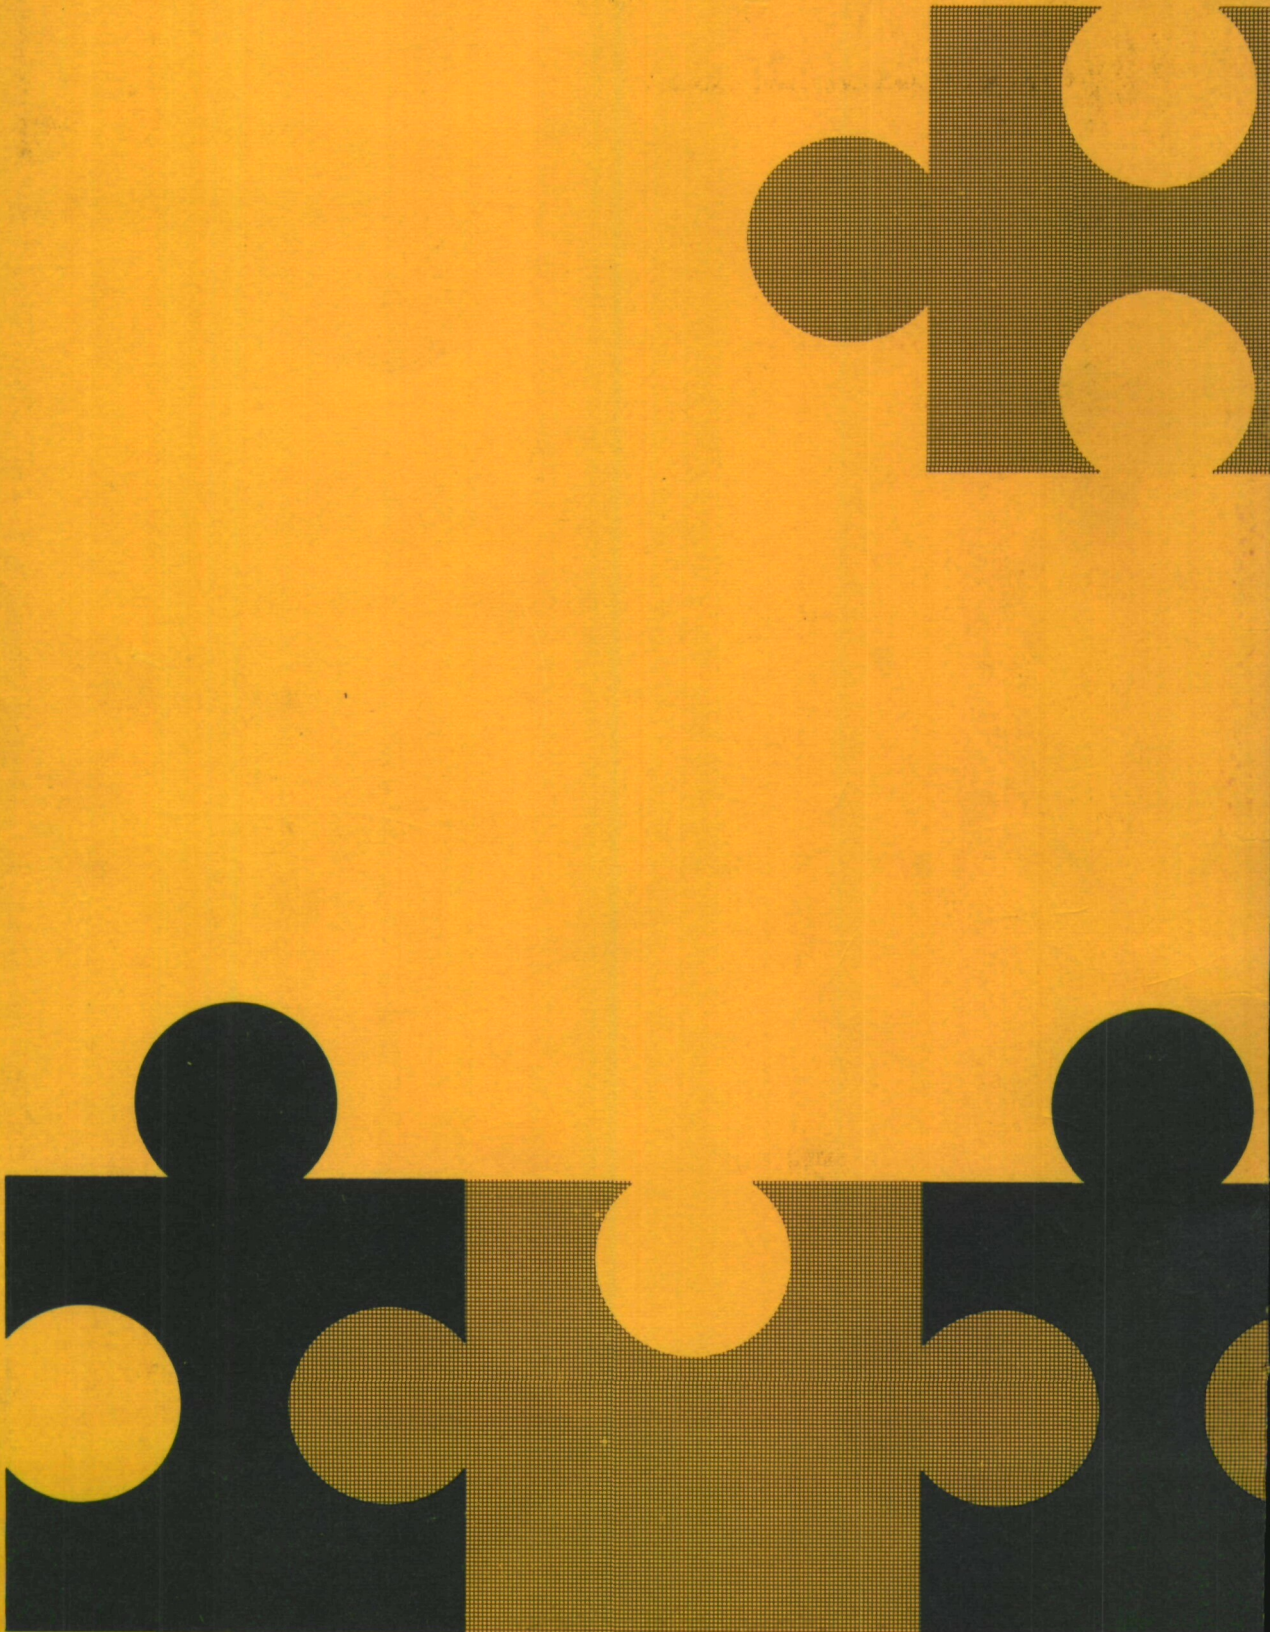
PLAN OF AIRCRAFT PATH AND SKID MARKS
VH-EAD, FIUMICINO AIRPORT, 30-4-70

The most significant skid mark was that commencing approximately at the point marked 3 and extending to just beyond the point marked 7. This was a nosewheel skid mark in which the marks of both tyres were clearly discernible. At the first point at which they could be observed the marks were fairly widely spaced (i. e. of the order of 20 inches centre to centre) and they then quickly converged until they were separated by approximately 14 inches centre to centre. These marks subsequently diverged again, approximately at the point marked 6. The other skid marks, both nosewheel and mainwheel, were consistent with those which are to be expected under the circumstances of high-speed, high-rate turns.
