COMANDO DA AERONÁUTICA
CENTRO DE INVESTIGAÇÃO E PREVENÇÃO DE
ACIDENTES AERONÁUTICOS

FINAL REPORT
A-162/CENIPA/2016

OCCURRENCE:	ACCIDENT
AIRCRAFT:	PT-REI
MODEL:	EMB-721D
DATE:	07DEC2016

This is the Final Report of the 07DEC2016 accident with the EMB-721D aircraft, registration PT-REI. It was classified as (SCF-PP) “System/Component Failure or Malfunction (Powerplant)”.

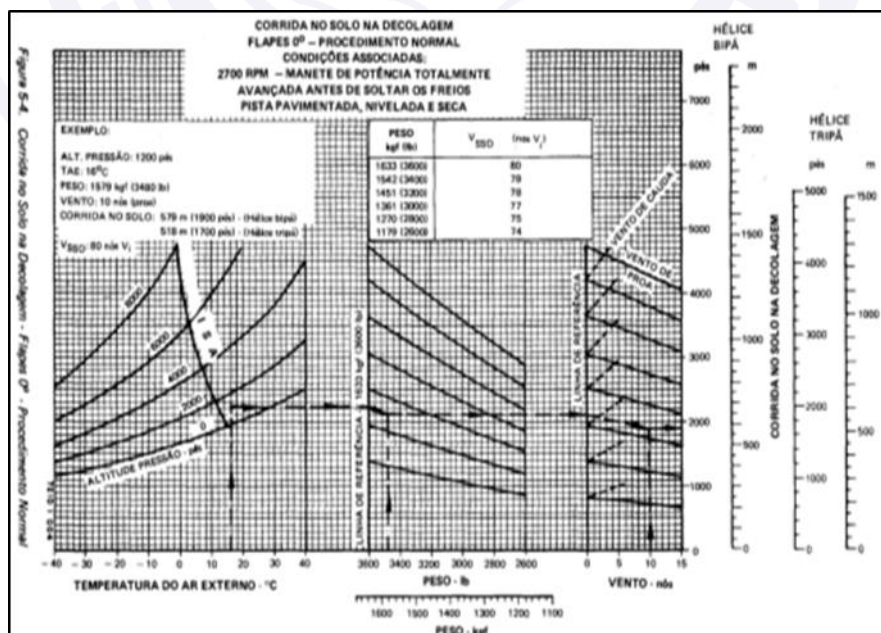
In section 5 of the aircraft manual, there was the following take-off run graph:

For the calculation of the takeoff distance, the conditions at the time of takeoff and the PMD were used as parameters. In this situation, the aircraft would need to travel approximately 650 meters to take off, out of a total of 799 meters available in SWFN.
