## **AVIATION INVESTIGATION REPORT A13H0001**

**CONTROLLED FLIGHT INTO TERRAIN  
7506406 CANADA INC.  
SIKORSKY S-76A (HELICOPTER), C-GIMY  
MOOSONEE, ONTARIO  
31 MAY 2013**

## Aviation Investigation Report A13H0001

Sikorsky S-76A (helicopter), C-GIMY

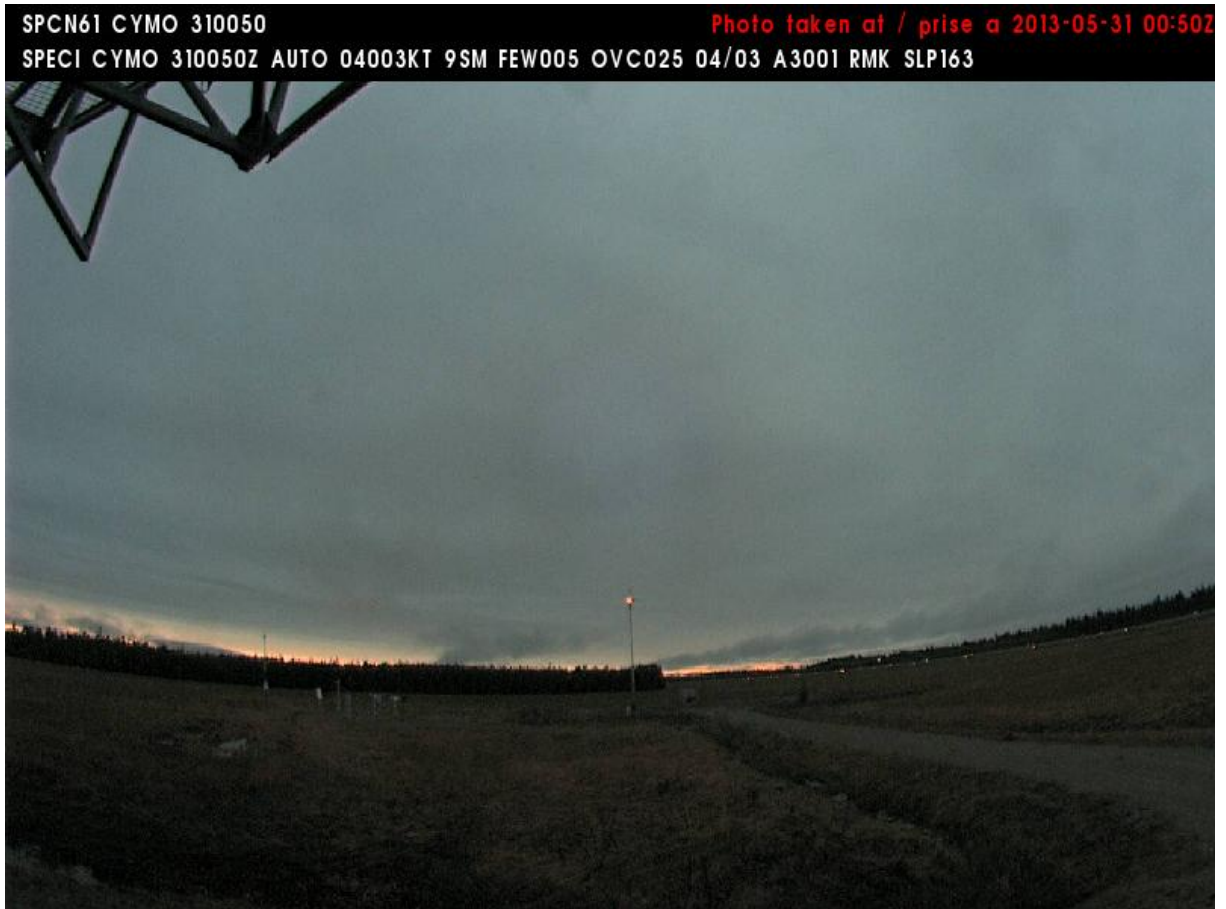
The airport is equipped with 2 weather cameras that take still images every 10 minutes. One of the cameras points to the northeast and the other points to the southwest. The camera pointing to the northeast is oriented in the general direction of Runway 06, paralleling it to the north. In the daylight image from this camera, it is possible to see a lit tower on the airfield and the treeline to the north of Runway 06. Images taken hours before the occurrence clearly show the tower and the treeline (Photo 1). In contrast, the only thing visible in a photograph from approximately the same time as the accident is the single light from the tower located on the airfield (Photo 2). No other cultural lighting, or ambient lighting from stars, is visible in the image.

Photo 1. Image taken by the northeast-oriented weather camera showing the lit tower and the treeline at Moosonee Airport at 2050 on 30 May 2013 (Source: NAV CANADA)
