REPORT

HCLJ510-000356	Accident		
Aircraft:	Sikorsky S-61N	Registration:	OY-HGZ
Engine(s):	2 - CT58-140-2	Type of flight:	Charter, VFR
Crew:	3 – no injuries	Passengers:	24 – no injuries
Place:	Kangia, Greenland	Date and time:	18.4.2007 kl. 1715 UTC

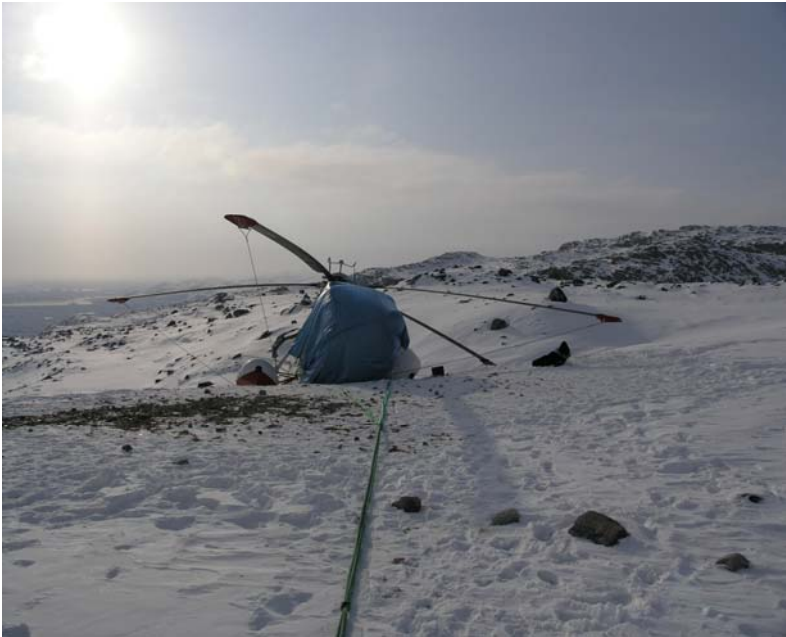
Accident site

The helicopter impacted with the front fuselage followed by the main and the tail landing gear. The helicopter came to rest in a nose-up position on approximately 17 degree sloping ground adjacent to the landing area. After the flight crew completed an emergency shut down of engine number one, the passengers evacuated the helicopter using the air stair door.

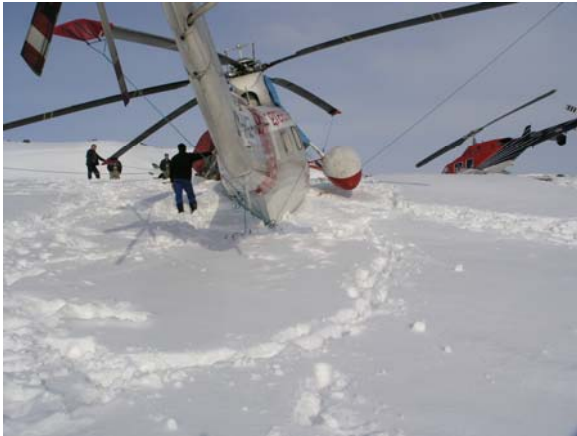
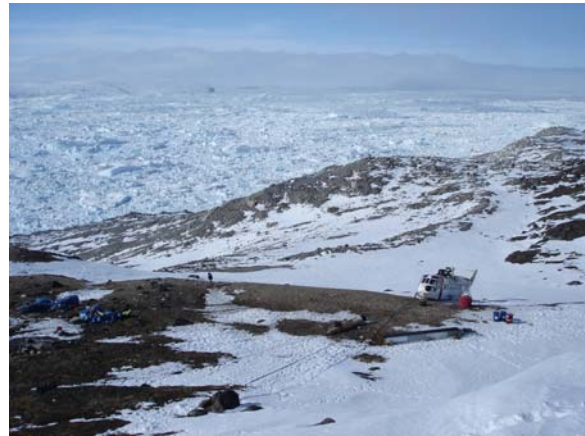
The landing area was situated at 500 ft msl and was a flat spot in a remote mountainous area, approximately 25 nm east of Ilulissat. The condition of the ground was five to ten centimeters light snow on top of 20 to 50 centimeters hard snow. There was a wind sock located in the eastern part of the landing area.

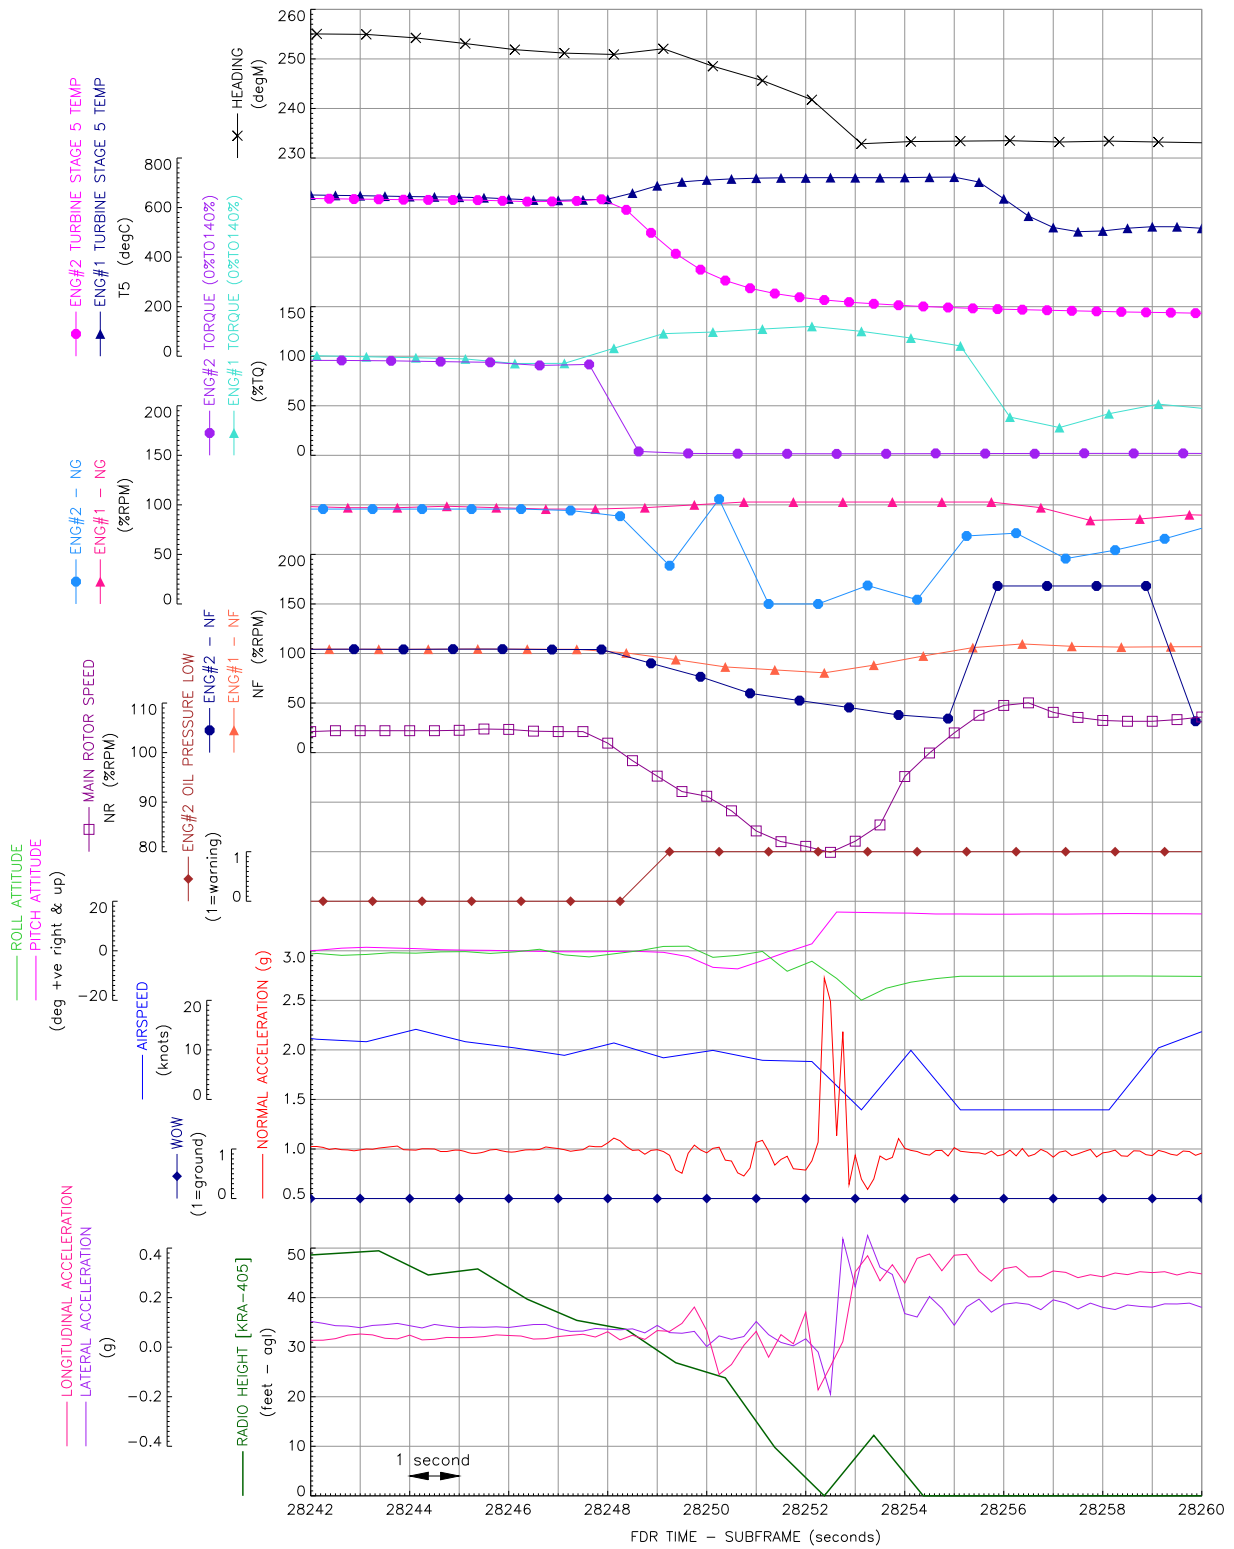
Accident flight.

Note: The eng. 2 data at 28250 sec. is an error as well as some data after the impact.

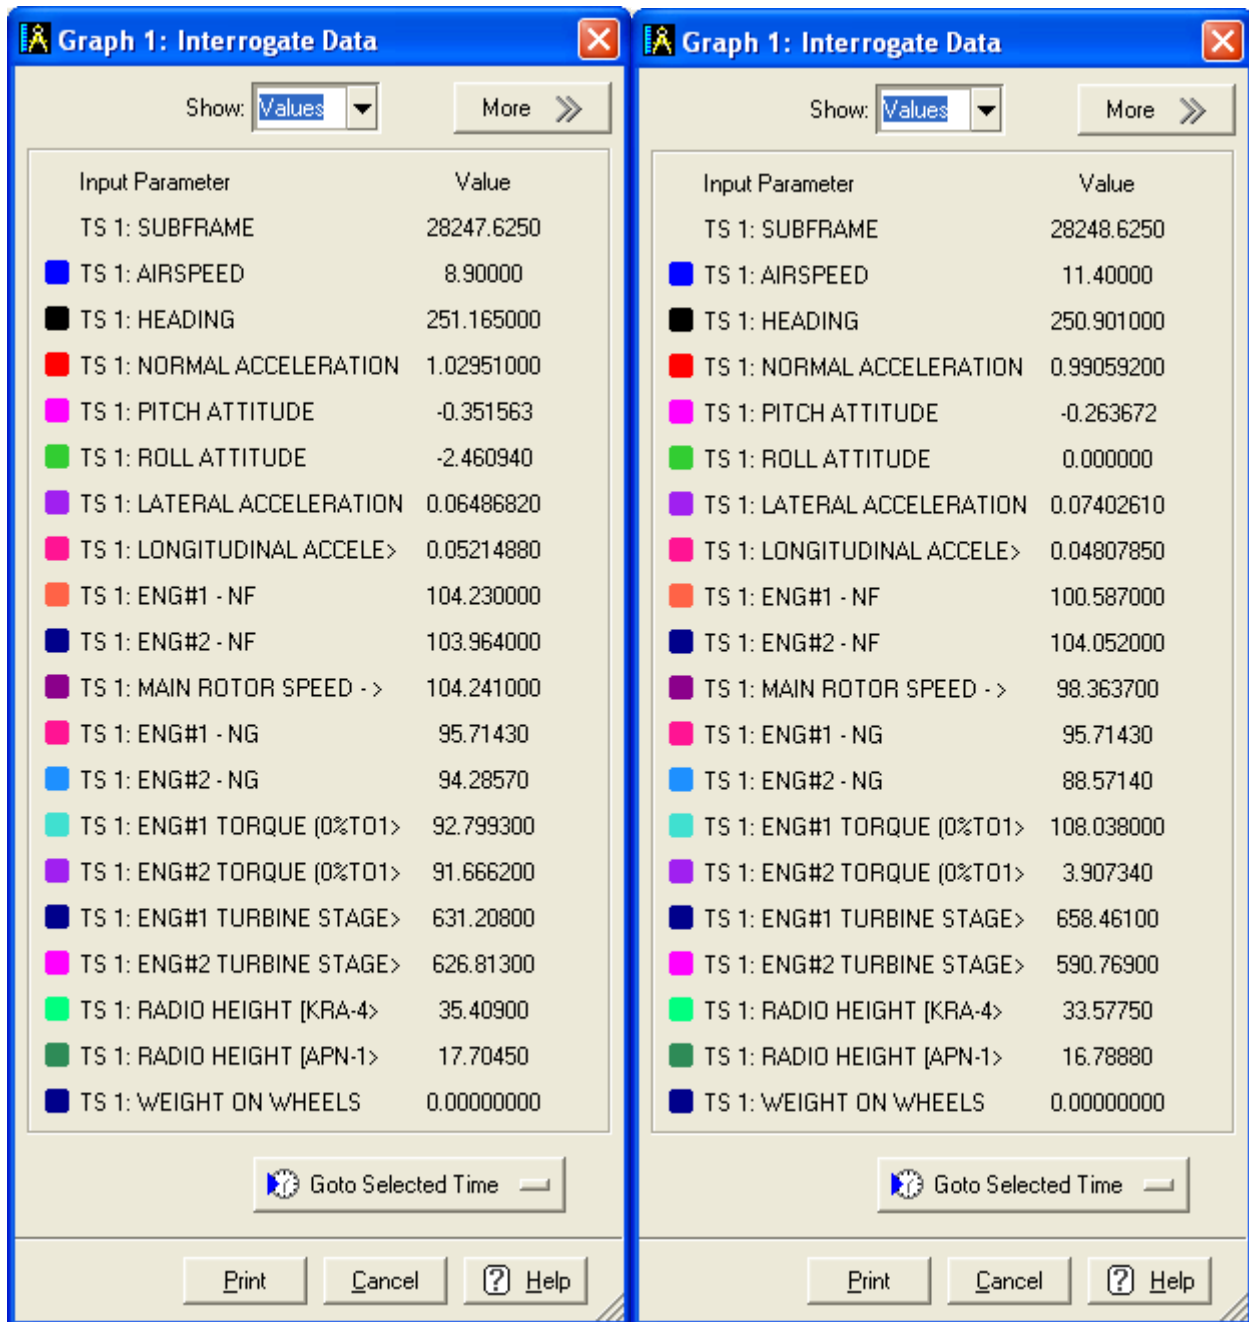
Below data demonstrate the development from 28247.6250 seconds to 28248.6250 seconds (one second).

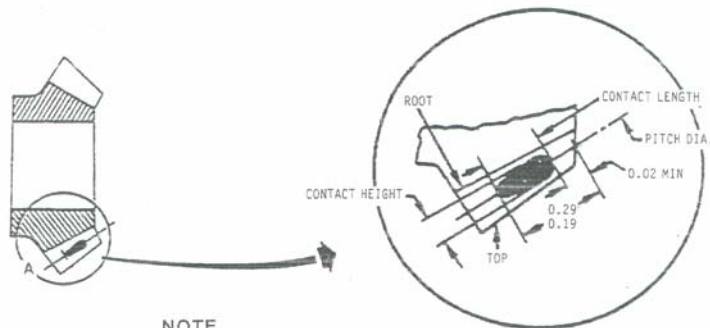
CONTACT LENGTH MUST BE 0.15 INCH MINIMUM BETWEEN LIMITS SHOWN.
CONTACT HEIGHT MUST BE 0.04 INCH MINIMUM AND CENTRAL ABOUT THE PITCH LINE.
CONTACT PATTERN MUST NOT RUN OFF THE TOP OR INTO THE ROOT OF THE GEAR TOOTH.
