## REPORT

| <b>HCL 69/00</b> | <b>Accident</b> | | |
| Aircraft Type: | Socata TB 10 | Aircraft Registration: | D-EACQ |
| Place: | South of Skovmose on Als | Date and time: | 29.11.2000, 1713 UTC |

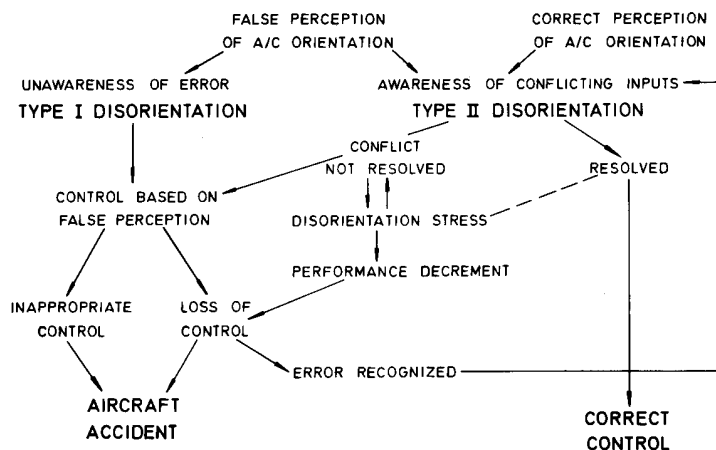
Type I disorientation is the greater hazard to flight safety. The pilot who bases his control of the aircraft on false cues may soon lose control and be left with insufficient time or altitude to regain control, even if he has the skill to re-establish his orientation from instruments or other veridical cues. However, loss of control *per se* is not necessarily a feature of the orientation error accident, though control is inappropriate in all incidents. The pilot who flies his aircraft into the ground

Figure 20.1 – Diagrammatic representation of how Types I and II disorientation can affect the pilot's control of the aircraft.

because of, say, an erroneous perception of pitch attitude on accelerating during a 'missed approach' manoeuvre, or because of an erroneous perception of ground clearance, has not lost control of his aircraft, for, given the sudden realization of his error, he could take appropriate action. Nevertheless, it is a disturbing fact, that many, perhaps the majority, of orientation error accidents are due to Type I disorientation in which the pilot did not realize that he was disorientated.
